**Geologic Hazards and
Geotechnical Investigation
Tax Lots 6100 and 6199, Map 06-11-34DA
N.W. Jetty Avenue
Lincoln City, Oregon**

Project #Y204427

October 23, 2020

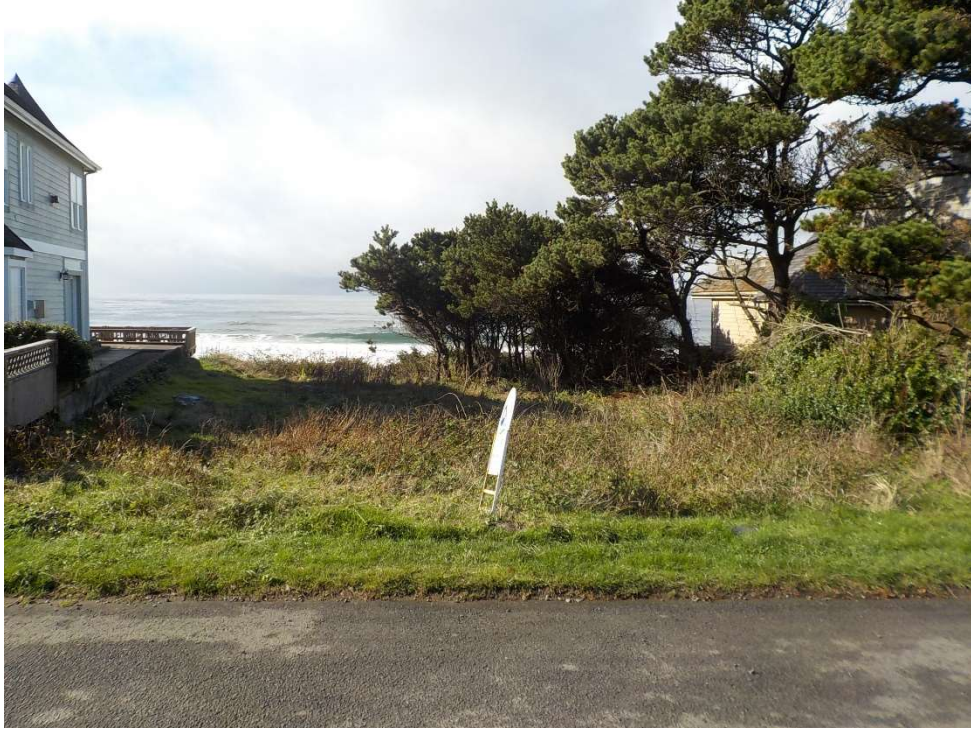
Photo 1 – Westerly view of the site from N.W. Jetty Avenue.

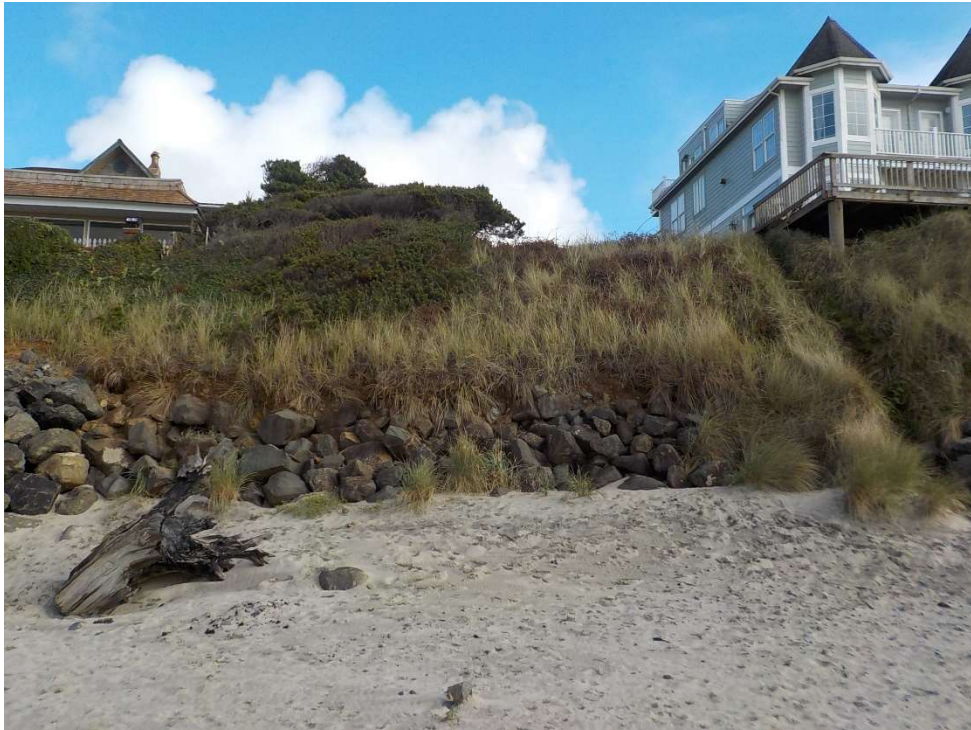
Photo 2 – Easterly view of the site from the beach.

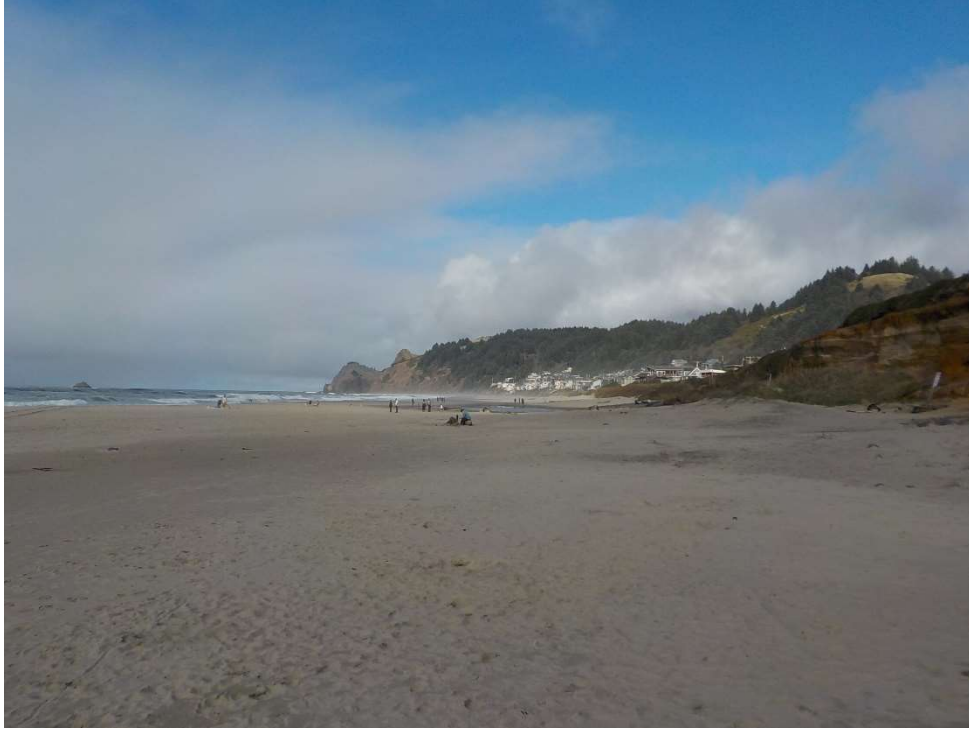
Photo 3 – Northerly view along the beach and the Pacific Ocean with Cascade Head in the distance.

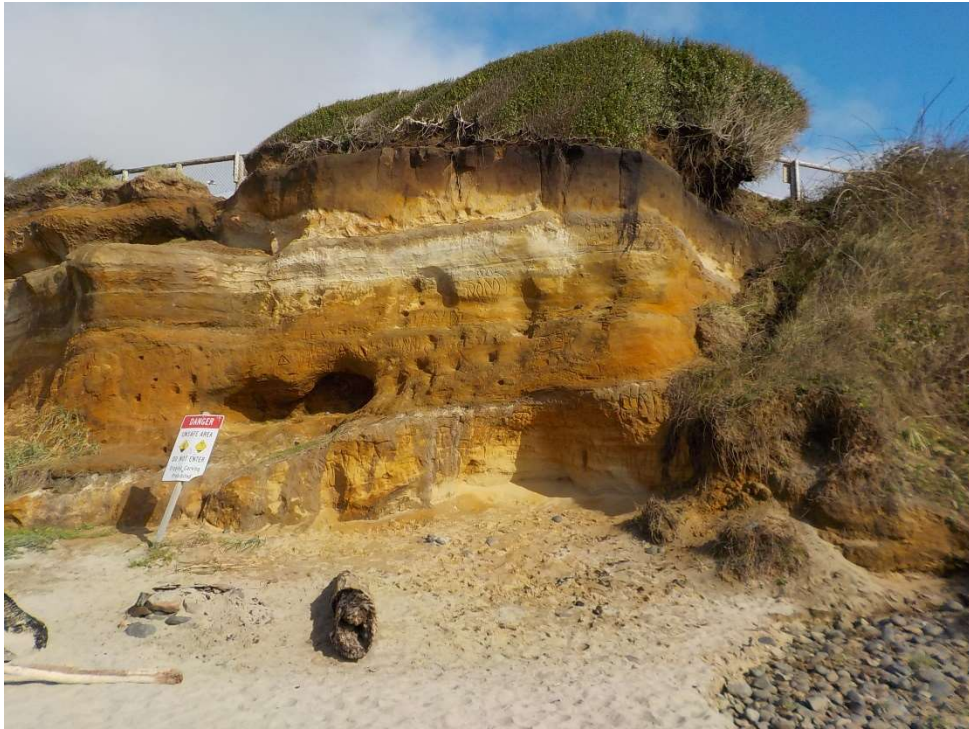
Detailed descriptions and analyses of geology and subsurface materials at the site are provided in Sections 3.1 and 3.3 below. Marine terrace deposits exposed north of the site at Roads End State Recreation Site consist of tan to light brown, moist, medium dense to dense, friable, fine-grained, cross-bedded sand, overlain by silt fill soil.

Photo 4 – View of the marine terrace sand and overlying soil exposed at Roads End State Recreation Site.

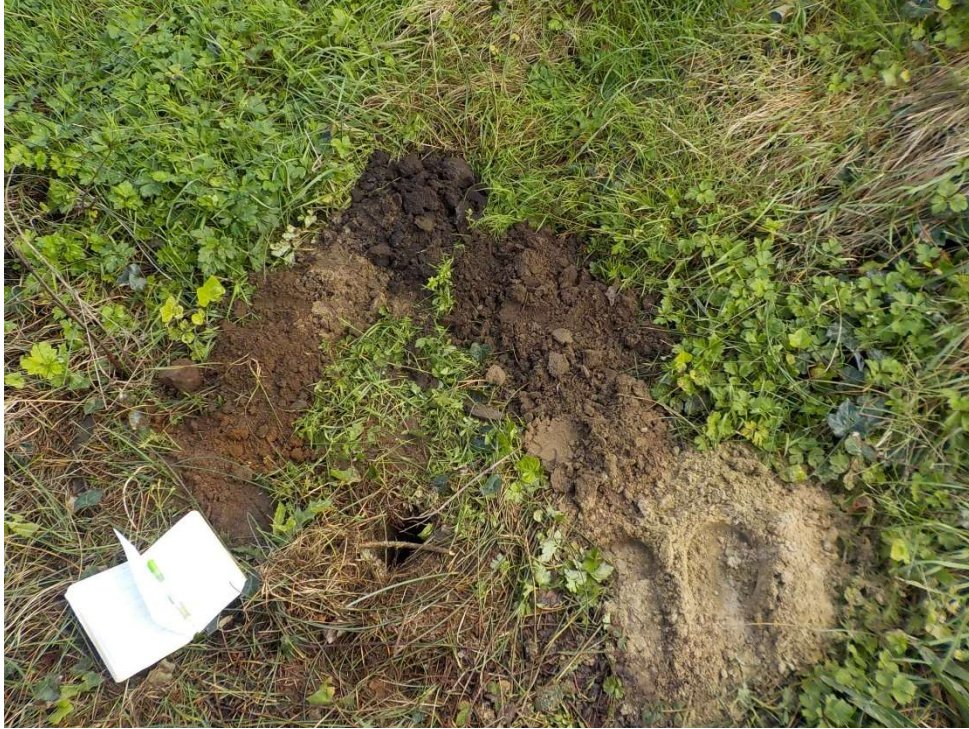
In general, materials encountered in borings consisted of approximately 1 to 2 feet of loose silt fill soils, underlain by soft to medium stiff silt and variably cemented dense sand. Free groundwater was not encountered in the borings. Soils exposed in the upper bluff fronting Roads End State Recreation Site approximately 50 feet north of the site are similar to those encountered in our hand augered borings.

Photo 5 – View of soils encountered in boring B-4.

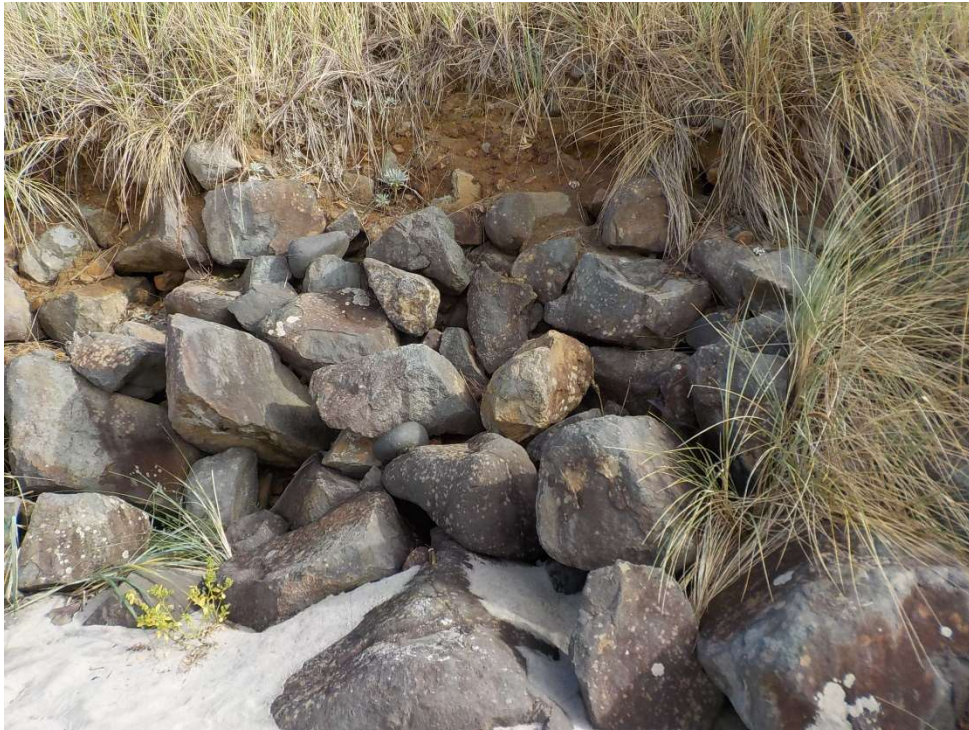
The bluff along the western part of the site is approximately 20 feet high and slopes down to the west from 20 to 50 degrees. The lower part of the bluff is partially protected from ocean wave erosion by a riprap revetment, which is currently in relatively poor condition. The revetment has been disturbed by wave action and slopes down to the west at approximately 50 degrees, which is steeper than typical for a riprap revetment. We observed indications of ocean wave erosion and minor sloughing along the lower bluff (Appendix A). We anticipate that the bluff above the revetment will continue to erode and slough due to ocean wave erosion unless the riprap revetment is repaired.

1. The riprap revetment at the base of the slope along the beach is in a state of disrepair. The area of the bluff above the revetment will continue to experience ocean wave erosion and sloughing until the revetment is repaired. We can assist with the oceanfront protection permit application process. There will be an additional cost associated with this.

Photo 6 – View of the damaged riprap revetment exposed at the base of the bluff slope.
