Subject: Geotechnical Investigation Report Proposed Apartment Complex Lincoln County Tax Lots: 07-11-11-BB-04302-00 and 07-11-11-BB-04300-00 Accessed by Northeast 25<sup>th</sup> Street Lincoln City, Lincoln County, Oregon EEI Report No. 20-047-1

# **GEOTECHNICAL INVESTIGATION REPORT**

Proposed Northeast 25<sup>th</sup> Street Apartment Complex Lincoln County Tax Lots: 07-11-11-BB-04302-00 and 07-11-11-BB-04300-00 Lincoln City, Lincoln County, Oregon

EEI Report No. 20-047-1

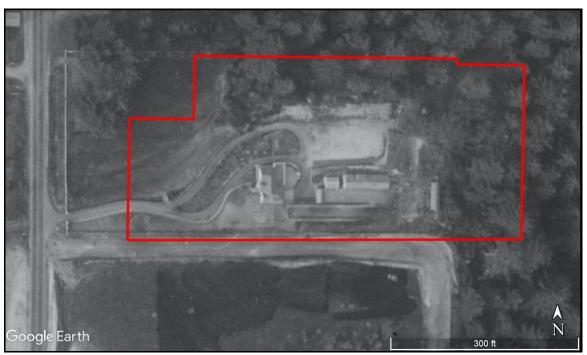
**Figure 4:** 1945 – The landscaping and outbuildings are more developed. We observed a concrete slab with floor tile in the area of the long building during our site investigation.

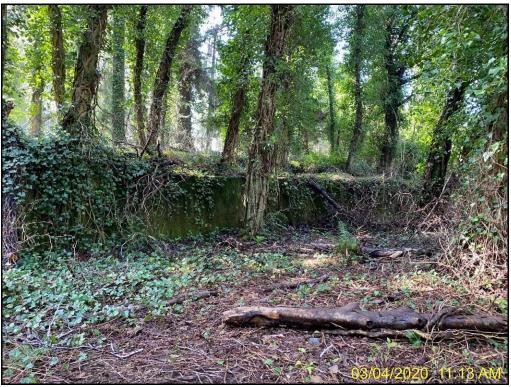
Photo 1: Upper area, terraced with retaining walls (near TP-5).

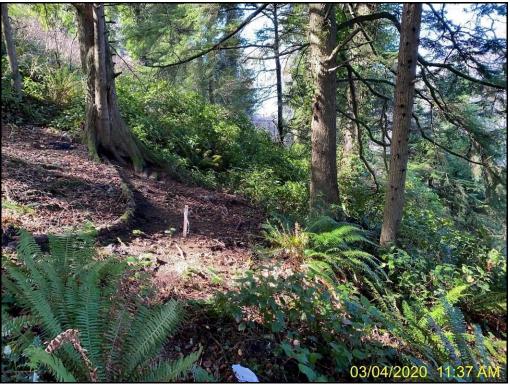
Photo 2: Looking west along slope above the cliff.

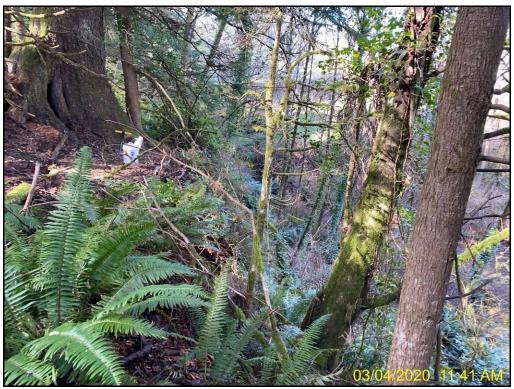
Photo 3: Looking west along the top of the cliff.

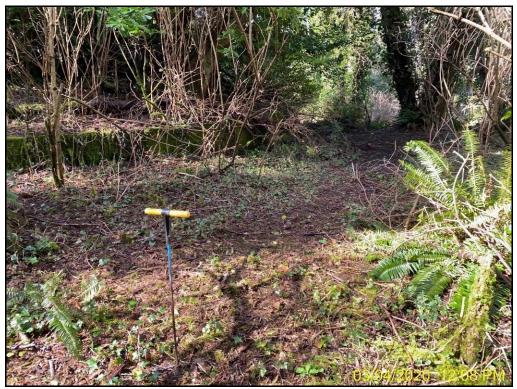
Photo 5: The top of the driveway coming onto the level area. Probe rod is touching asphalt.

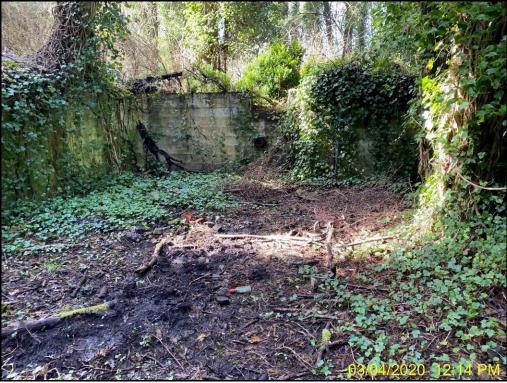
Photo 6: Retaining wall with a large drain pipe near where old residence had been.

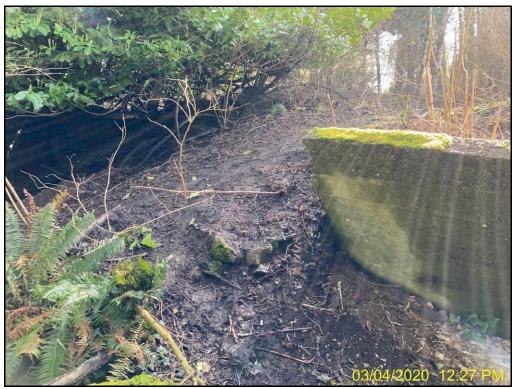
Photo 7: Looking southeast at failed retaining wall near where driveway had entered property from the west.

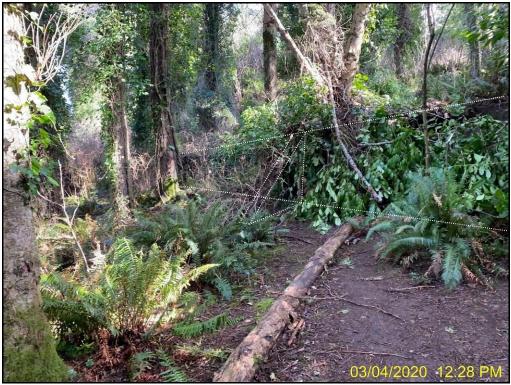
Photo 8: Lower driveway area with buttressed retaining wall covered in vegetation.

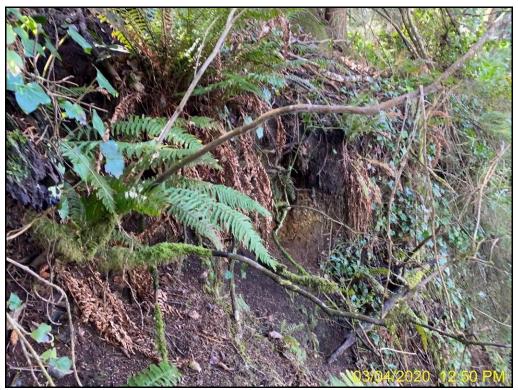
Photo 9: Siltstone exposed in upper cliff face.

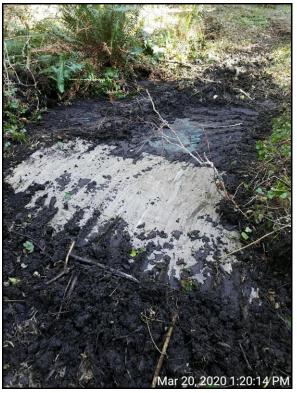
Photo 11: Tiled floor buried under veneer of soil.

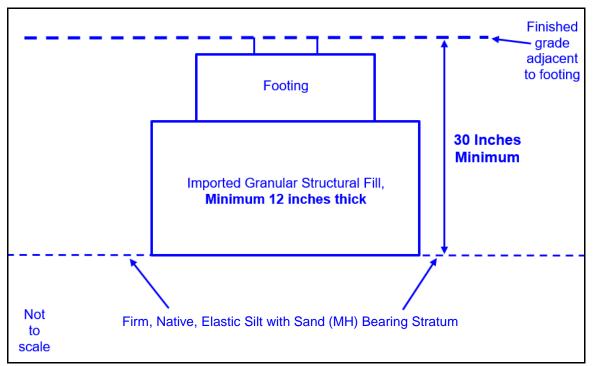
**Figure 11:** Footing sketch showing minimum structural fill thickness of 12 inches and minimum 30-inch embedment depth recommendation for proposed footings.

The base of the dirty rock should be at least 30 inches below adjacent design site grades. Furthermore, as also recommend above, foundations on slopes should be spaced at least 10 feet horizontally away from the undisturbed slope face, and set back at least 30 feet horizontally from the top of the cliff.

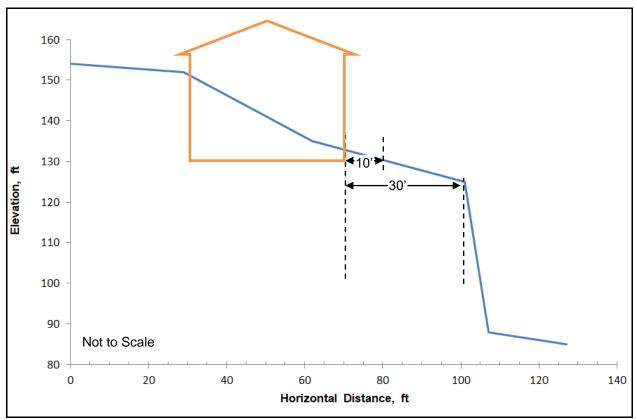
Figure 12: Slope Profile with setbacks

6. Close proximity of the building foundation to slopes. As stated above, the property is sloping with a 35-foot tall cliff along the north property line. We recommend that all structures and driveways be set back 30 feet horizontally from the face of the cliff. Additionally, the foundation should be embedded such that the downhill face of the footings are a minimum of 10 feet horizontally away from the undisturbed slope face in order to provide sufficient passive earth pressure.
