# Geotechnical Report

NW Jetty Avenue  
Next to 5209 NW Jetty Avenue  
Lincoln City, OR

Terry Reede

11 February 2021

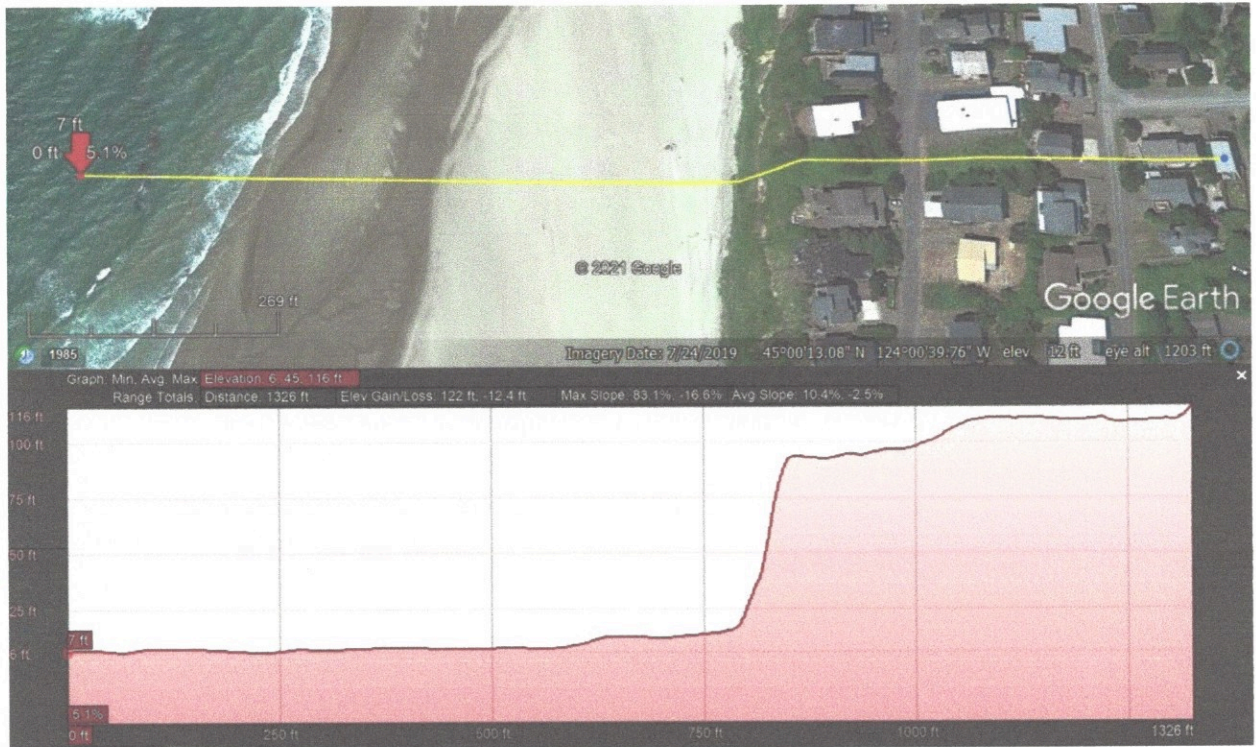
The western edge of the site abuts an ocean-facing bluff. This bluff stands about 80 feet tall. The majority of the grade change is accommodated by non-vegetated, vertical slopes. The debris pile at the base of the appear to be roughly 20 feet wide. The Google Earth DEM suggests that the debris pile is roughly 30 feet tall.

Figure 1: Slopes at the subject site, as presented by Google Earth.

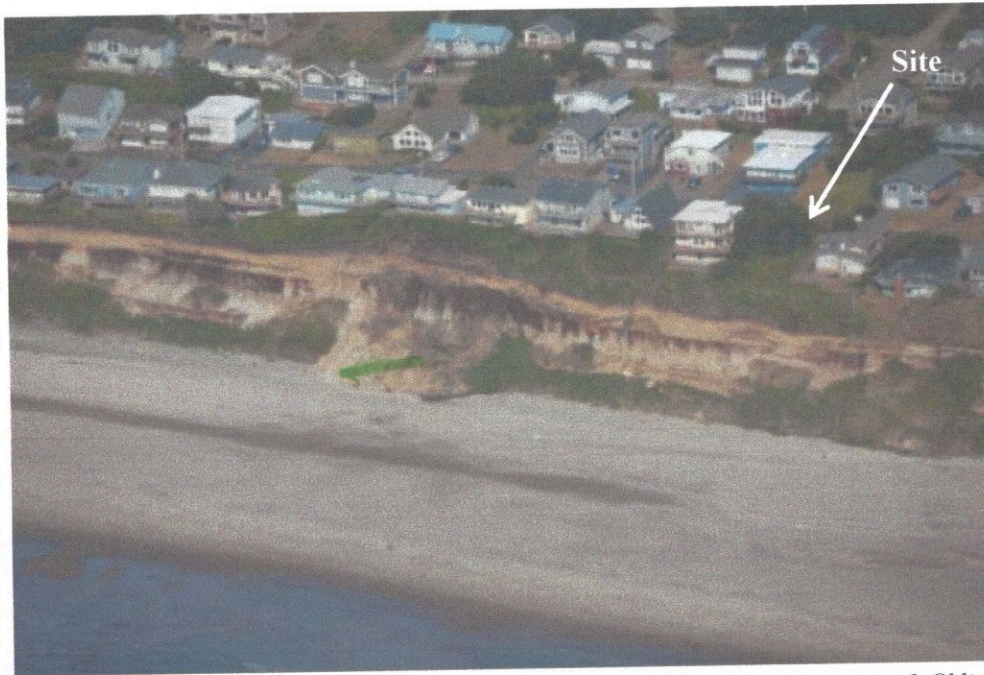
Figure 2: Image of the subject site and adjacent parcels, excerpt from O-15-06. Original caption read: Oblique aerial photo of homes perched along the cliff top at Roads End, Lincoln City, Oregon. Dark banding in the upper terrace face reflects ground water seepage down through the terrace sediments, where it comes in contact with the less permeable tertiary siltstones of the Yamhill Formation. Note the recent slump failure in mid photo (photo: E, Harris, DOGAMI, 2011).

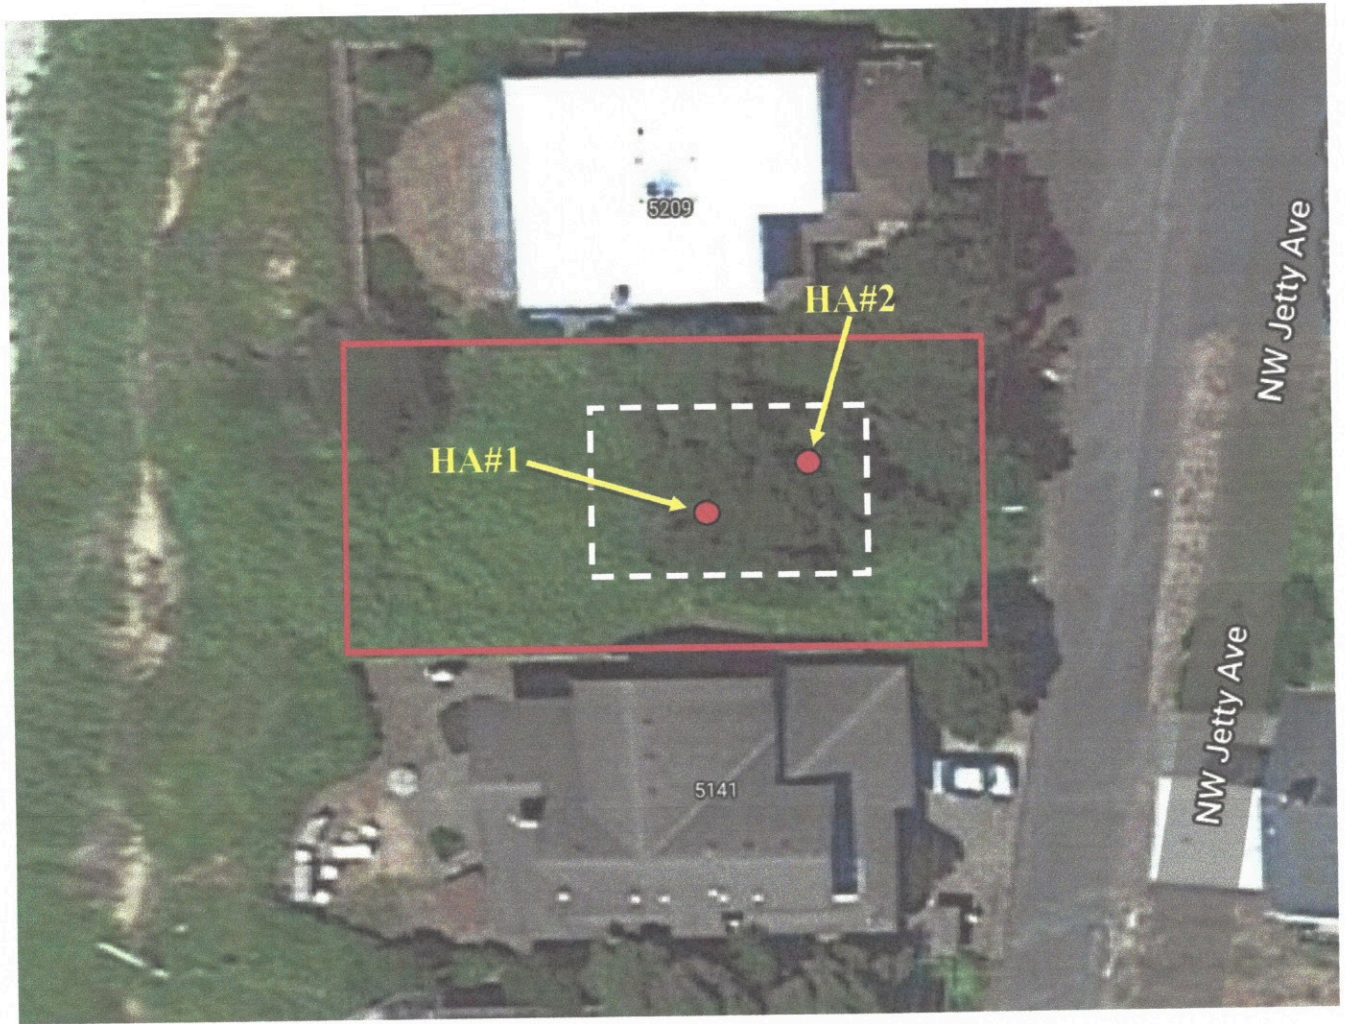
Figure 3: Testing Locations

A total of two (2) borings were excavated with a hand auger. The locations of the borings are shown on above site photos. A engineer in training (EIT) excavated, and logged the subsurface materials. A professional engineer review the soil logs .RSS found fine grained medium dense sandy SILT with moisture contents that vary from 8.3% to 12.6% See figure 3 for locations.
