**Geologic Hazards and
Geotechnical Investigation
Tax Lot 1000, Map 07-11-22BD,
SW Bard Loop
Lincoln City, Oregon**

Project #Y224627

July 7, 2022

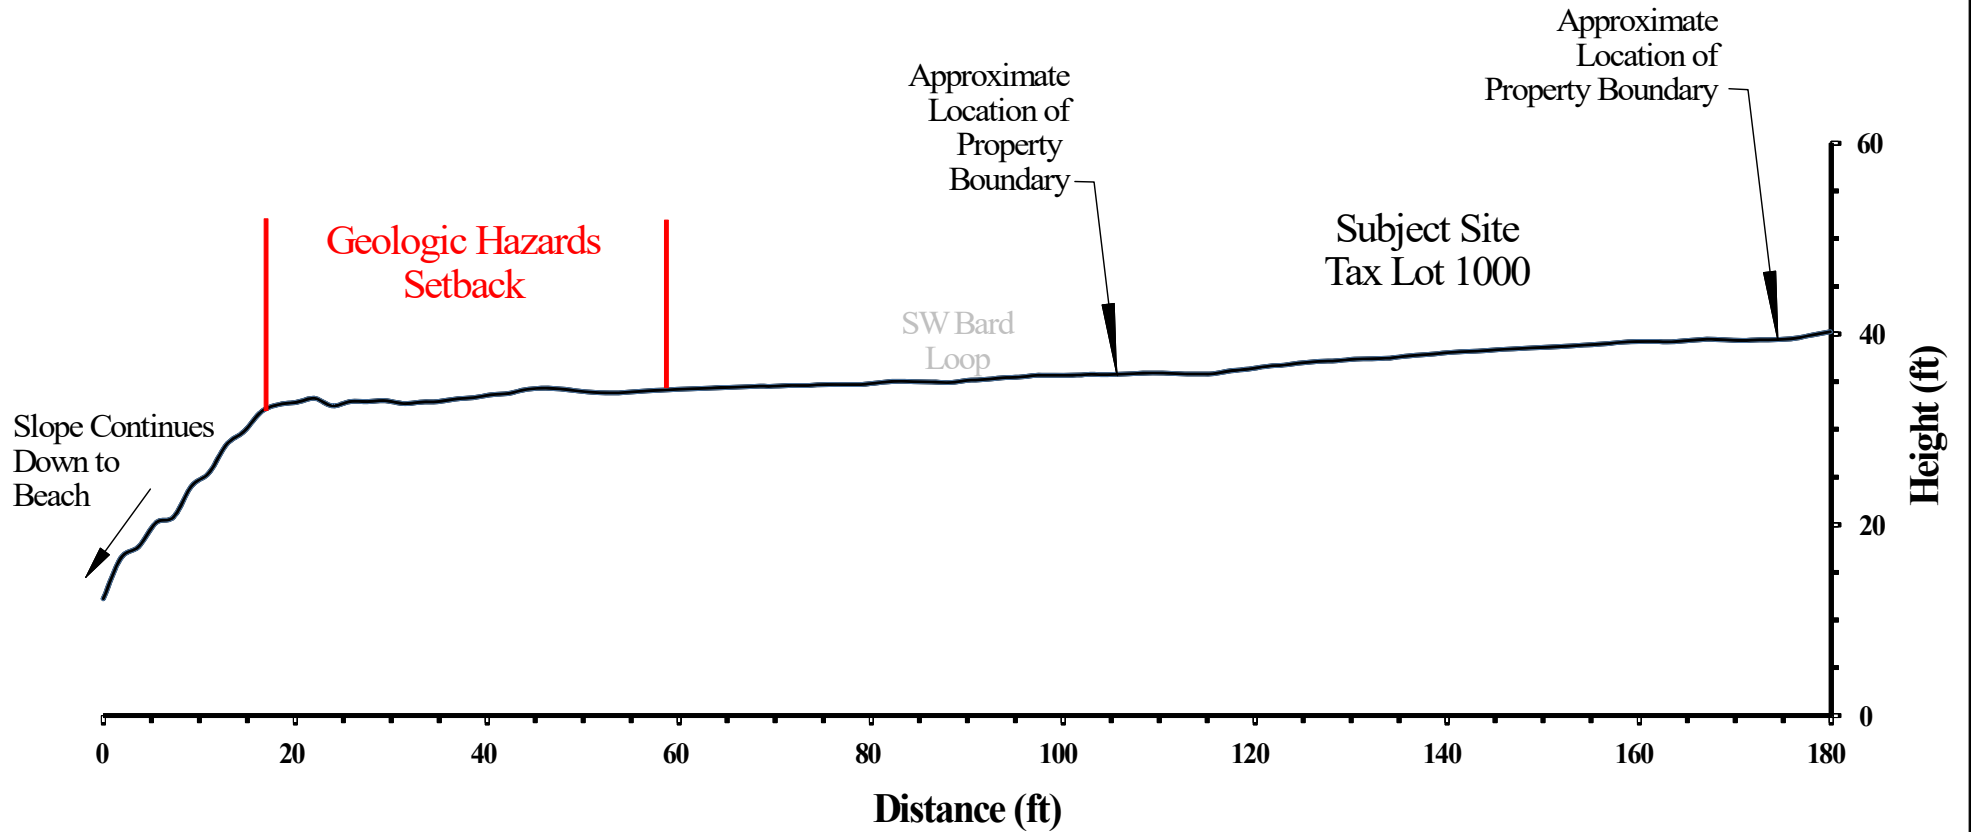
Date: 07/07/2022	Project #Y224627	Prepared by: MGB
Scale: 1" = 20'		Approved by: JDG
Slope Profile A-A' Tax Lot 1000, Map 7-11-22BD Lincoln City, Oregon		
H.G. Schlicker & Associates, Inc.		Figure 4

1. The bluff slope west of the site is undergoing continuous erosion, sloughing, and landsliding, which can fail back 5 to 15 feet or more at a time. Undercutting by ocean waves causes retreat of the toe of the slope, resulting in instability and failures along the upper slope. The western portion of the subject site lies in the mapped low-risk coastal erosion hazard zone.

Based on the average annual erosion rate of the bluff west of the site, a 60-year expected life of the structure, plus the 5 feet psychological setback, we recommend that foundations be setback a minimum of 41 feet east of the upper bluff edge. The western property boundary of the site is located approximately 100 feet east of the upper bluff edge; therefore, no additional geologic hazard setback from the bluff edge is required at this time. We have determined this oceanfront setback based on an average annual erosion rate of 0.6 ft/yr for 60 years and have added Lincoln City's required additional 5 feet.

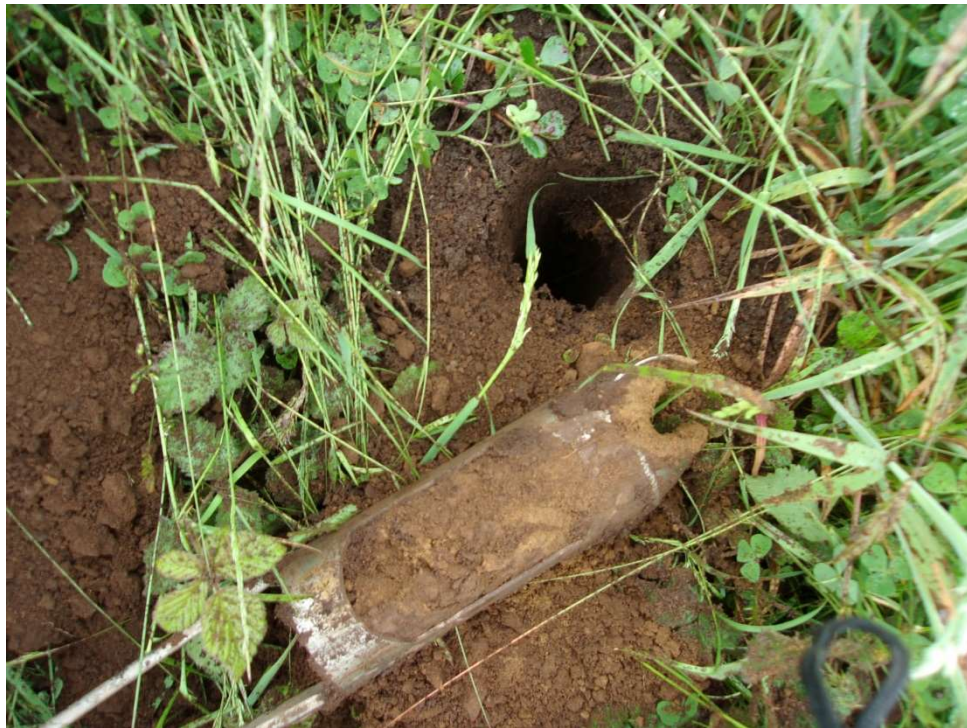
B-1	<u>Depth (ft.)</u>	<u>USCS</u>	<u>Description</u>
	0.0 – 2.0	ML	Sandy SILT; dark brown, dry, loose; Organic-rich.
	2.0 – 4.5	SM	Silty SAND; brown, dry, loose to medium dense. Increasing density with depth. Generally non-cemented.
B-2	<u>Depth (ft.)</u>	<u>USCS</u>	<u>Description</u>
	0.0 - 0.5	OL/PT	Organic SILT; dark brown, moist, loose. With decayed wood/peat.
	0.5 - 1.0	ML	SILT; dark brown, wet, loose/soft.
	1.0 – 5.0	ML	Sandy SILT; brown, wet, loose to medium dense. Increasing density with depth.

We generally encountered soft, silty soils to depths up to approximately 1 to 2 feet, overlying loose to medium dense silty and sandy soils. Probing the site met little resistance to a depth of approximately 2.5 to 3.5 feet.

Photo 4 – Close-up view of the soils encountered in boring B-1.

2. Fill, soft/loose, disturbed, and organic-rich soils at least approximately 2 feet deep or more are present at the site and will need to be removed from footing and slab areas prior to construction.
3. There is an inherent regional risk of earthquakes along the Oregon Coast, which could cause harm and damage structures. The site lies outside the mapped tsunami inundation hazard zone. However, a tsunami impacting the Lincoln City area could cause harm, loss of life, and damage to structures. These risks must be accepted by the owner, future owners, developers, and residents of the site.

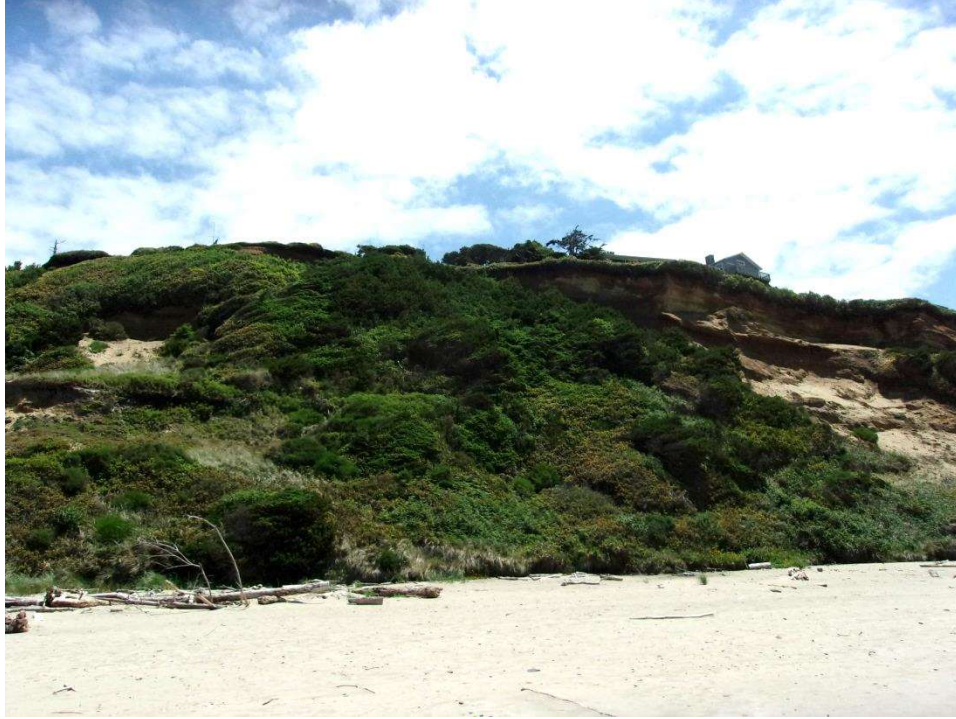
The site is located approximately 100 feet east of a high and steep bluff slope that is undergoing erosion and sloughing as the result of wind, rain and ocean wave activity. Several landslides were observed along the bluff in the area of the site. These landslides appear to have failed back from the bluff edge from 5 to 15 feet. The upper oversteepened bluff is more susceptible to sloughing and landsliding than the lower bluff due to the steepness of the upper bluff segment and the poorly consolidated nature of the sediments. A review of Google Earth

Photo 5 – Easterly view of the bluff slope, west of the subject site.

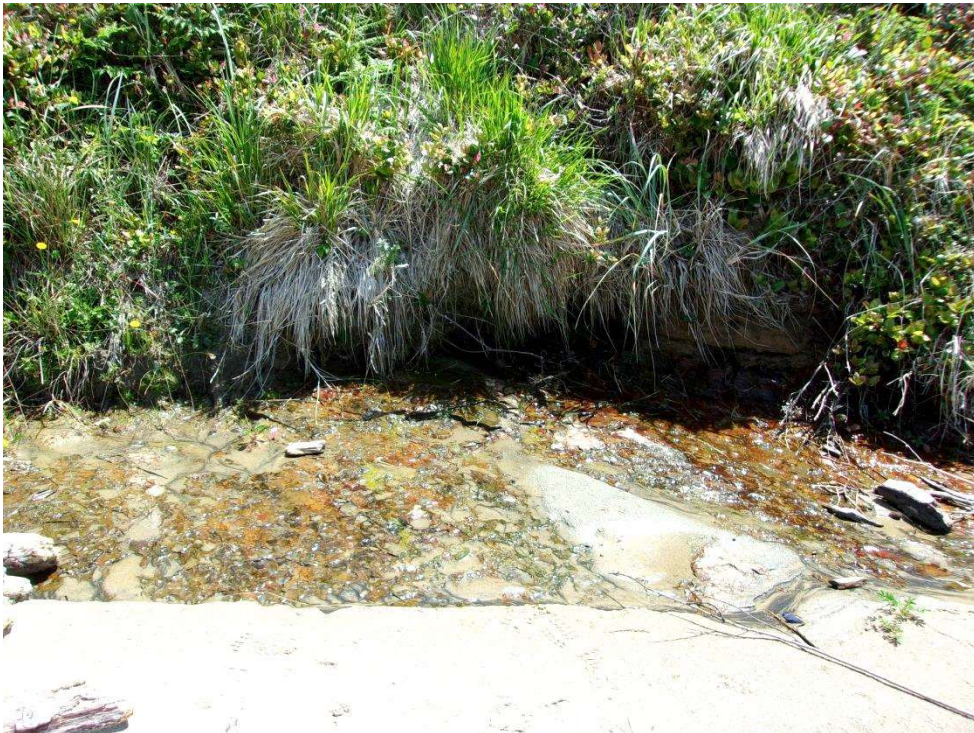
Exposed mudstone bedrock was observed at the base of the bluff slope (Appendix A). We estimate sand depths along the beach at this time to be up to about 6 feet thick.

Photo 6 – Close-up view of the base of the bluff where water was emanating from over the exposed mudstone.
