**Geologic Hazards and
Geotechnical Investigation
For Retaining Wall
Tax Lot 2801, Map 07-11-22CD
2808 SW Anchor Court
Lincoln City, Lincoln County, Oregon**

Project #Y234666

February 10, 2023

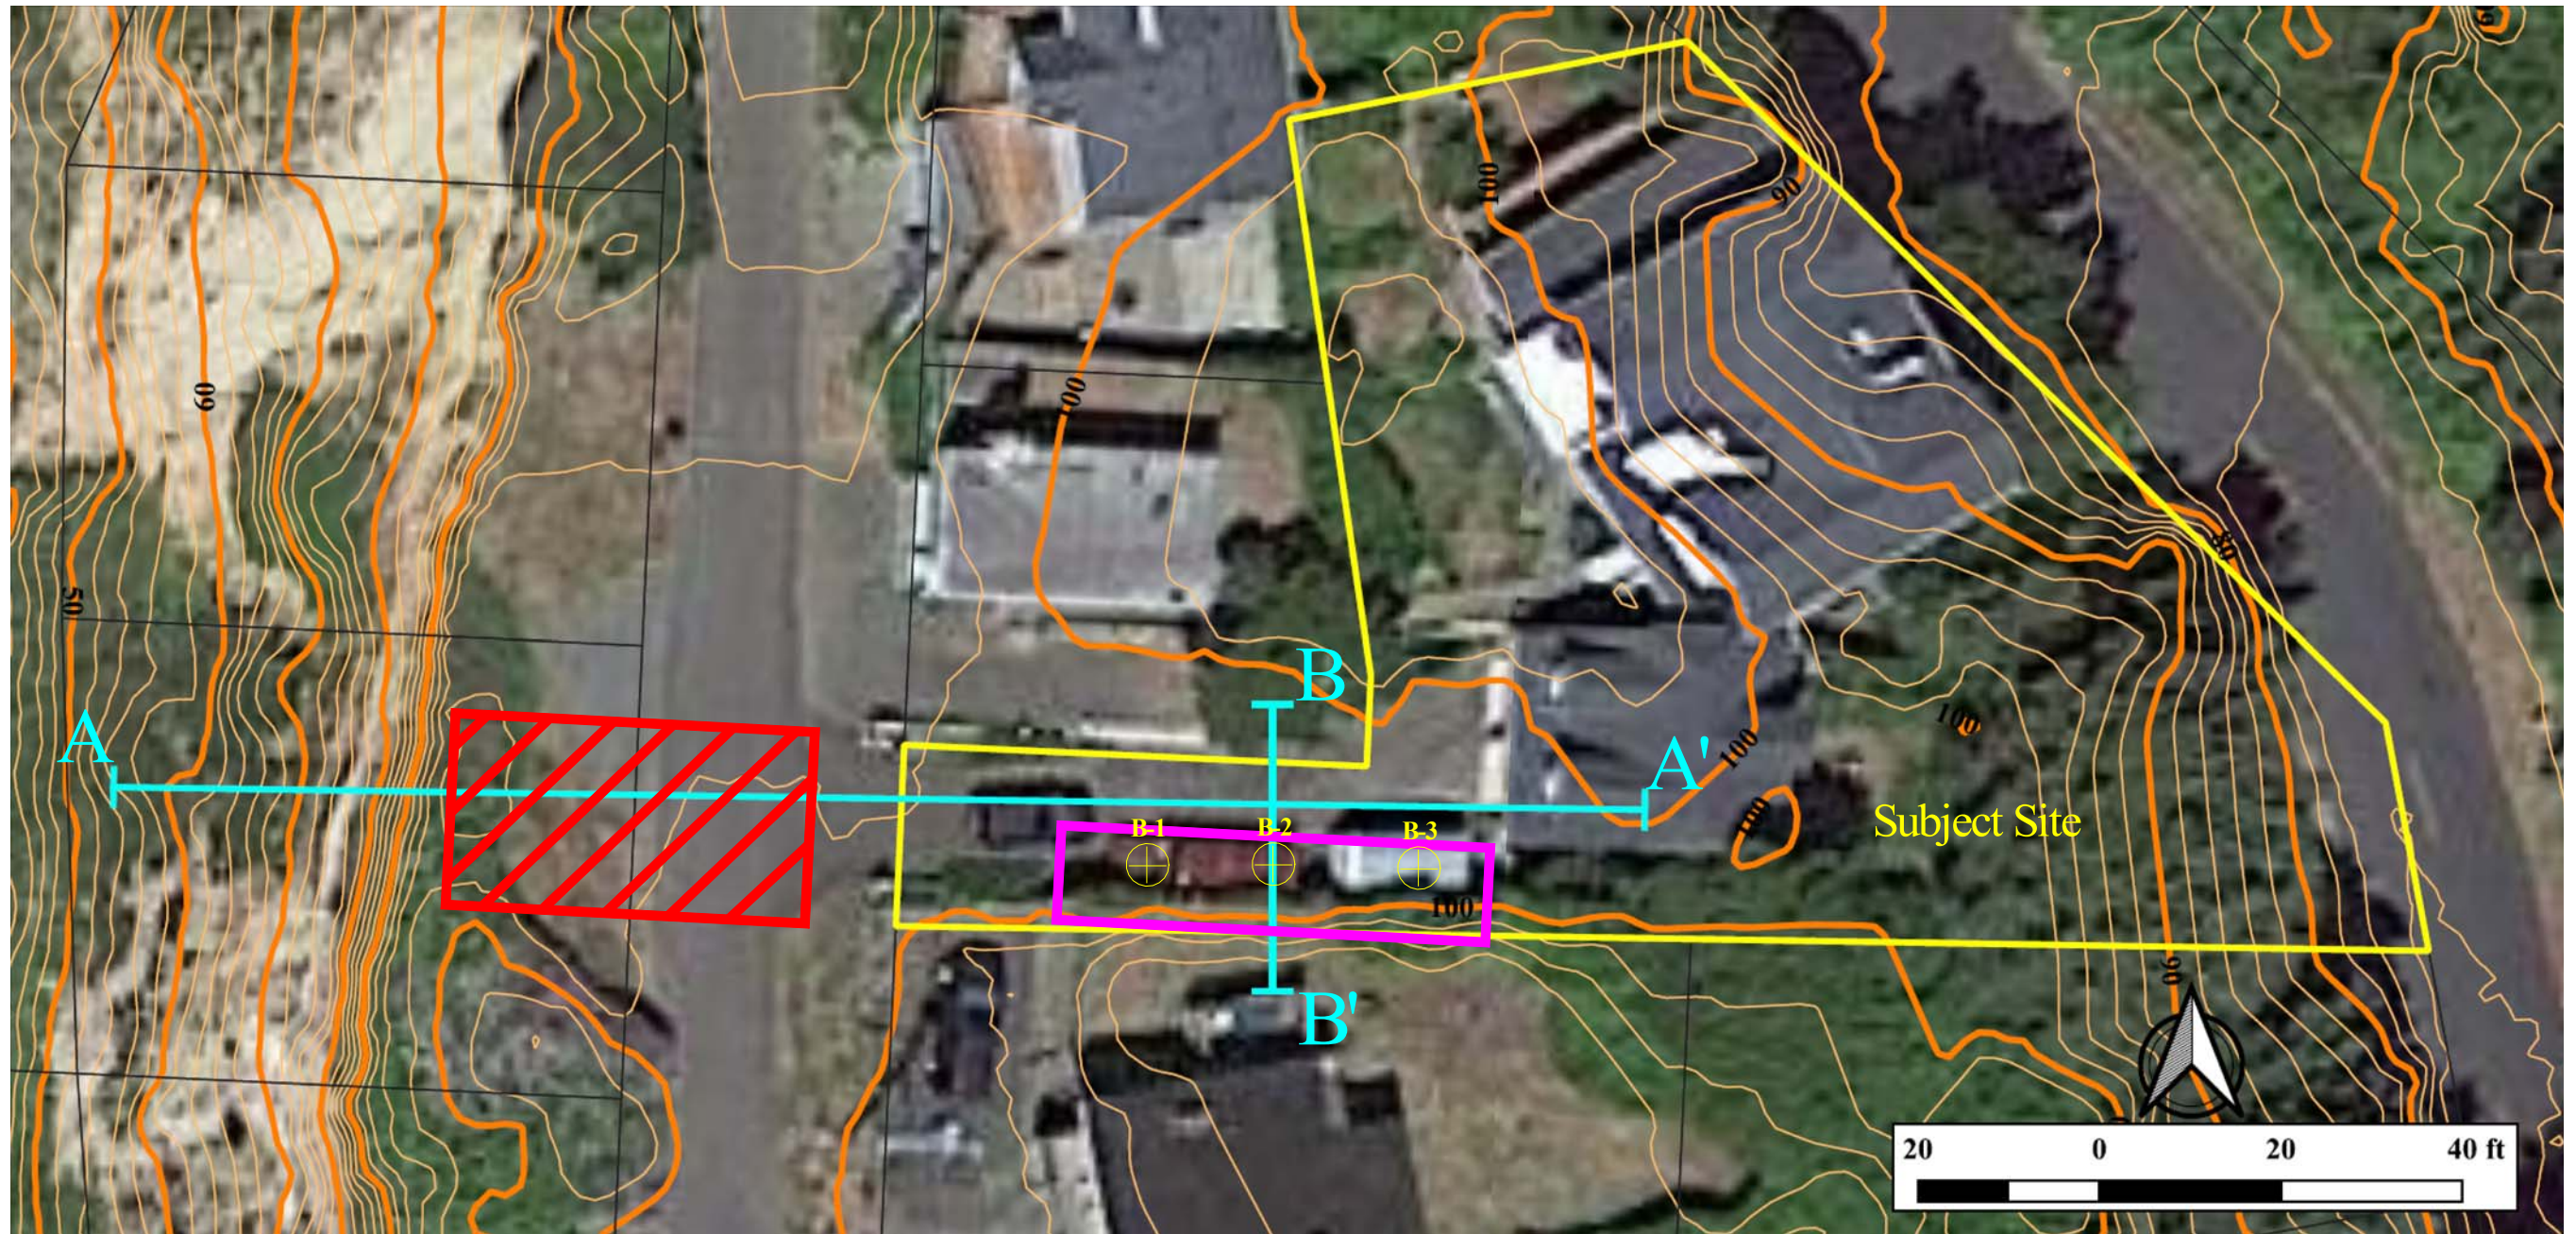
H.G. Schlicker & Associates, Inc.		Figure 3

To help mitigate future recession of the bluff caused by erosion and landsliding, we recommend that new shallow foundations for the retaining wall be set back a minimum of 41 feet east of the upper bluff edge, as shown on Figures 3 and 4. The proposed construction lies well east of this oceanfront bluff setback area.

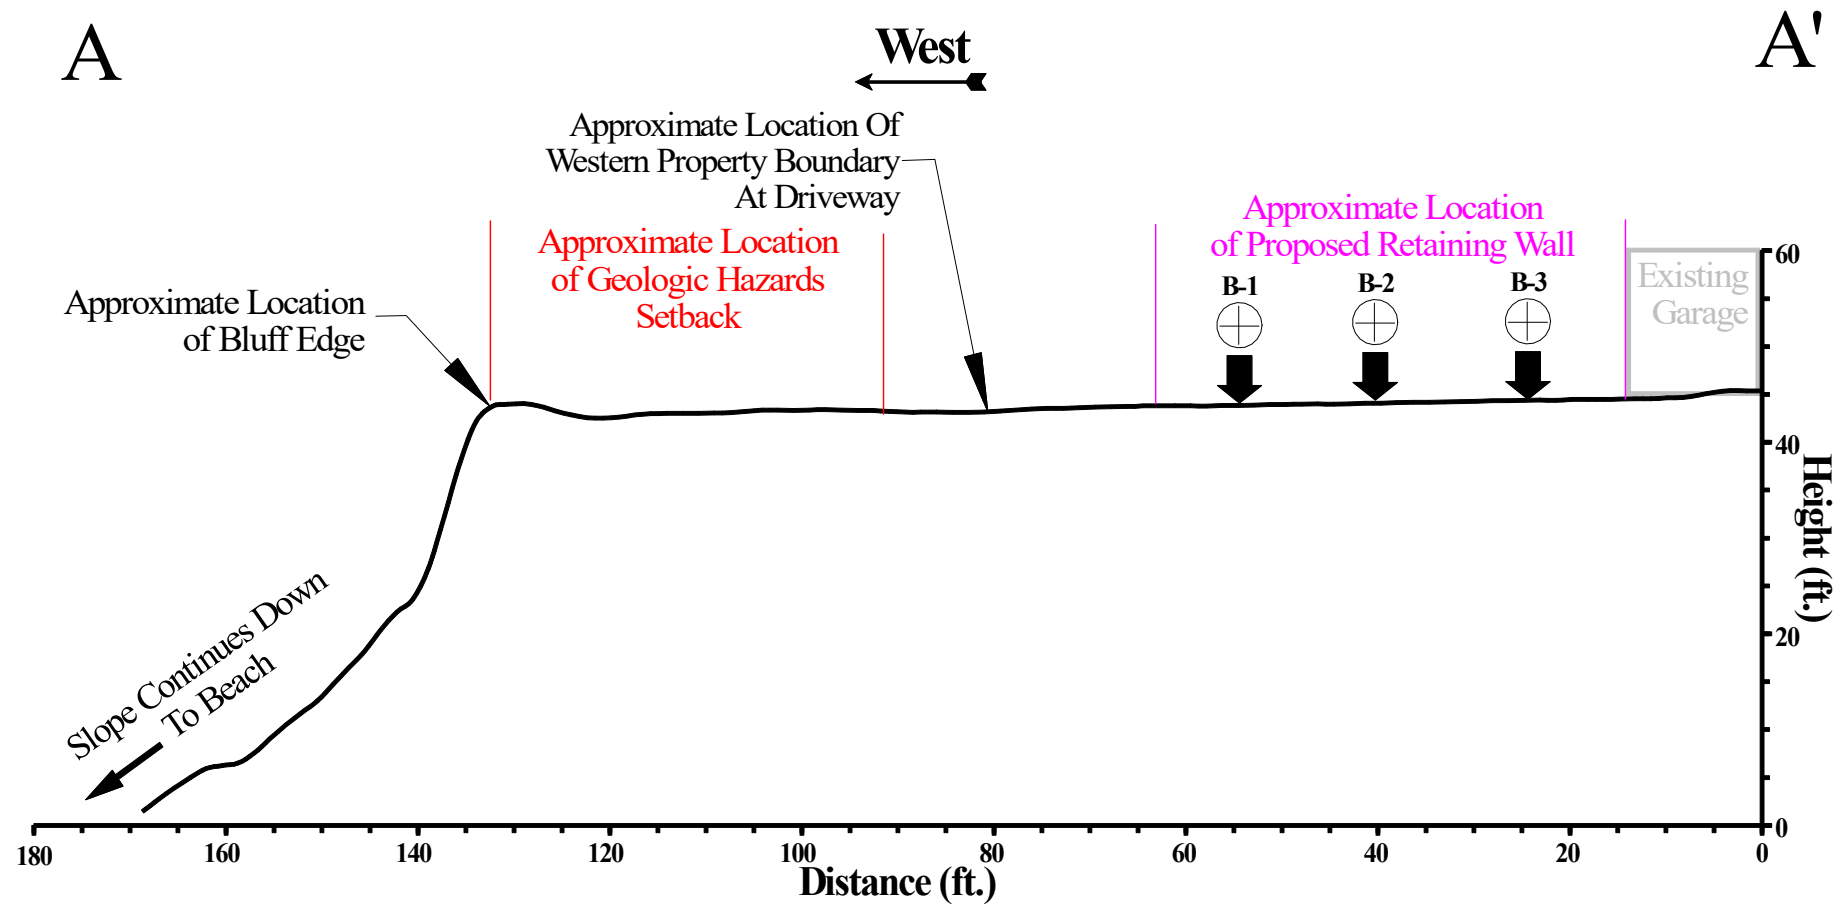
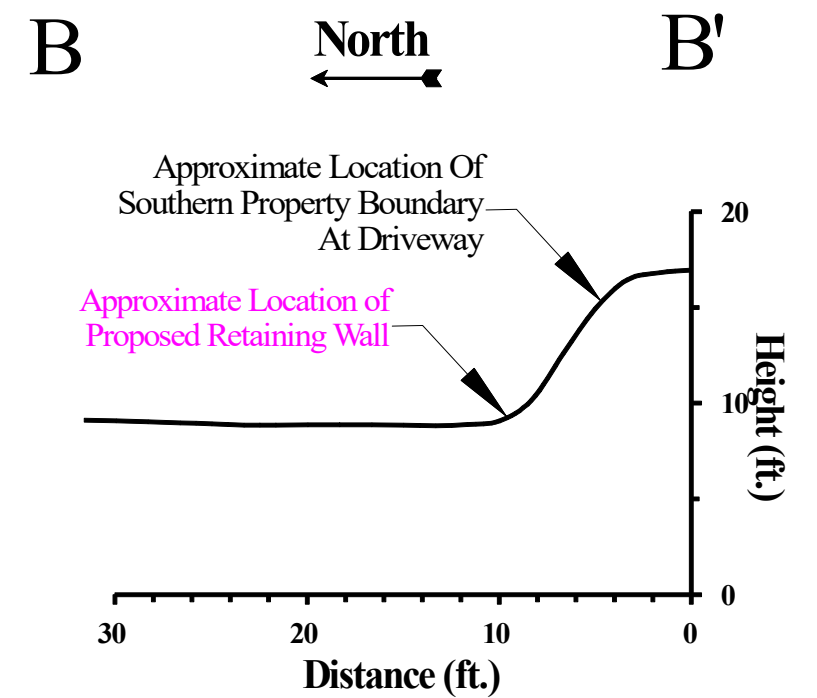
Figure 4

The area of the proposed retaining wall, along the driveway in the southwestern portion of the site, is generally flat to slightly sloping to the west (Figures 3 and 4).

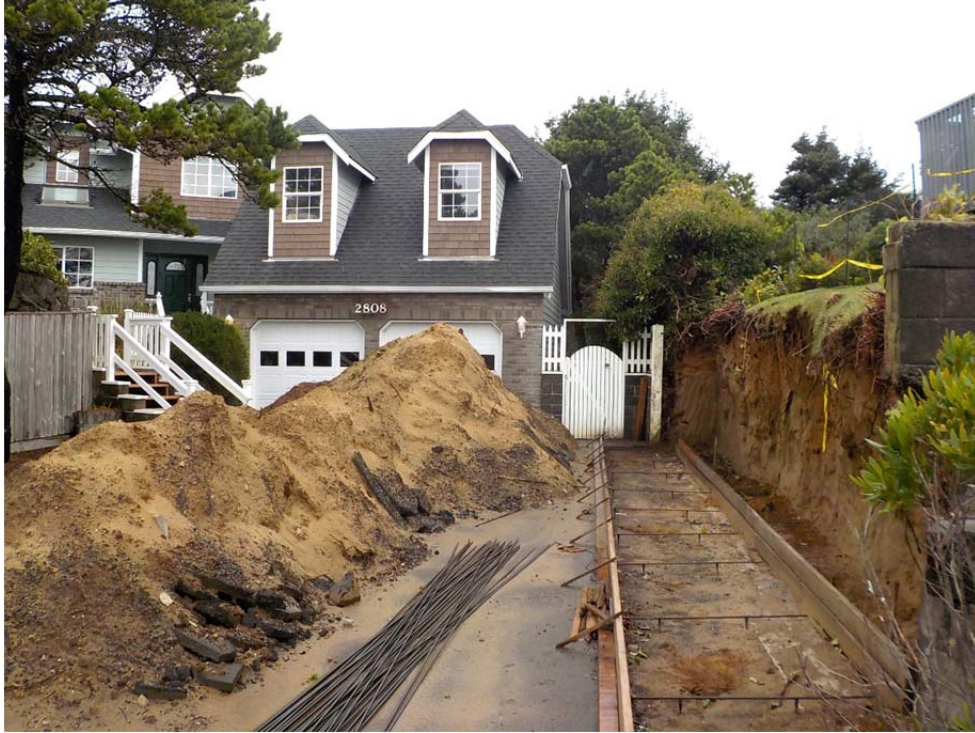
Photo 1 – Easterly view of the site from the driveway near SW Anchor Court.
