**Geologic Hazards and  
Geotechnical Investigation  
For Retaining Wall  
Tax Lot 2801, Map 07-11-22CD  
2808 SW Anchor Court  
Lincoln City, Lincoln County, Oregon**

Project #Y234666

February 10, 2023

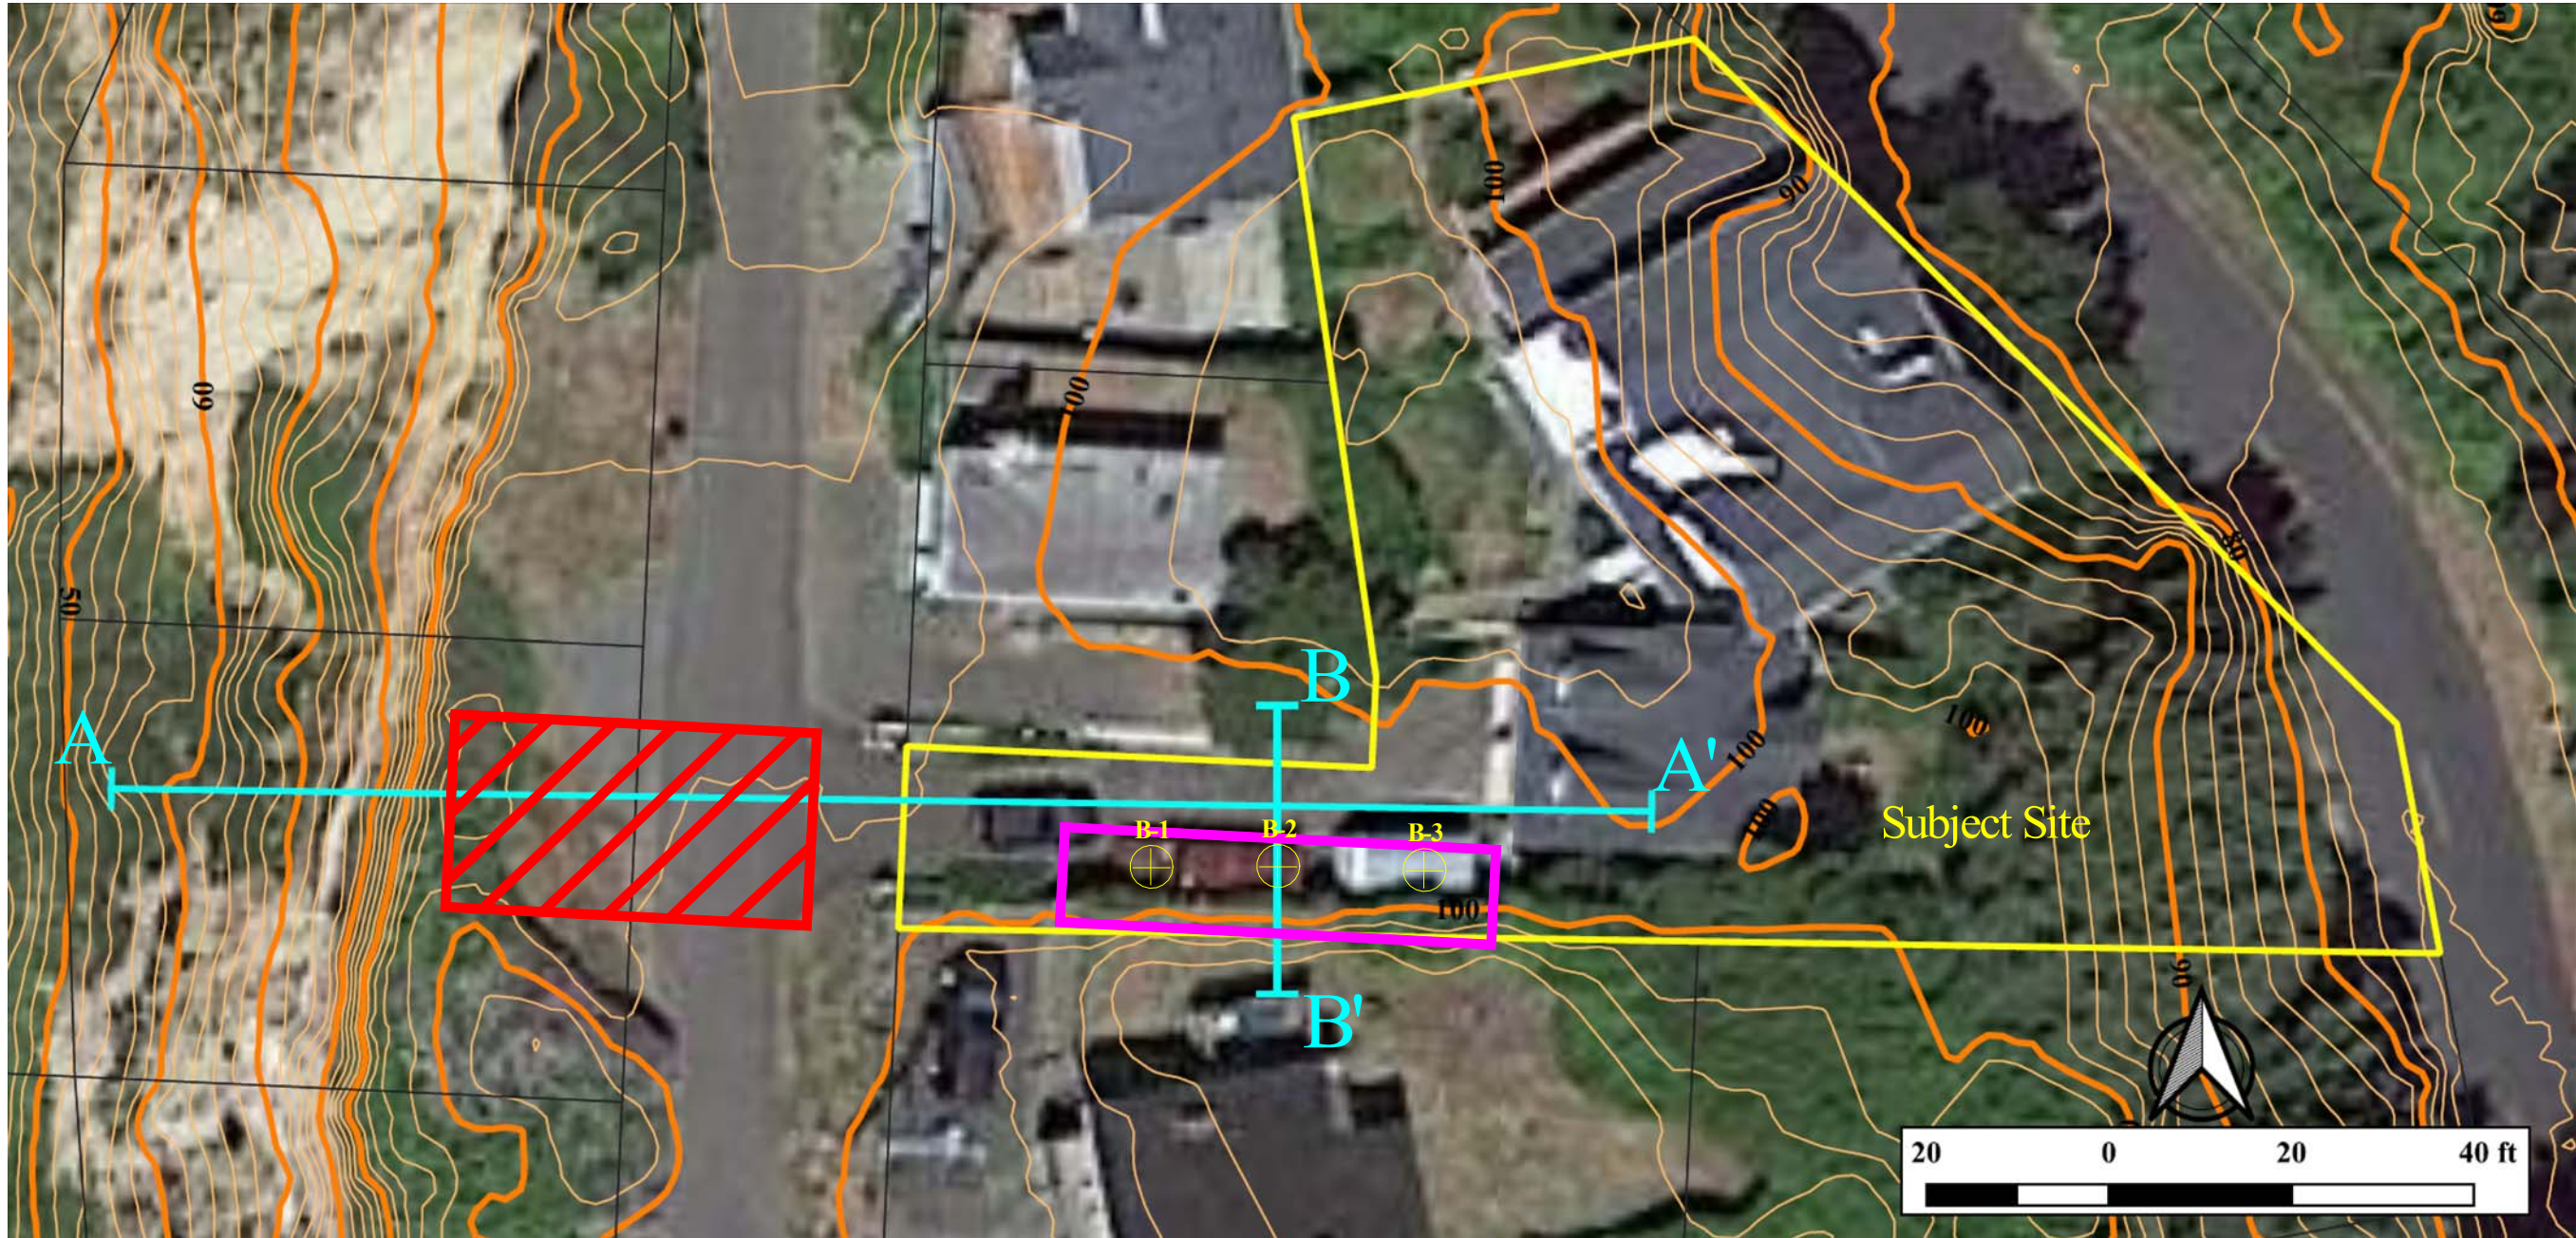
<b>H.G. Schlicker &amp; Associates, Inc.</b>		<b>Figure 3</b>

approximately 15 to 20 feet high east-facing hill slope along SW Anchor Avenue (Figures 2, 3 and 4). Lidar derived elevations at the site range from approximately 80 feet at the base of the eastern hillslope to approximately 104 feet at the upper portion of the site (NAVD 88) (Figure 3).

The area of the proposed retaining wall, along the driveway in the southwestern portion of the site, is generally flat to slightly sloping to the west (Figures 3 and 4).

To help mitigate future recession of the bluff caused by erosion and landsliding, we recommend that new shallow foundations for the retaining wall be set back a minimum of 41 feet east of the upper bluff edge, as shown on Figures 3 and 4. The proposed construction lies well east of this oceanfront bluff setback area.

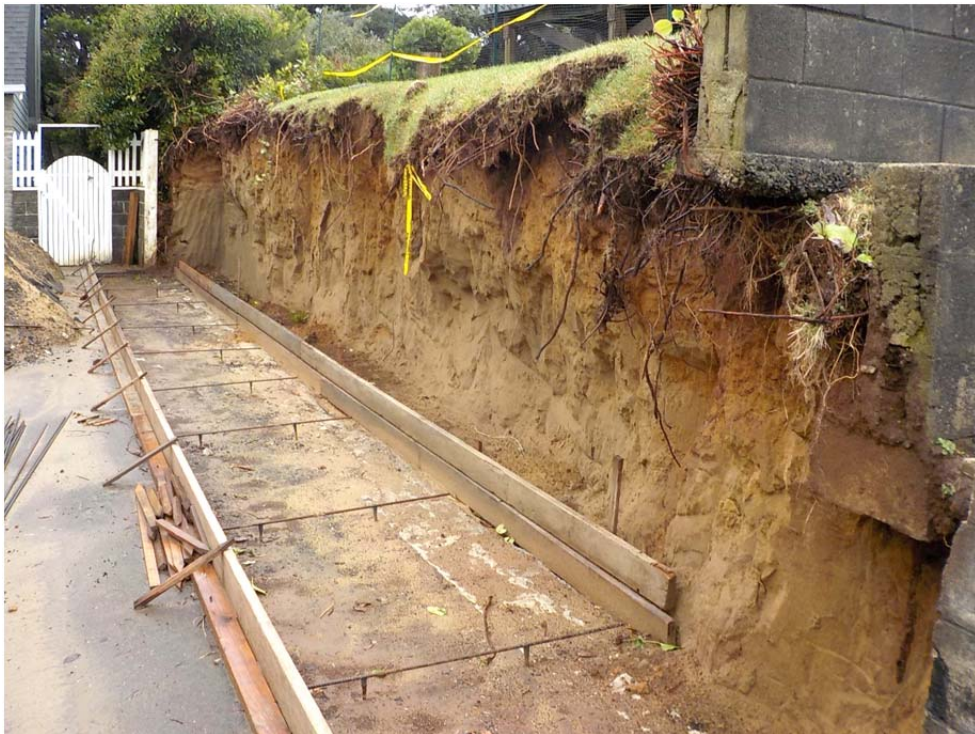
We observed indications of minor wind and rain erosion along the exposed north-facing cut slope in the area of the proposed retaining wall along the southern boundary of the site.

Photo 2 – View of the cut slope and area proposed for the retaining wall.

Temporary unsupported cut and fill slopes less than 9 feet in height should be sloped no steeper than 1 horizontal to 1 vertical (1H:1V). If temporary slopes greater than 9 feet high are desired, or if water seepage is encountered in cuts, HGSA should be contacted to provide additional recommendations. Temporary cuts in excess of 5 feet high and steeper than 1H:1V will likely require appropriate shoring to provide for worker safety, per OSHA regulations. Temporary cuts should be protected from inclement weather by covering them with plastic sheeting to help prevent erosion.

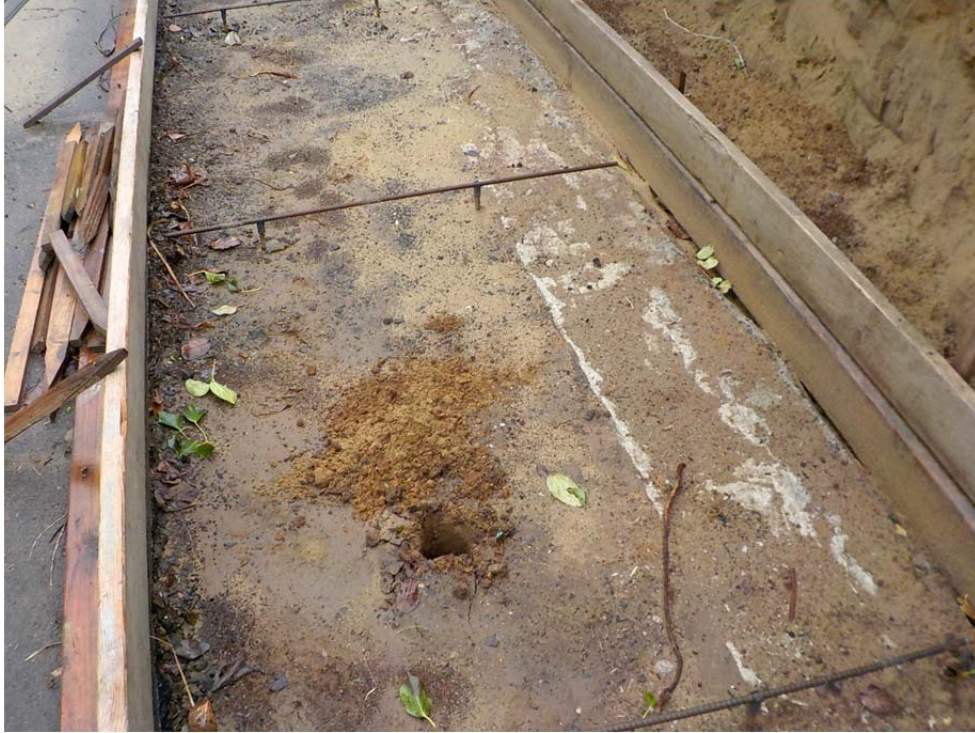
<b>B-1</b>	<b><u>Depth (ft.)</u></b>	<b><u>USCS</u></b>	<b><u>Description</u></b>
	0 – 0.66	SM FILL	Silty SAND FILL; brown, wet, loose to medium dense. With numerous gravel fragments.
	0.66 – 1.0	SP	SAND; light brown, wet, loose to medium dense. Boring terminated in medium dense sand.
<b>B-2</b>	<b><u>Depth (ft.)</u></b>	<b><u>USCS</u></b>	<b><u>Description</u></b>
	0 – 0.66	SM FILL	Silty SAND FILL; brown, wet, loose to medium dense. With numerous gravel fragments.
	0.66 – 1.0	SP	SAND; light brown, wet, loose to medium dense. Boring terminated in medium dense sand.
<b>B-3</b>	<b><u>Depth (ft.)</u></b>	<b><u>USCS</u></b>	<b><u>Description</u></b>
	0 – 0.5	SM FILL	Silty SAND FILL; brown, wet, loose to medium dense. With numerous gravel fragments.
	0.5 – 1.0	SP	SAND; light brown, wet, loose to medium dense. Boring terminated in medium dense sand.

In general, materials encountered at shallow depths in the area of the proposed retaining wall were loose to medium-dense sand overlain with approximately 6 to 8 inches of loose fill soil. We also observed that concrete remained in the excavated area, which appeared to be remnants of the previous retaining wall footing.

Photo 3 – View of soils encountered in boring B-1.

All footing areas should be stripped of all organic and loose/soft soils and existing fills.

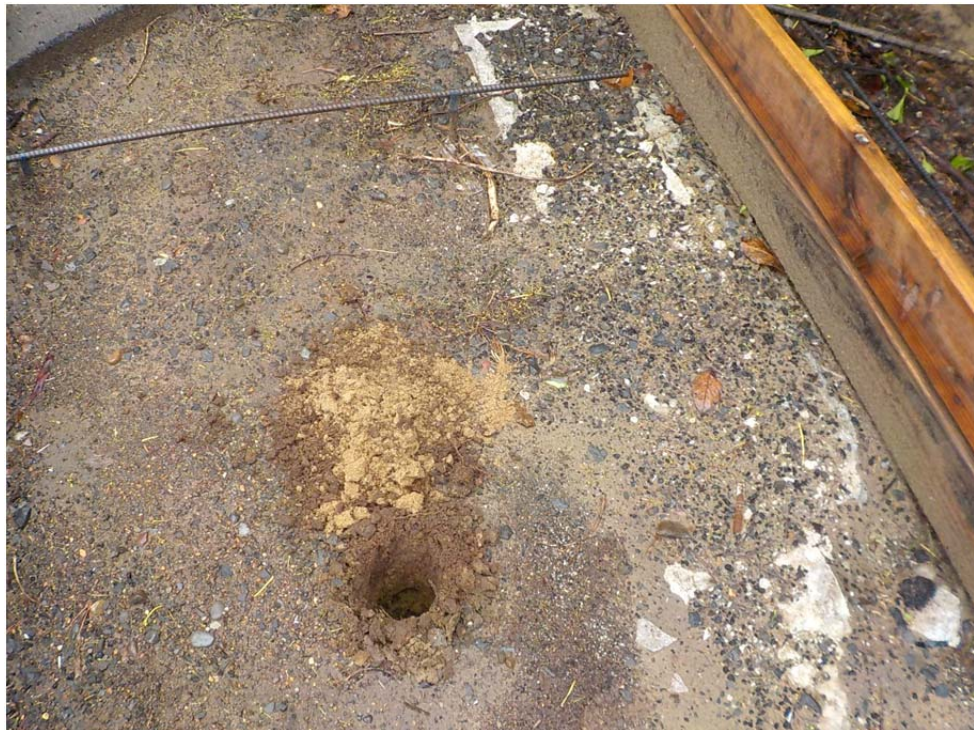
Photo 4 – View of the soils encountered in boring B-3.

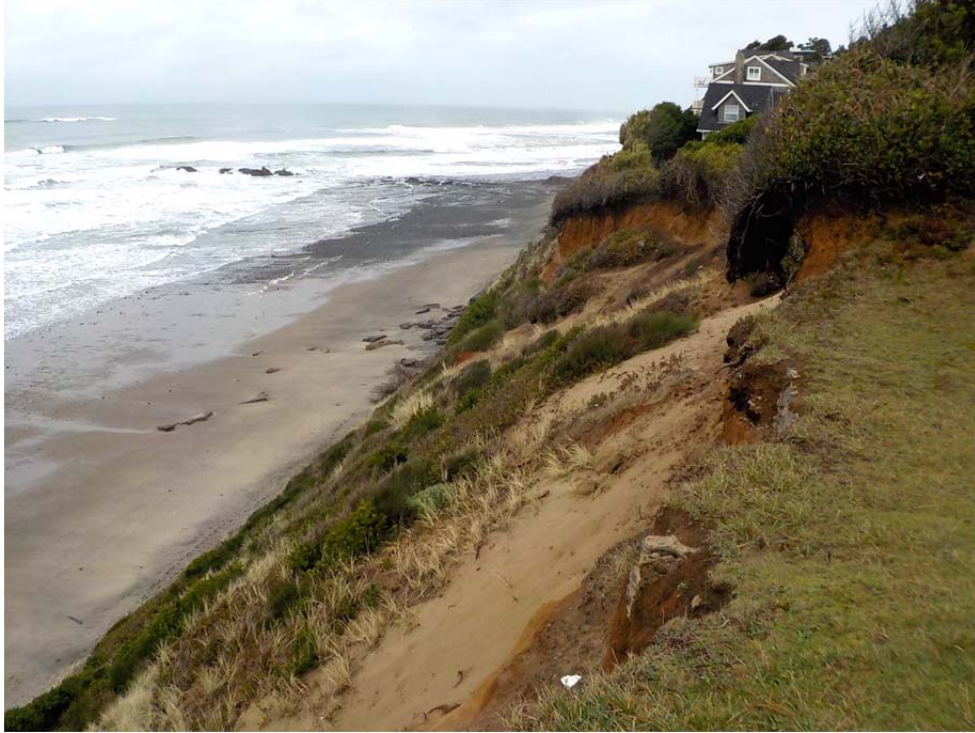
Photo 5 – Northerly view of the bluff slope, beach, and ocean, west of the site, from near the bluff edge.

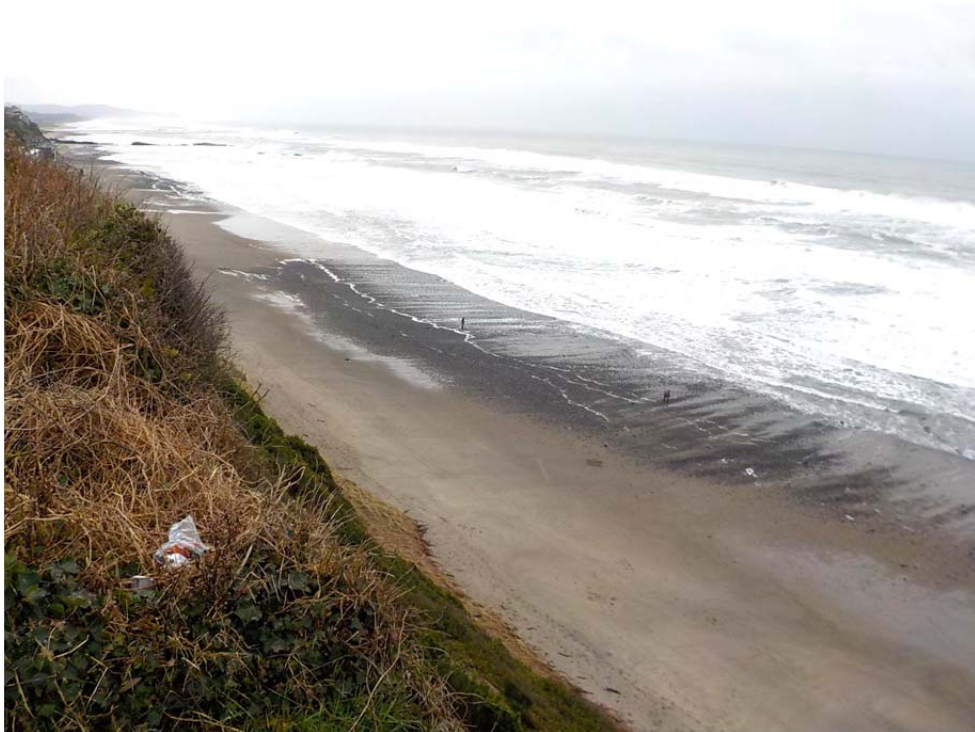
Photo 6 – Southerly view of the bluff slope, beach and ocean, west of the site, from near the bluff edge.

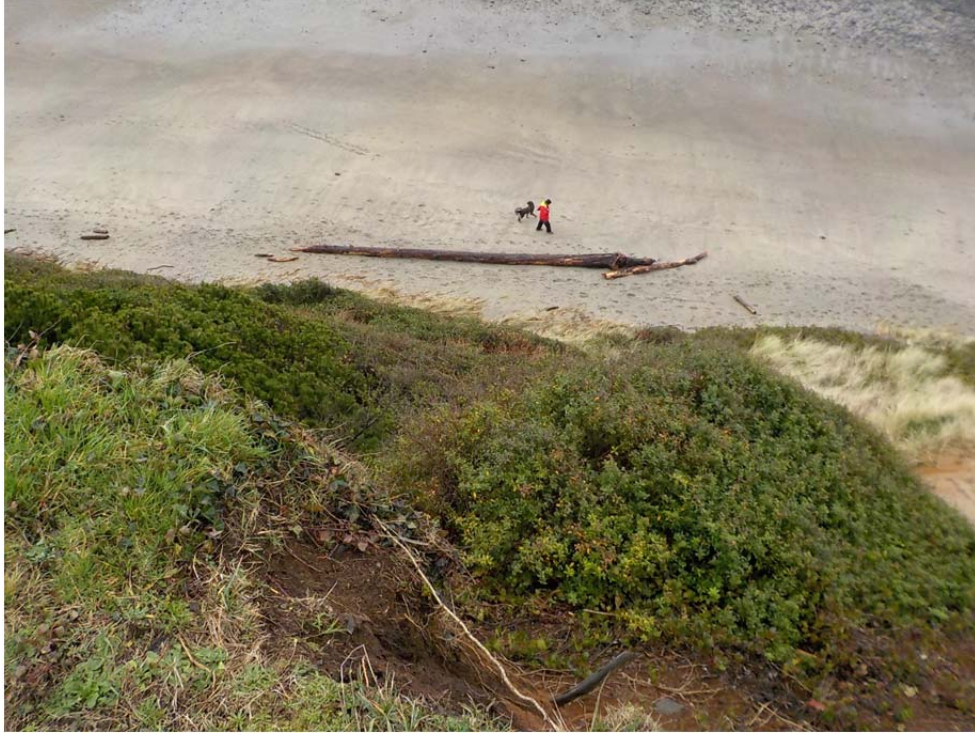
Photo 7 – Downslope view of the bluff slope and beach from near the bluff edge.
