**Update to a Geologic Hazards and
Geotechnical Investigation
Tax Lots 1300 and 1800, Map 7-11-34BA
The Pointe
Lincoln City, Oregon**

**Prepared for:
Northwest Coastal Investments**

Project #Y184132C

April 18, 2023

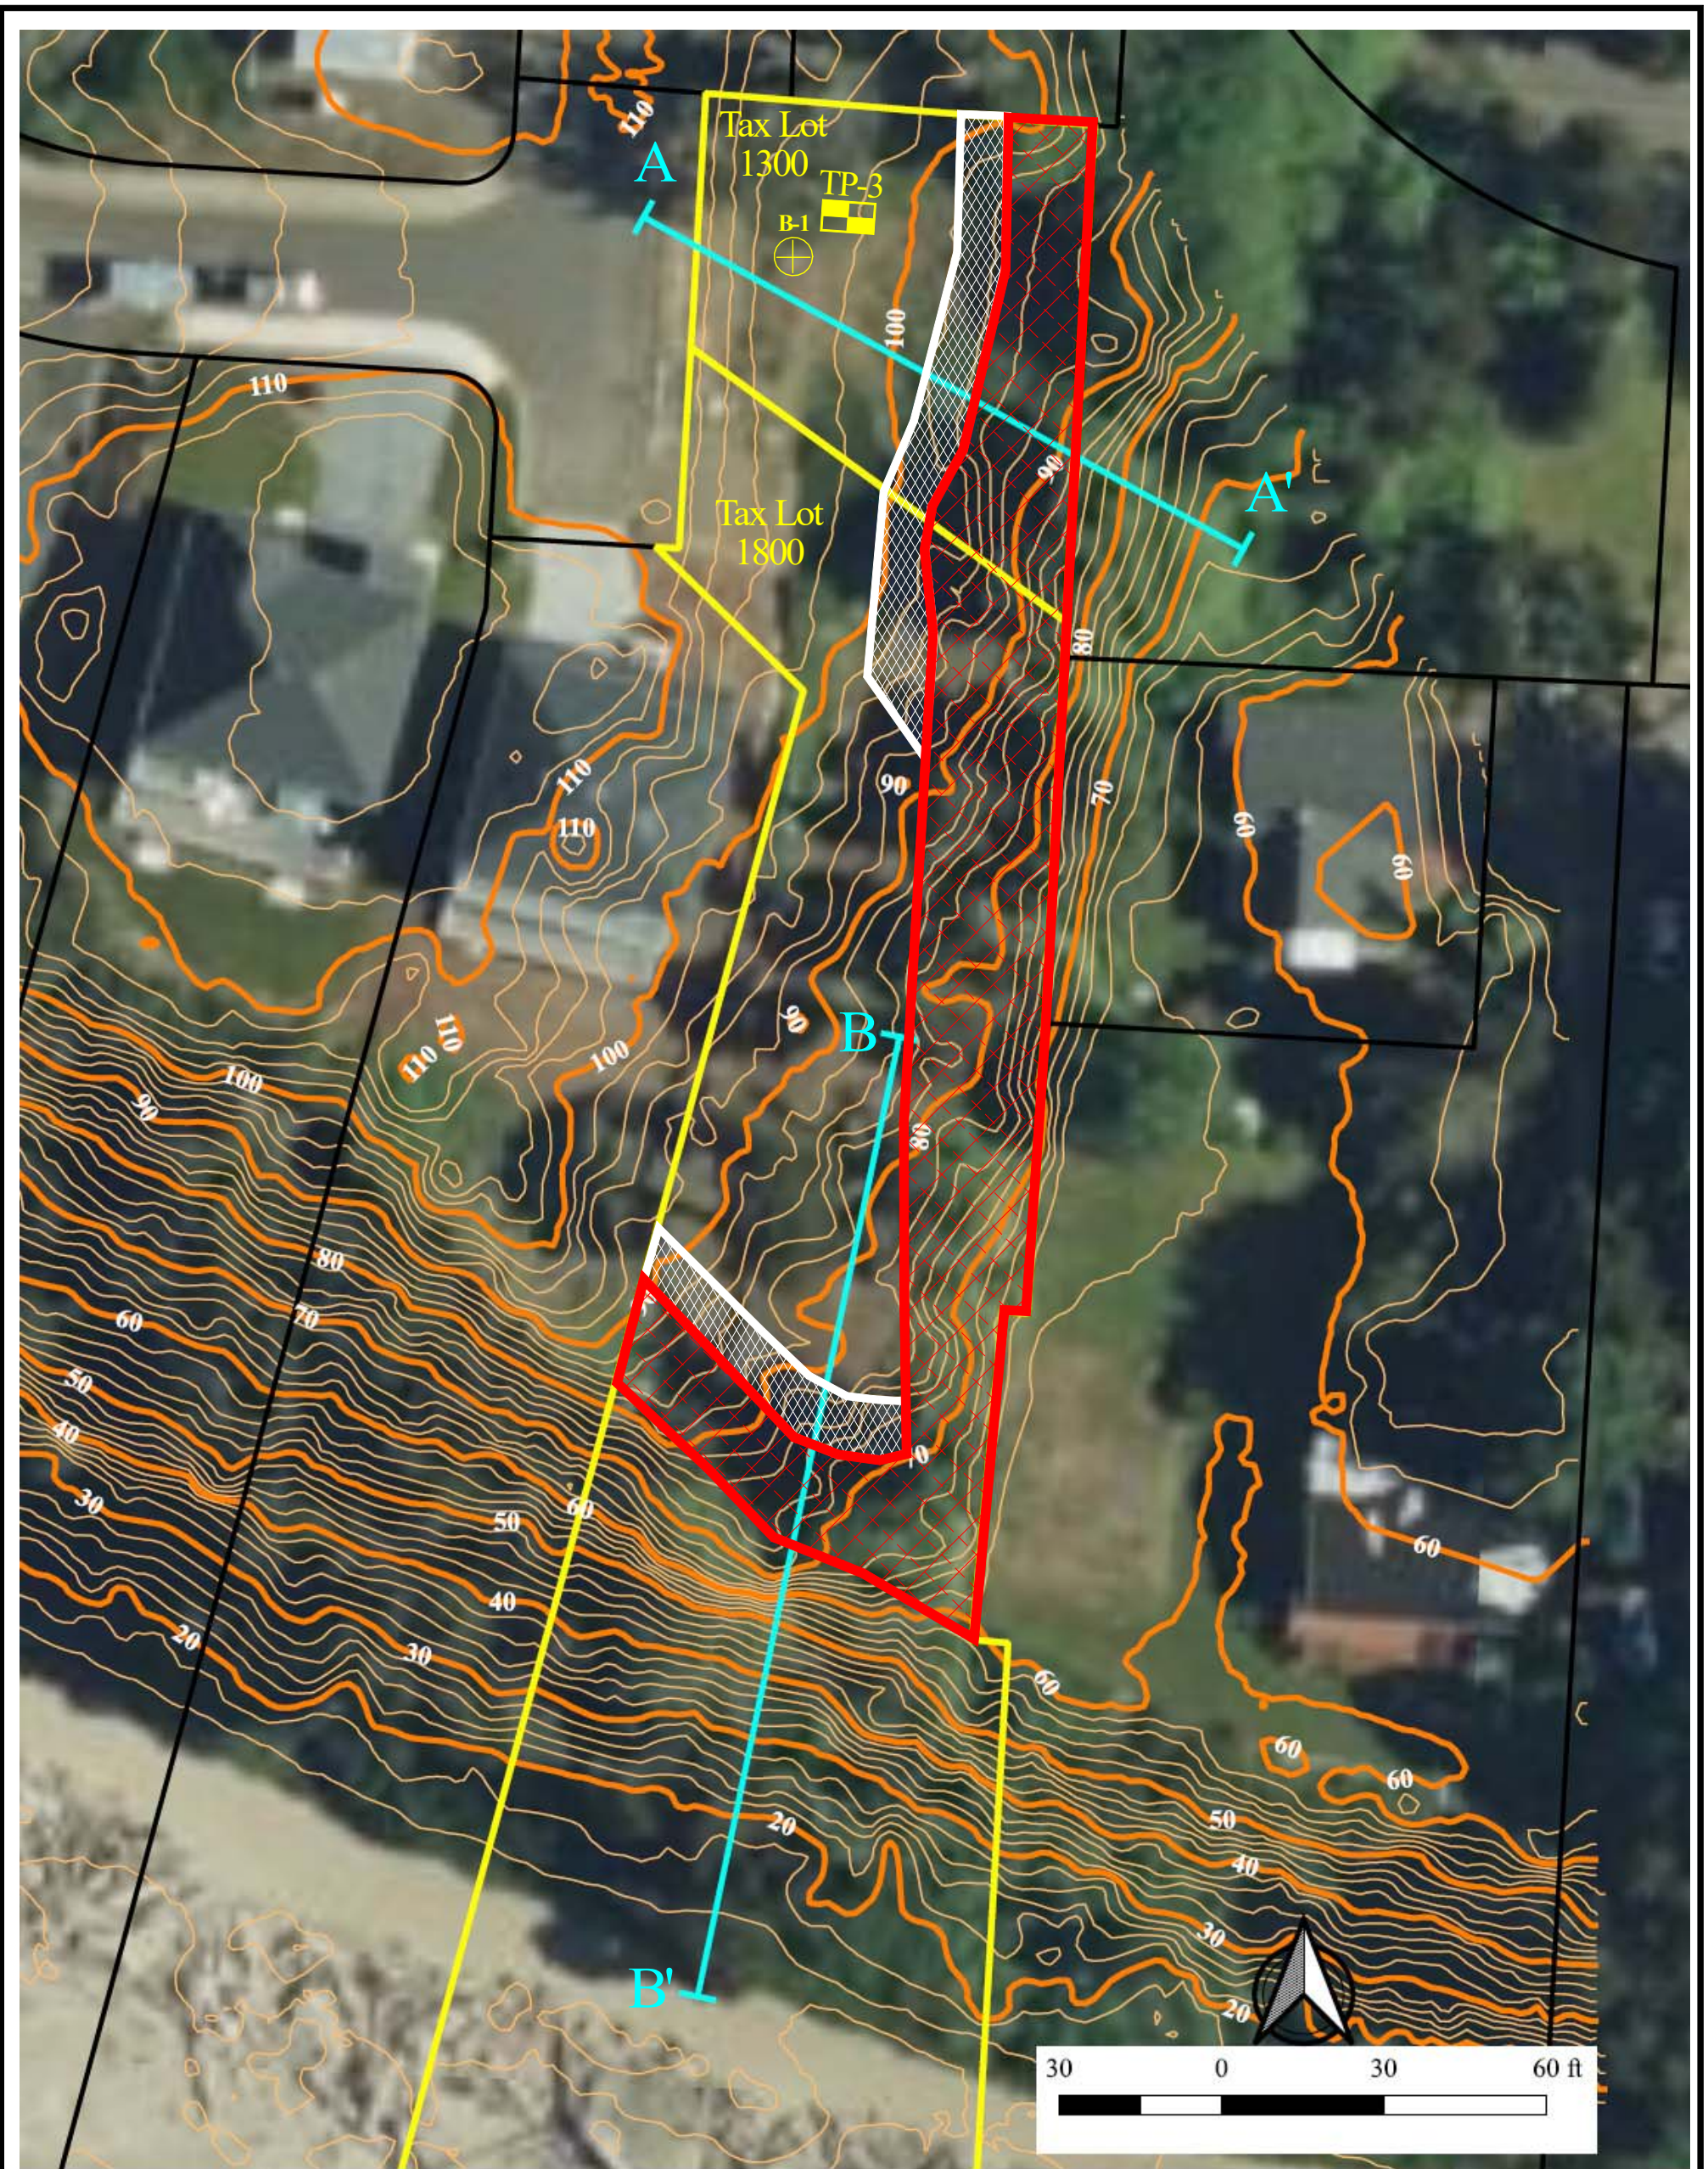
Figure 3

4. Areas not suitable for building or development are shown on Figures 3 and 4 due to their proximity to the oceanfront bluff slope and steep slopes along the eastern portion of the site. Areas that will require the use of deep foundation systems are also shown on Figures 3 and 4 and discussed below. However, to account for the thickness of unsuitable fill on Tax Lot 1300 in the area of the proposed house and reduce the amount of required over-excavation, consideration should be given to a foundation system consisting of grade beams supported on deep foundations such as augered pile for the western portion of Tax Lot 1300.

We also recommend a *top-of-slope* geologic hazards setback from the easterly-facing slopes along the site's eastern boundary (Figures 3 and 4). Structures west of the deep foundation area on Tax Lot 1300 can utilize standard continuous and isolated spread shallow foundations; however, as discussed herein, we anticipate the greatest amount of uncontrolled fill in this area.

To help mitigate future recession of the bluff caused by erosion and landsliding, we recommend that foundations and development be set back a minimum of 20 feet north of the upper bluff edge, as shown on Figures 3 and 4. This setback would allow room on the subject property to mitigate slope issues should a (less probable) larger landslide occur in the future. An approximately 10 feet area north of this geologic hazards setback, from 20 to 30 feet from the bluff edge, will require deep foundations. New structures more than 30 feet from the southern upper bluff edge can utilize standard continuous and/or isolated spread shallow foundations.

Figures 3 and 4 identify the areas of required geologic hazards setback, required deep foundations, and the allowable area for shallow foundations. To account for the thickness of unsuitable fill on Tax Lot 1300 in the area of the proposed house and reduce the amount of required over-excavation, consideration should be given to a foundation system consisting of grade beams supported on deep foundations in the western portion of the site.

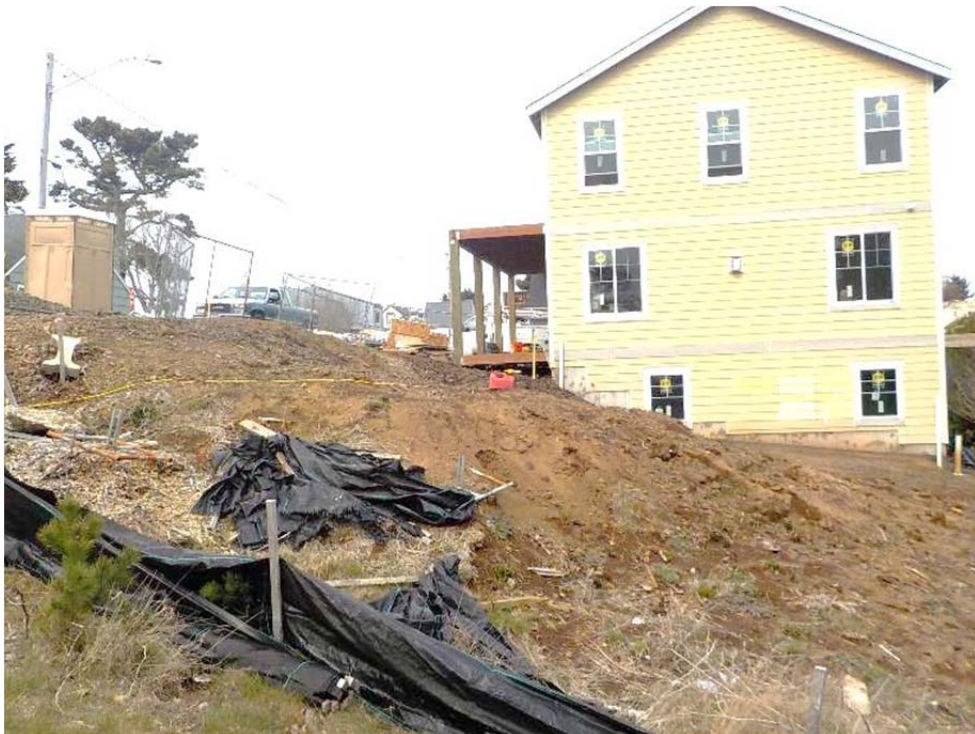
Photo 2 – Northerly view of Tax Lot 1300. Note the stockpile of fill soil and debris.

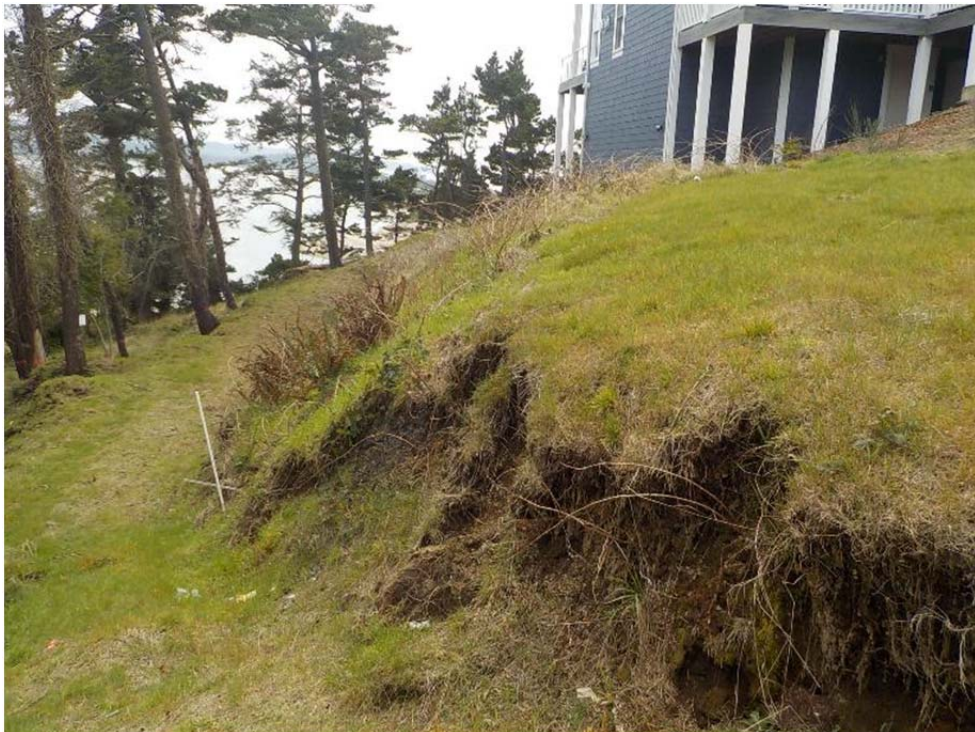
Photo 4 – Southerly view of Tax Lot 1800. Note the unretained cut slope.

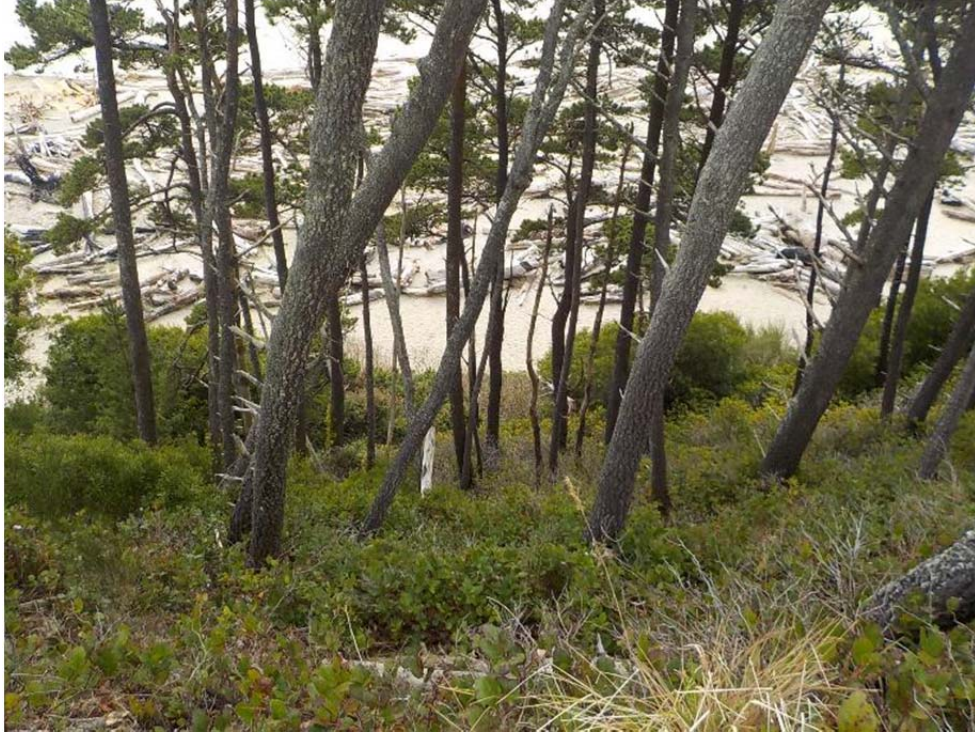
1. The bluff slope on the south part (Tax Lot 1800) of the site is undergoing continuous erosion, sloughing and shallow landsliding, which can fail back 3 to 15 feet or greater at a time. Undercutting by ocean waves and lateral erosion by the Siletz Bay river mouth can cause retreat of the toe of the slope, resulting in instability and failures along the slope. These hazards are common to oceanfront property in this area.

Photo 7 – Downslope view of the bluff slope and beach on the southern portion of Tax Lot 1800.

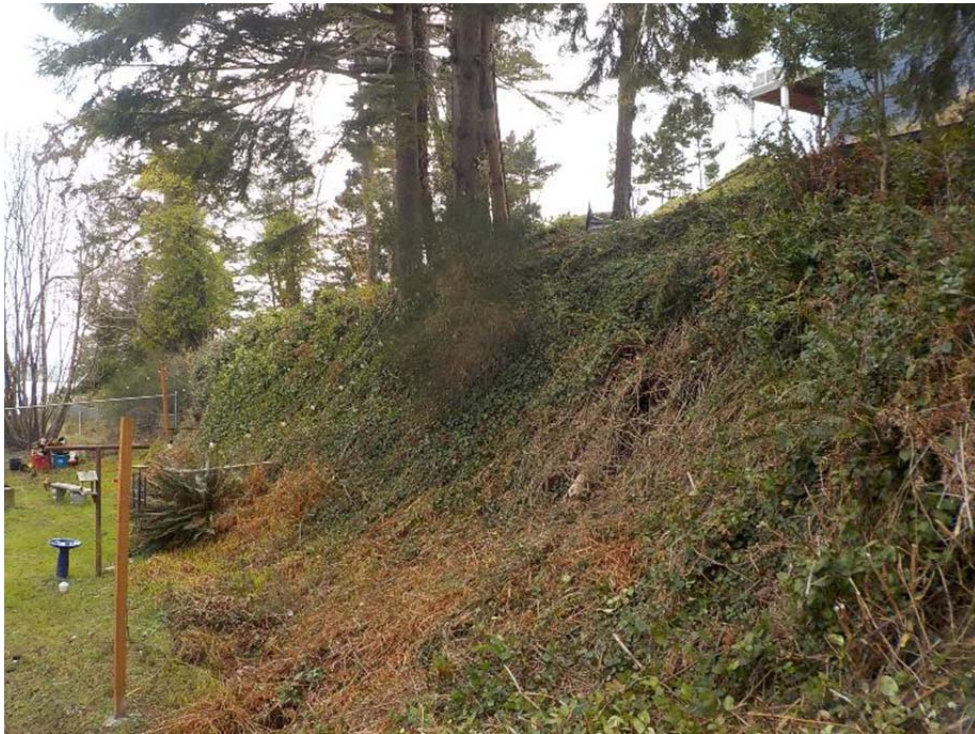
2. The steep slopes along the eastern property line are susceptible to erosion, sloughing, and shallow landsliding, which can fail back 5 to 10 feet or greater at a time. These slopes will continue to experience erosion, sloughing, and shallow landsliding until a more stable slope angle is achieved.

Photo 8 – Southerly view of the steep slopes along the eastern portion of Tax Lot 1800.

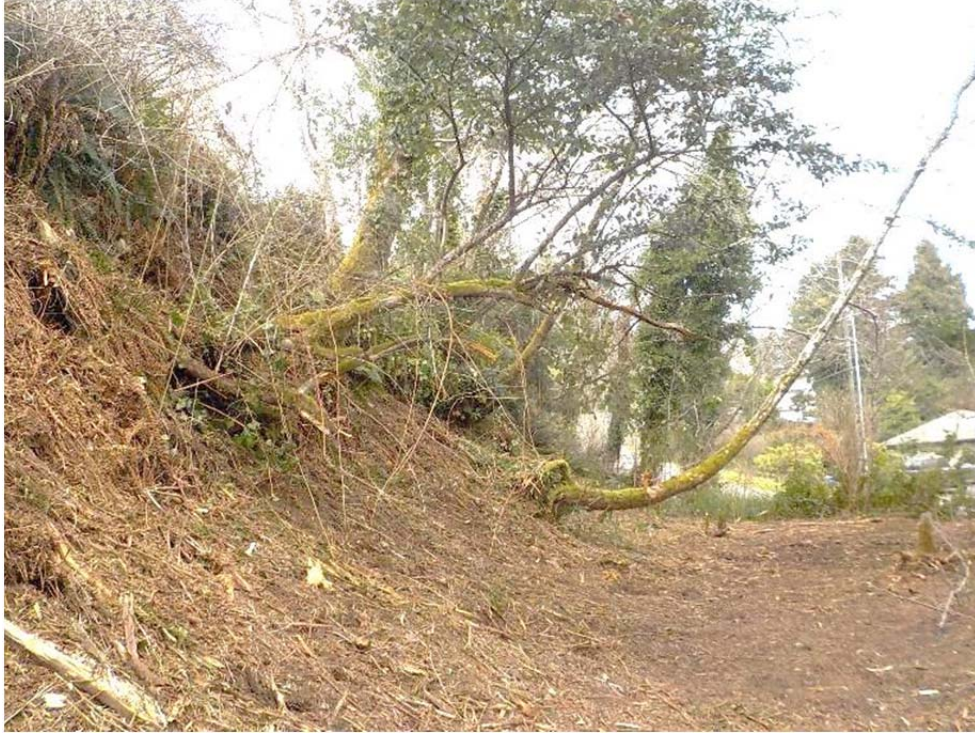
Photo 9 – Northerly view of the steep slopes along the eastern portion of Tax Lot 1300.

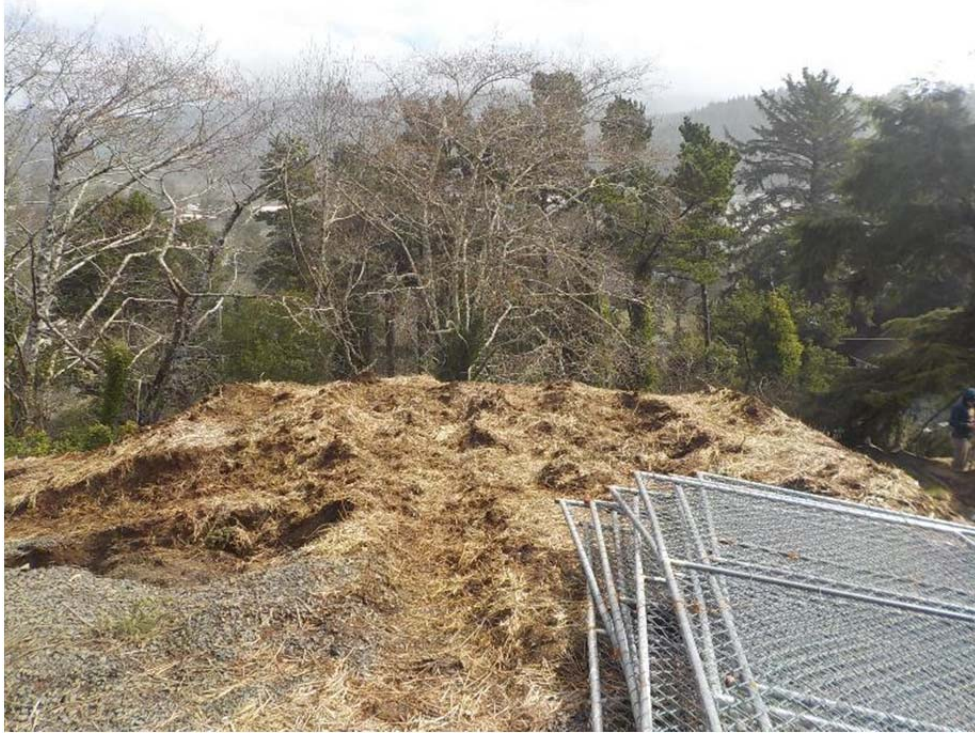
3. The site has been subject to prior grading activities with areas of thick uncontrolled fill. Based on past site observations, fill, soft/loose, disturbed, and organic-rich soils approximately 10 feet deep or more are present at the site and must be removed from footing and slab areas before construction.

Photo 11 – Easterly view of the large fill stockpiled on Tax Lot 1300 (3/22/2022).

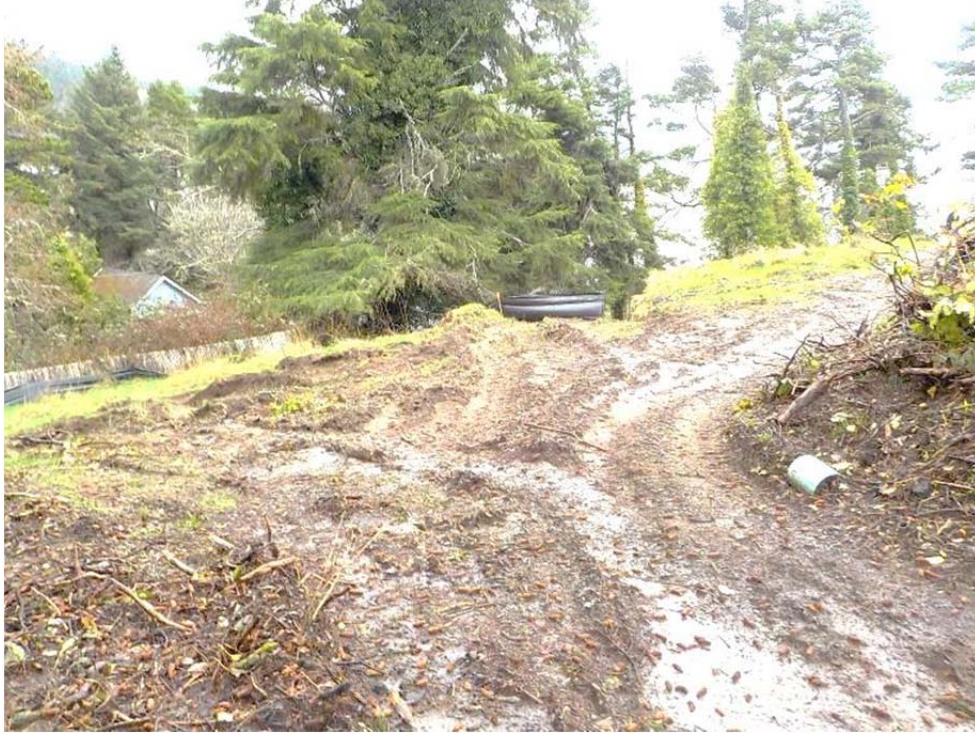
Photo 13 – View of the disturbed ground surface from grading and construction activities on Tax Lot 1300 (1/31/2020).

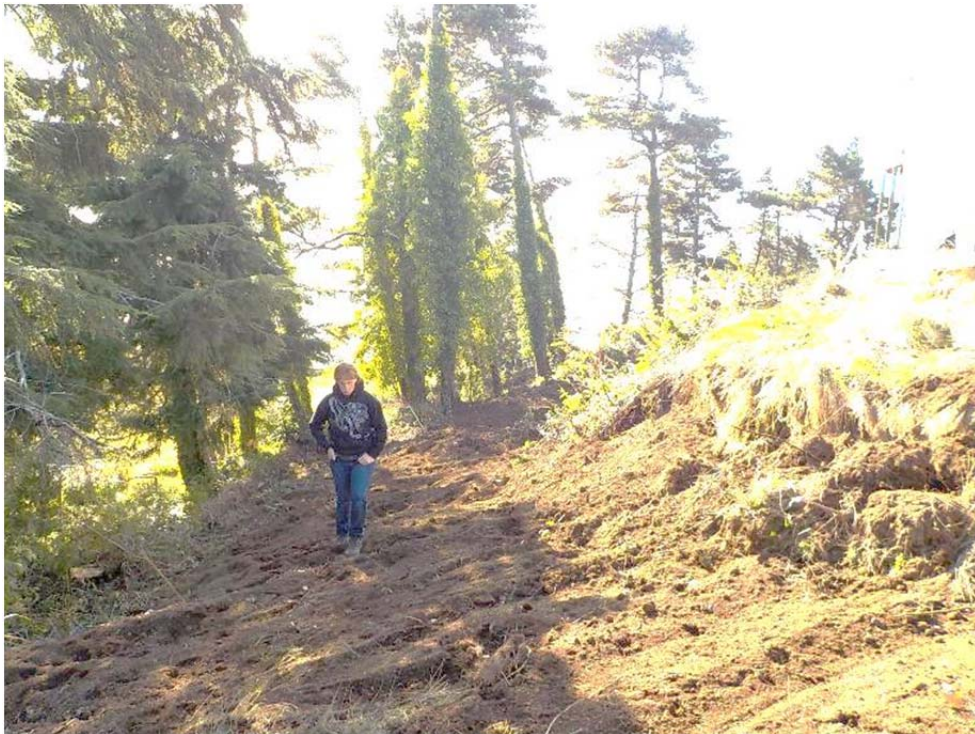
Photo 14 – View of the disturbed ground surface from grading activities on Tax Lot 1800 (10/31/2019).

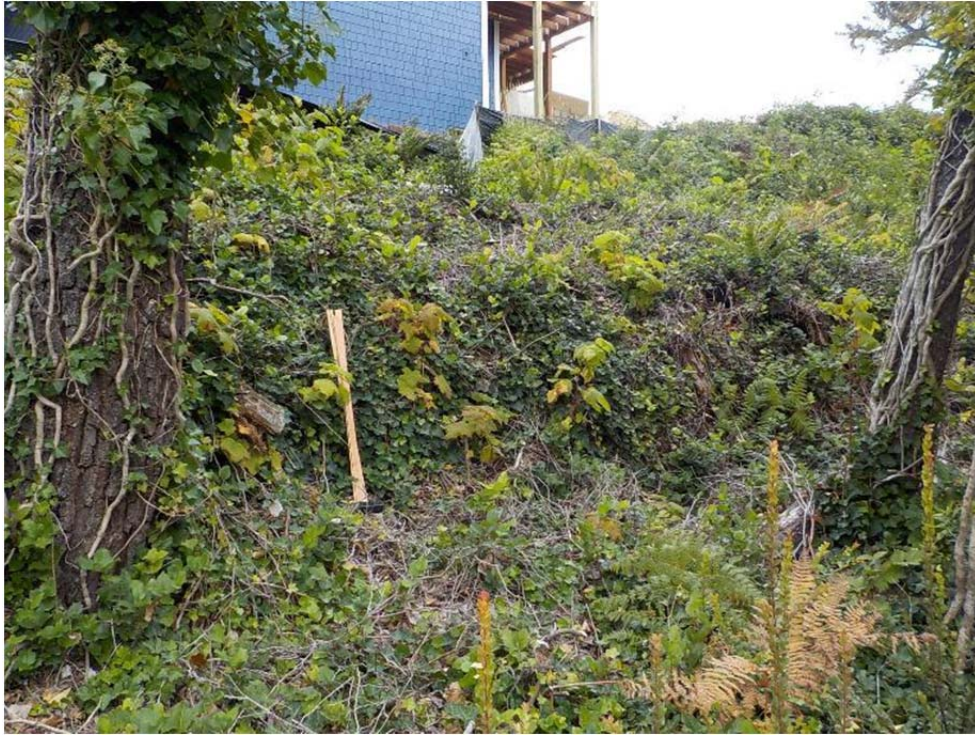
Photo 15 – View of a scarp-like feature on Tax Lot 1800 (10/15/2019).

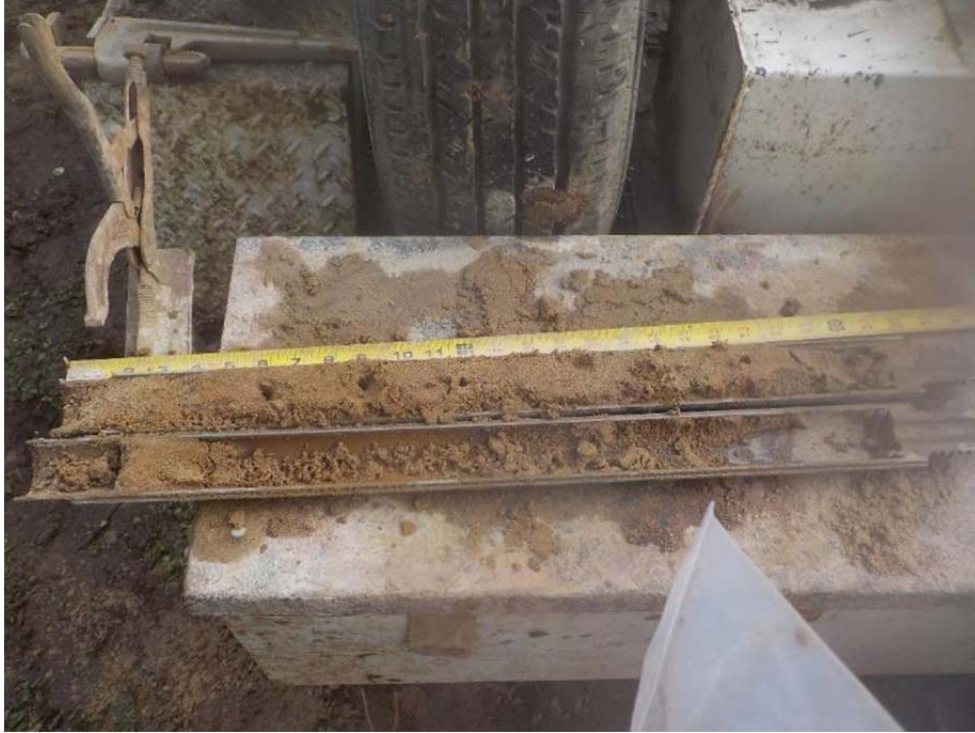
Photo 17 – Close-up view of the native dense sands typical of that recovered in the boring (4/12/2018).

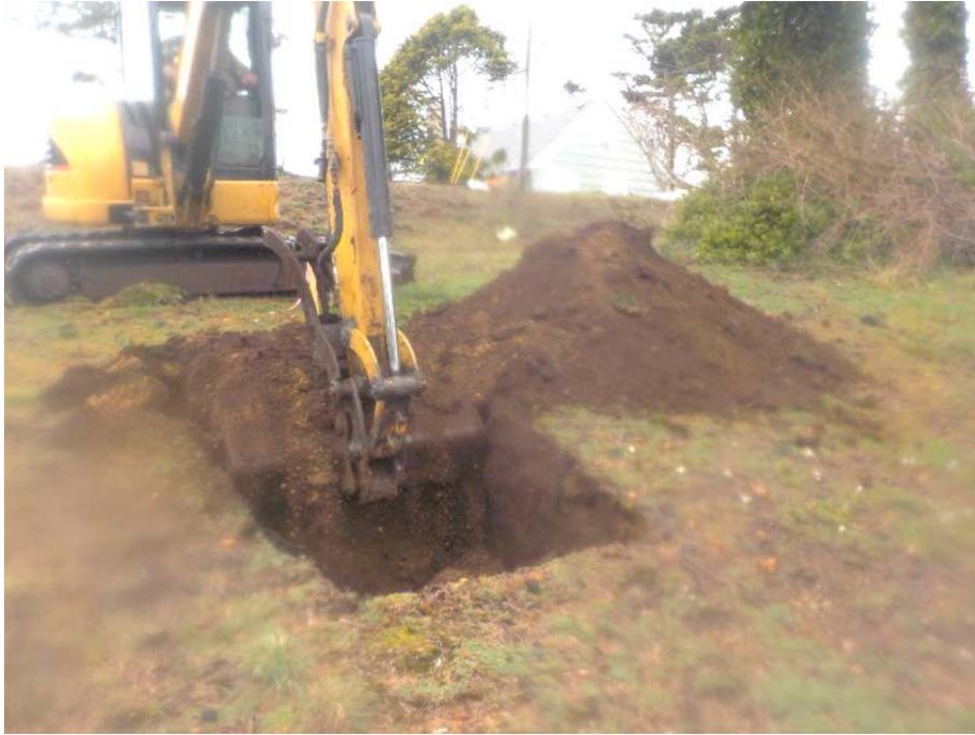
Photo 19 – View of a test pit excavated on Tax Lot 1300 (04/05/2018).

All test pits in footing, slab, and driveway areas should be excavated to their full depth and replaced with structural fill per the recommendations provided herein. The approximate location of the test pit is shown on Figures 3 and 4.

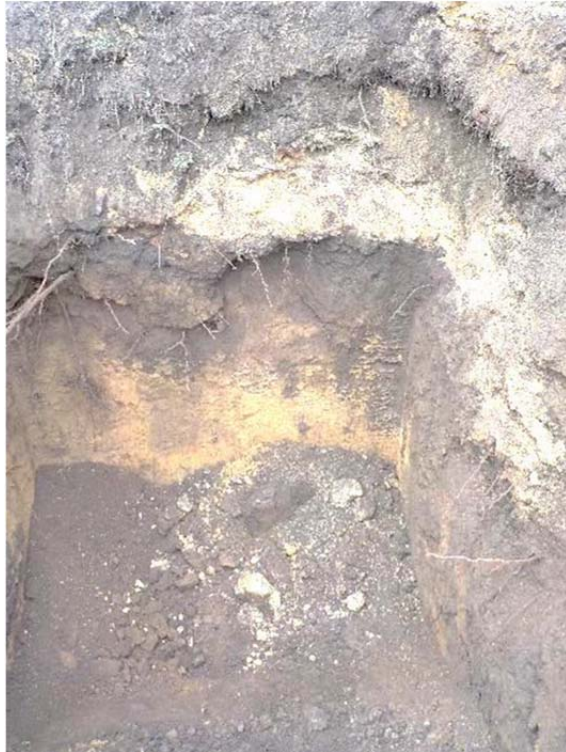
Photo 20 – View of the native dense sand underlying organic-rich soils and fill exposed in the test pit (04/05/2018).
