Geotechnical Report for Deck

3730 SW Anchor Court
Lincoln City, Oregon

Prepared for:
TnT Builders

3 August 2022
Revised and updated 3 May 2023
Revised 14 July 2023
Revised 21 November 2023

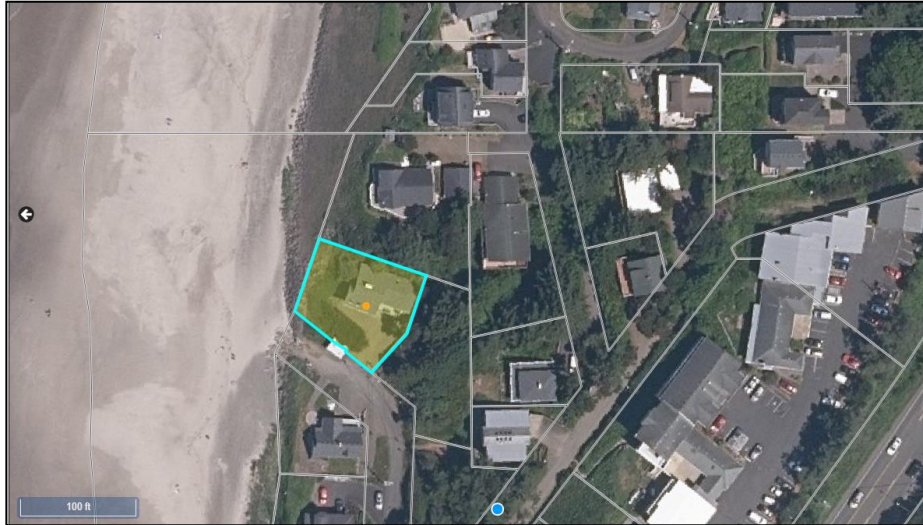
Lincoln County web maps: 2021 aerial image of the site.

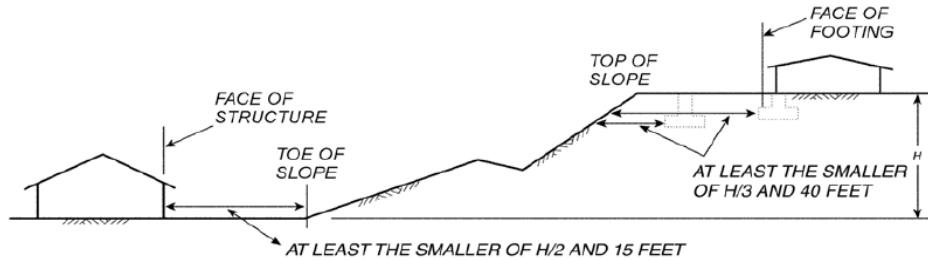
**FIGURE 1808.7.1
FOUNDATION CLEARANCES FROM SLOPES**

The new deck must be embedded into the slope following the building code. The planned setback means the deck post meet the desired slope setback. See figure below. RSS does suggest embedded the post 2ft into the ground for erosion protection.

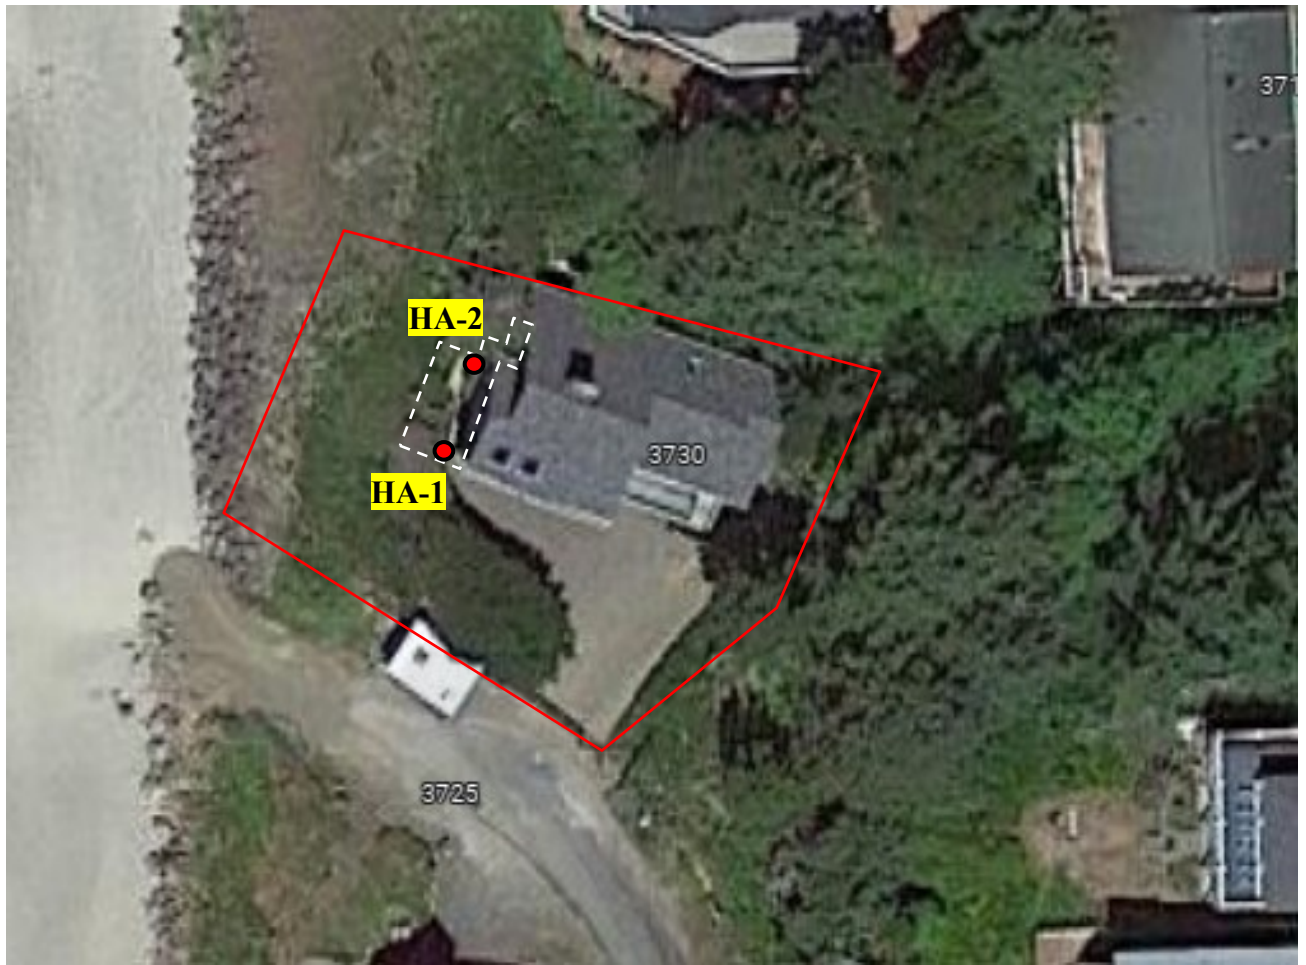
Figure 2: Testing Locations

The site was investigated by drilling two (2) hand-auger borings. The bore holes are shown on Figure 2 in the appendix. An EIT, engineer-in-training, observed the excavation of the borings and logged the subsurface materials. A registered professional engineer reviewed the results. Boring logs detailing materials encountered is in the appendix. The logs were created using the Unified Soil Classification and Visual Manual Procedure (ASTM-D 2488). RSS found tan, medium to coarse grained poorly-graded SAND on site.
