July 19, 2019

RE: GEOLOGIC HAZARD ASSESSMENT AND GEOTECHNICAL EVALUATION
4633 SOUTHWEST BEACH AVENUE
TAX LOT 7-11-27-CD 3600, ACCOUNT R420048
LINCOLN CITY, OREGON 97367
Branch Engineering Inc Project No. 19-225

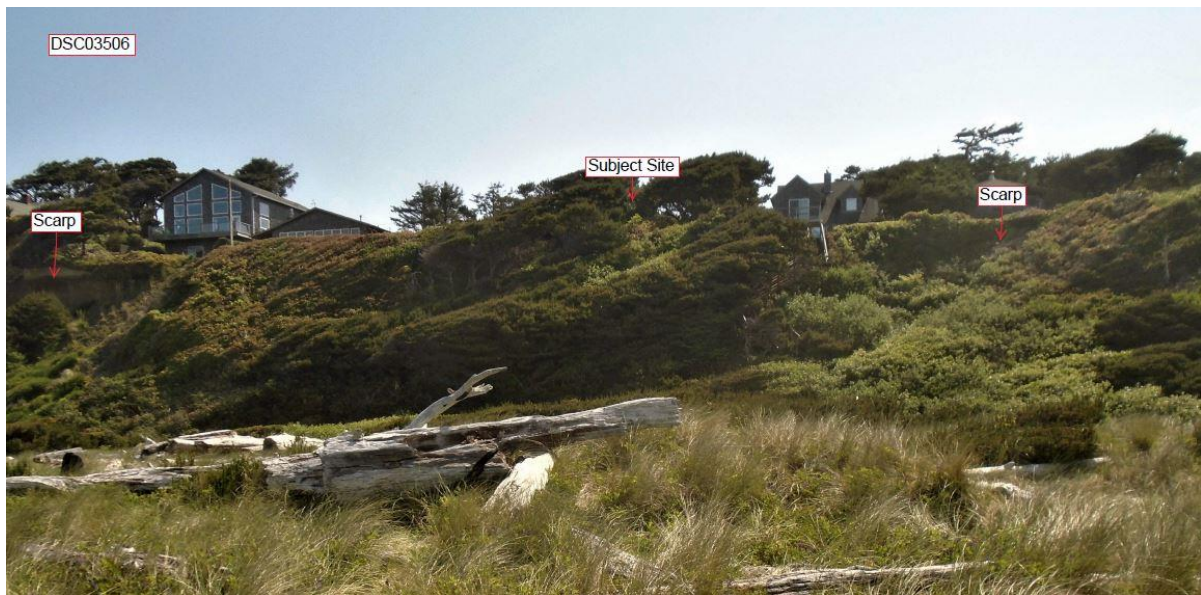
Near vertical bare soil scarps were observed (see below Photo DSC03506) on the south-neighboring parcel and a couple of parcels to the north as mentioned above.

The south-neighboring scarp is likely the headscarp of the recent landslide mentioned in the Schlicker report. The northern scarp may be a continuation of the headscarp observed on the subject site in 2001 but now obscured by vegetation, or the headscarp of a separate but similar landslide.

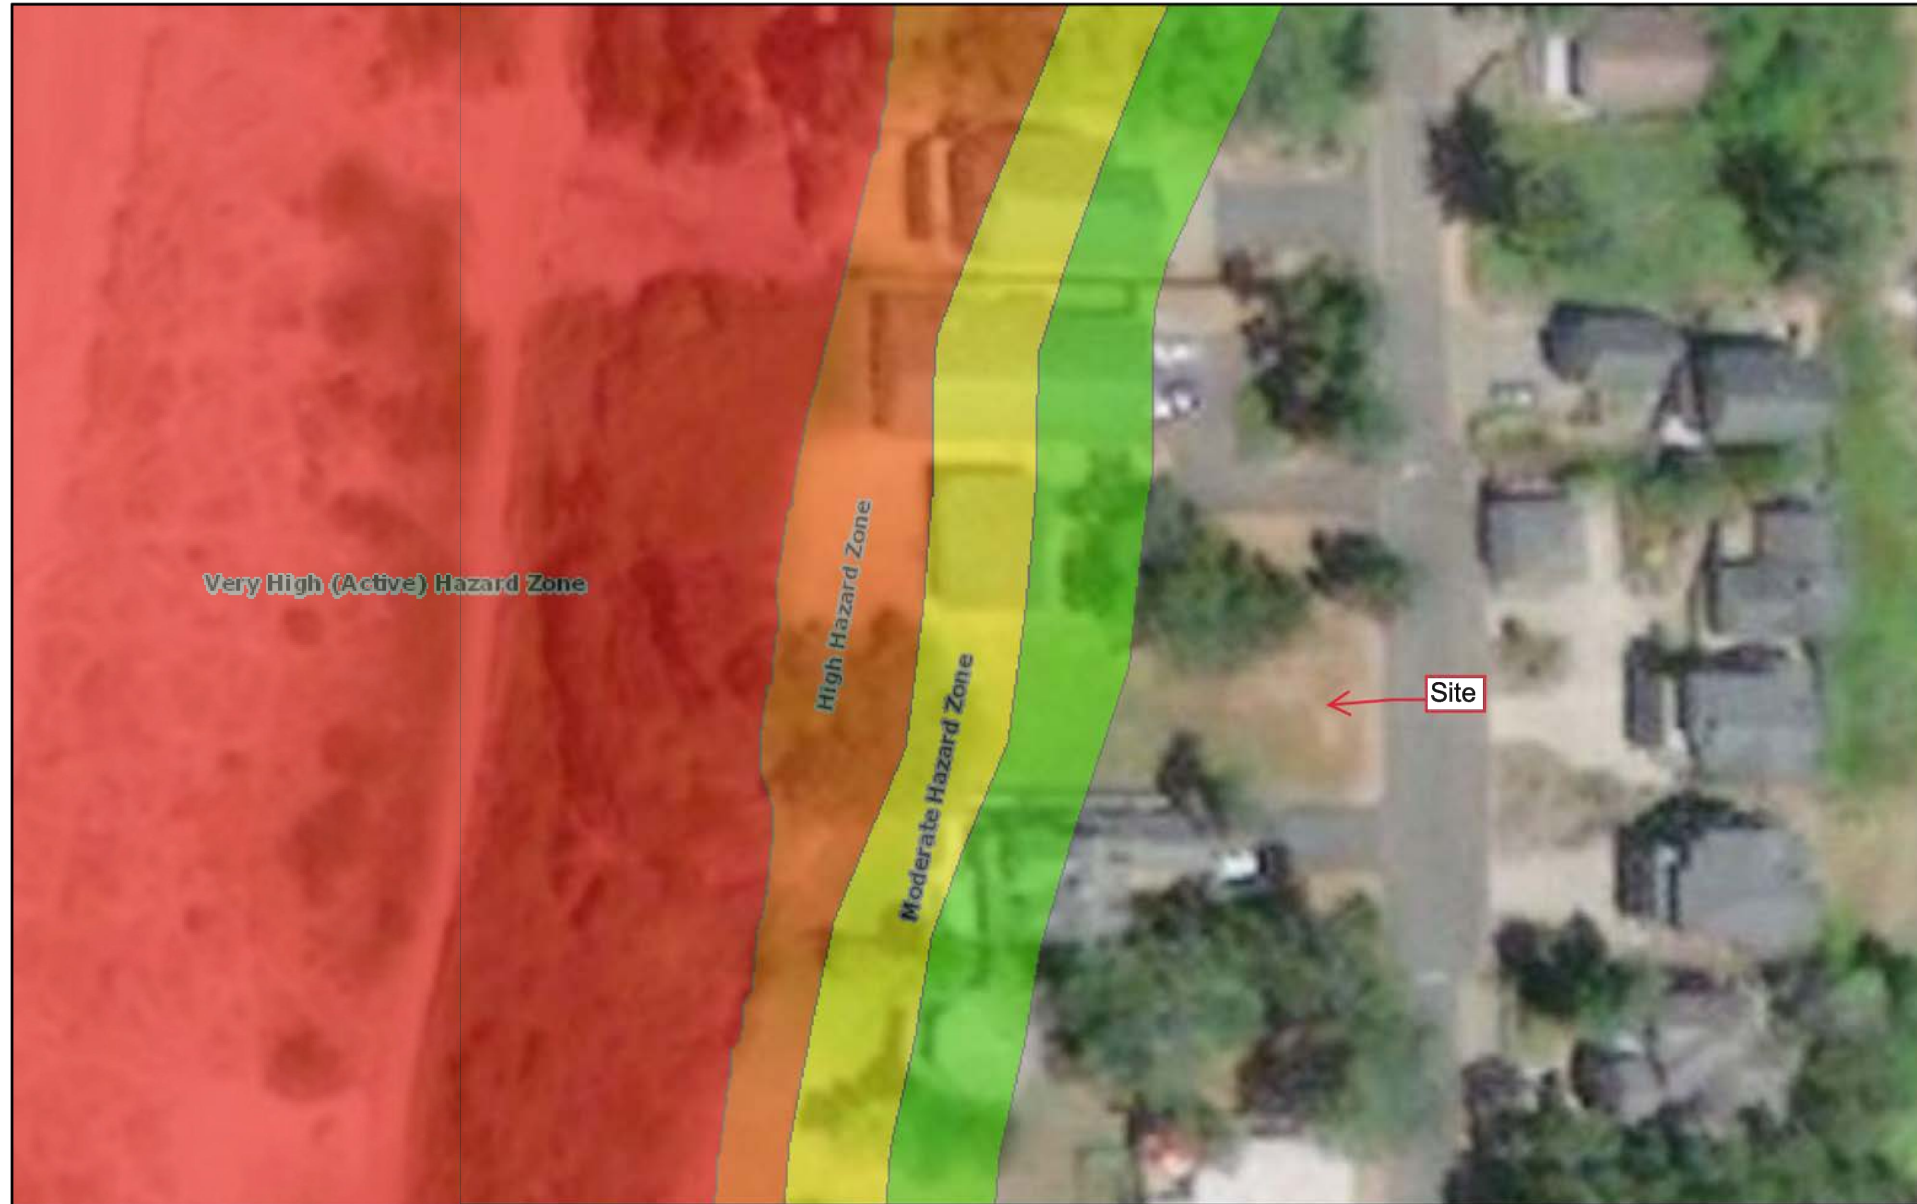
HazVu Coastal Erosion Hazard Map

The steeper slopes and beach west of the subject parcel are mapped in the active Coastal Erosion Hazard Zone in DOGAMI O-04-09 and on the HazVu website (DOGAMI HazVu Coastal Erosion Hazard Map, Figure 7). DOGAMI LIDAR Bare Earth Slope imaging shows the steep western slopes begin about 190 feet west of the SW Beach Avenue pavement. A schematic of the anticipated erosion rate is shown on Figure 15 (Bluff Erosion Hazard Zone Diagram) where the

The DOGAMI HazVu website maps no coastal erosion hazard west of the SW Beach Avenue pavement for about 80-feet, low hazard from about 80- to 110-feet, medium hazard from about 110- to 140-feet, high 140- to 195-feet and very high hazard beyond 195-feet. OFR-04-09, upon which the website is based, has an erosion zone diagram that suggests a residence built 140-feet or less from the pavement would be relatively safe from bank erosion concern for about 60 years, and construction east of a line 110-feet would be relatively safe for about 100 years. These values suggest a bluff retreat rate of about 80-feet in 100-years, or 9-inches a year, or about 16-feet since the 2001 Schlicker report. In our opinion the HazVu ratings are highly conservative based on our observations; however, faster erosion rates may occur with increased sea level rise due to global warming (DOGAMI OFR-04-09 also estimates a net sea level rise of about 1.5 millimeters per year subsidence relative to the current sea level in the Lincoln City vicinity). Comparison of 2001 and 2018 Google Earth images in our opinion shows possible bluff retreat of up 5-7 feet in that time period by incremental erosion rather than landsliding and in our opinion a value of about 4-inches per year is a good estimate for a current erosion rate at the edge of the bluff. It should be noted that the slope break vicinity observed in the 2001 Google Earth images appeared grassy with a lack of brush and dense vegetation that would tend to slow erosion. The increased density of vegetation now present may slow the erosion rate to a couple inches a year or less. If the dune west of the base of the slopes disappears due to erosion, waves could undercut the slope and increase the erosion rate more in line with the HazVu prediction of about 9-inches per year.

A conservative estimated erosion rate of 9 inches a year as suggested by the HazVu Coastal Erosion Hazard website would result in about 40-feet of bluff regression over the design life of 50 years, essentially the same as the set-back from the slope-break recommended in the Schlicker report. Presently the slopes steepen significantly about 195-feet from the pavement, or 180-feet from the east property boundary and in 50 years the distance could decline to about 140-feet from the property line. Adding another 20-feet as a safety buffer, we recommend 120-feet as the maximum setback from the eastern property line for standard rebar-reinforced spread footings. Deep foundations along the western wall and the southwestern corner of the residence (closest point to anticipated future instability) would add an additional factor of safety if desired, or reinforcing the footings to facilitate future underpinning may also be considered in design, if that should become necessary. Siting the structure further west would likely require additional geotechnical investigation including deeper geotechnical borings, slope stability analysis and piles into the dense subgrade materials.

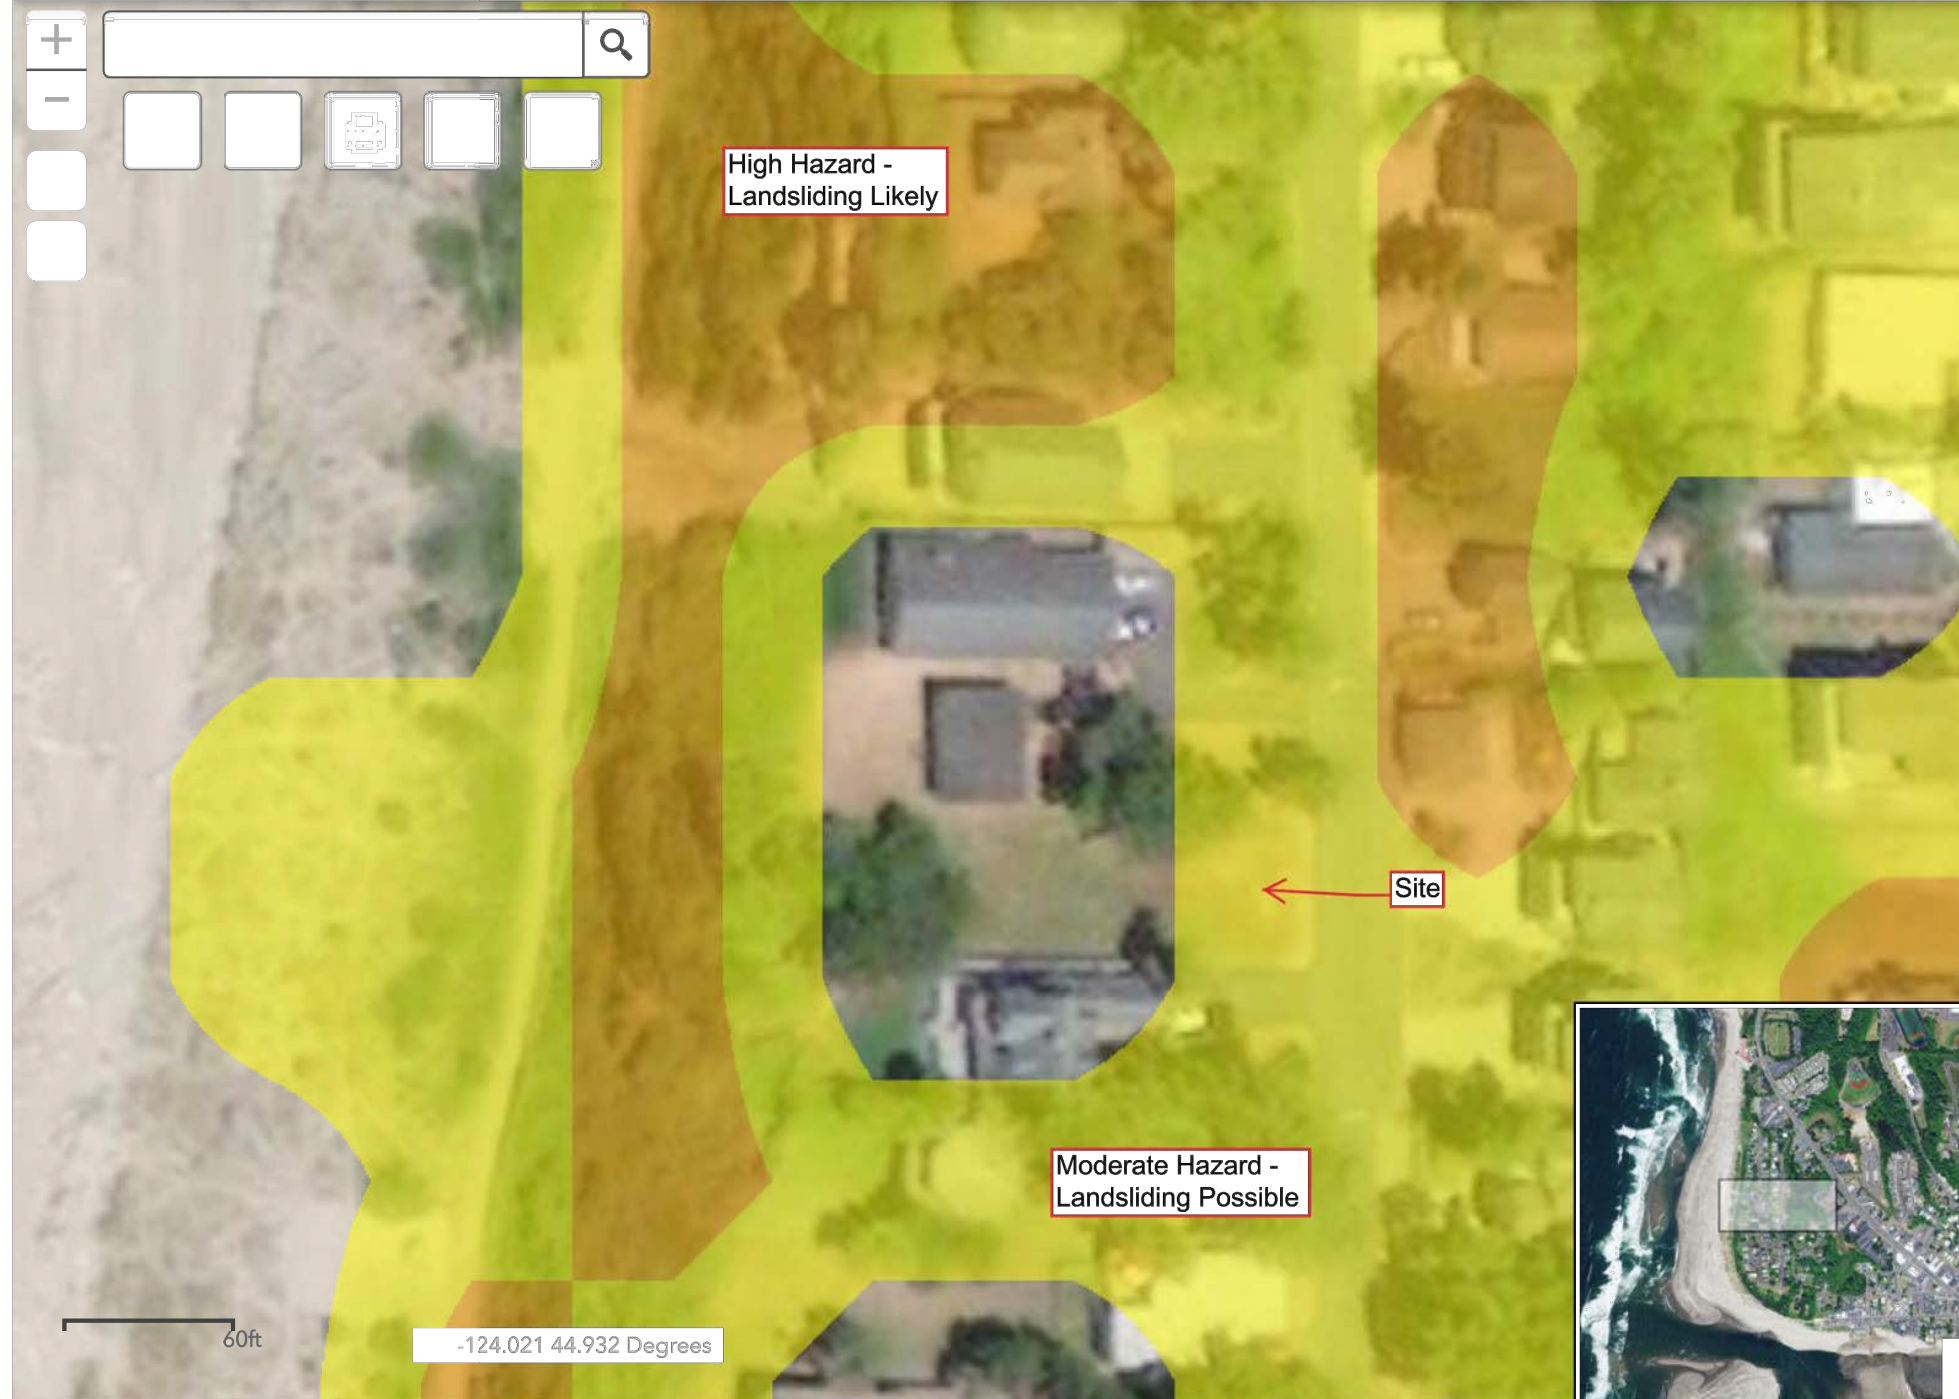
HazVu Landslide Hazard Map

The DOGAMI HazVu website does not map any landslides (Figure 8) in the site vicinity but does rate the eastern and western margins of the parcel at moderate risk from landsliding - landsliding is possible. The steep slopes west of the parcel are rated at high risk - landsliding is likely due to future bank erosion from wave action, and the central area of the subject site, the likely location of the proposed residence, has no mapped landslide risk.

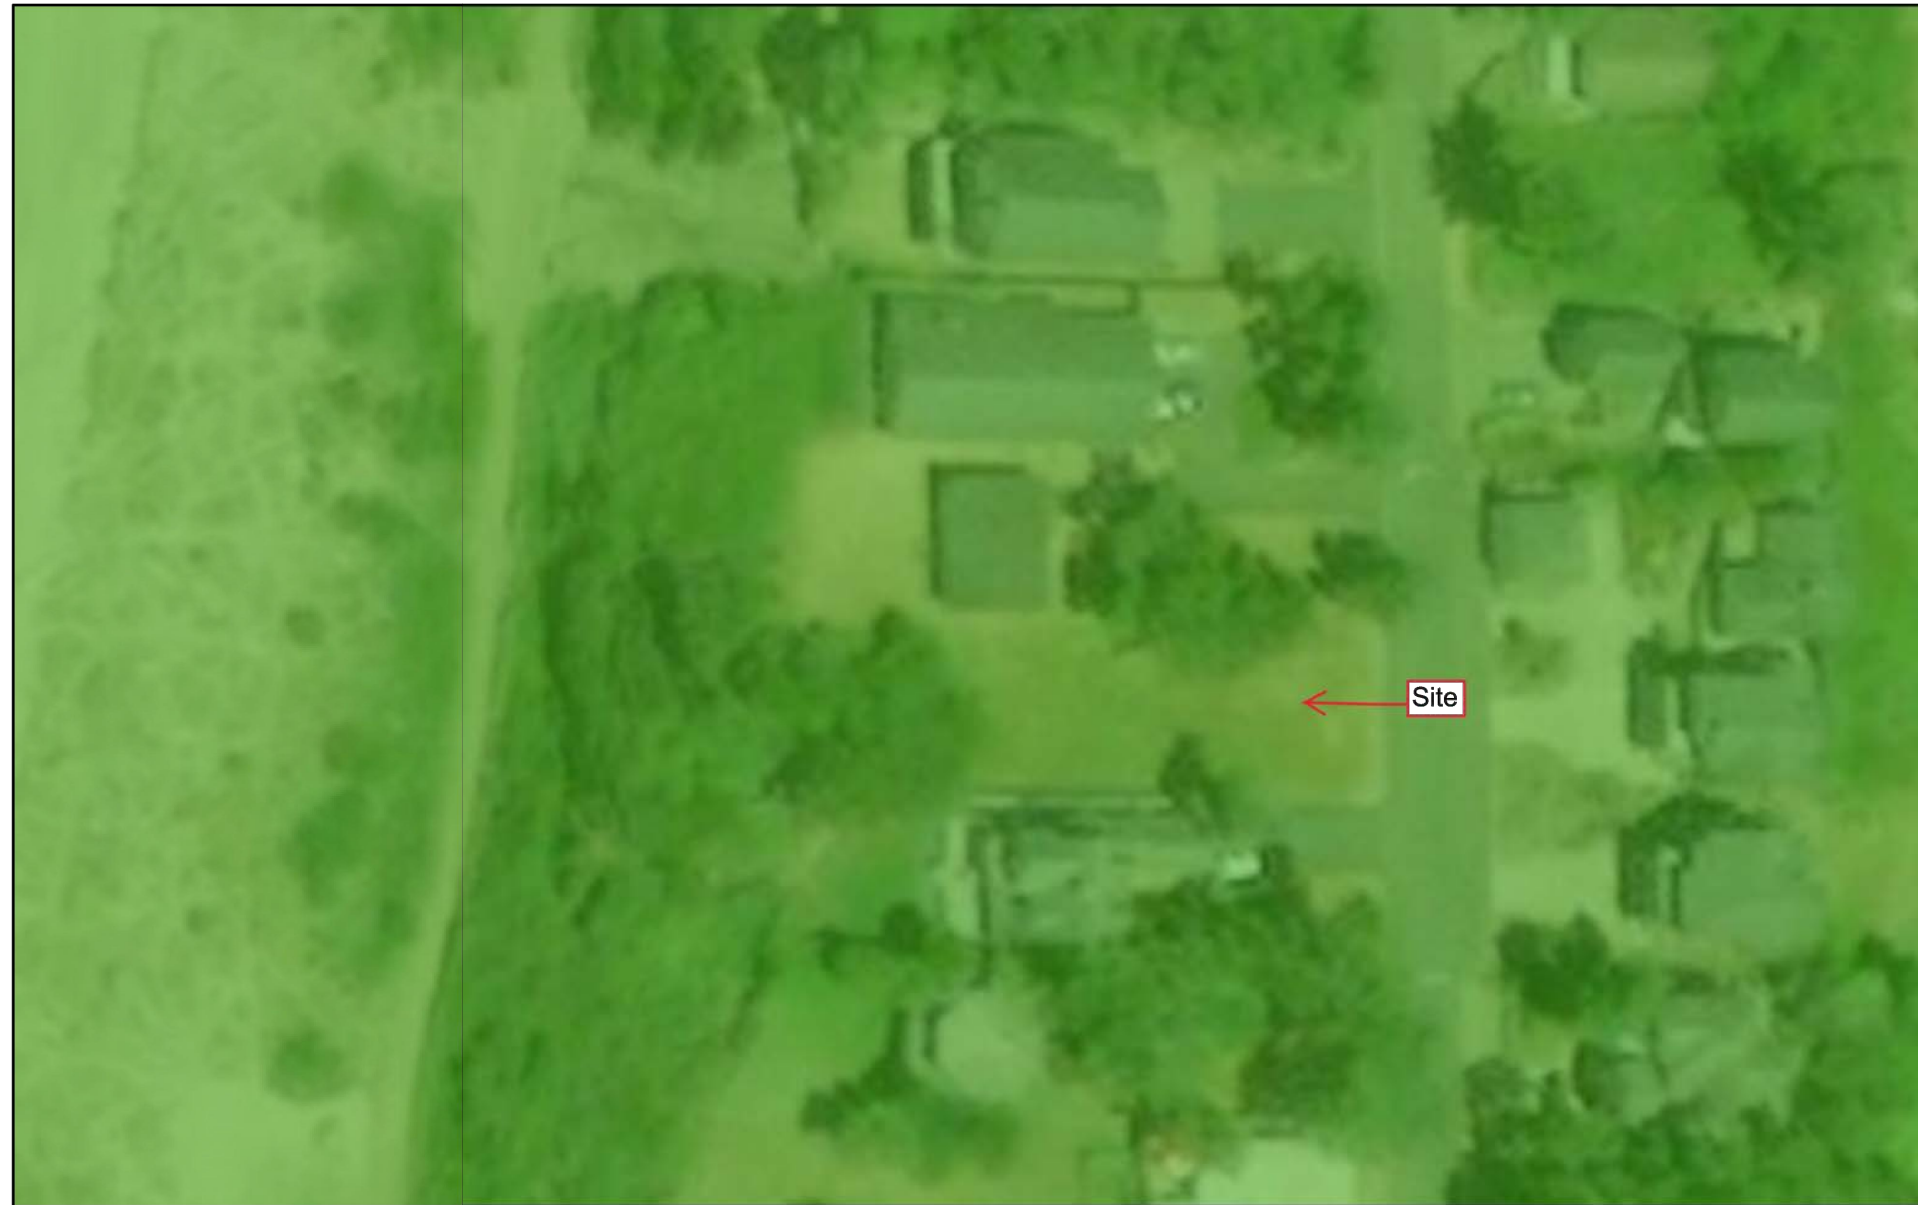
HazVu Liquefaction Hazard Map

Most geologists believe large subduction zone earthquakes will remobilize old slides and generate new landslides in areas prone to instability. In our opinion this site is at a relatively high risk for damage to structures in the event of an earthquake. HazVu rates the soil liquefaction hazard for the site vicinity as low, with severe shaking in the event of a CSZ earthquake and very strong shaking for more distant or lesser earthquakes. The statutory tsunami inundation line is mapped by both HazVu and DOGAMI TIM Linc02 at the approximate slope break, below the proposed homesite vicinity. It should be noted that one of the effects of a large CSZ earthquake could be instantaneous subsidence along the coast of up to 5-feet as the stress causing the upward bowing of the continental plate is released.

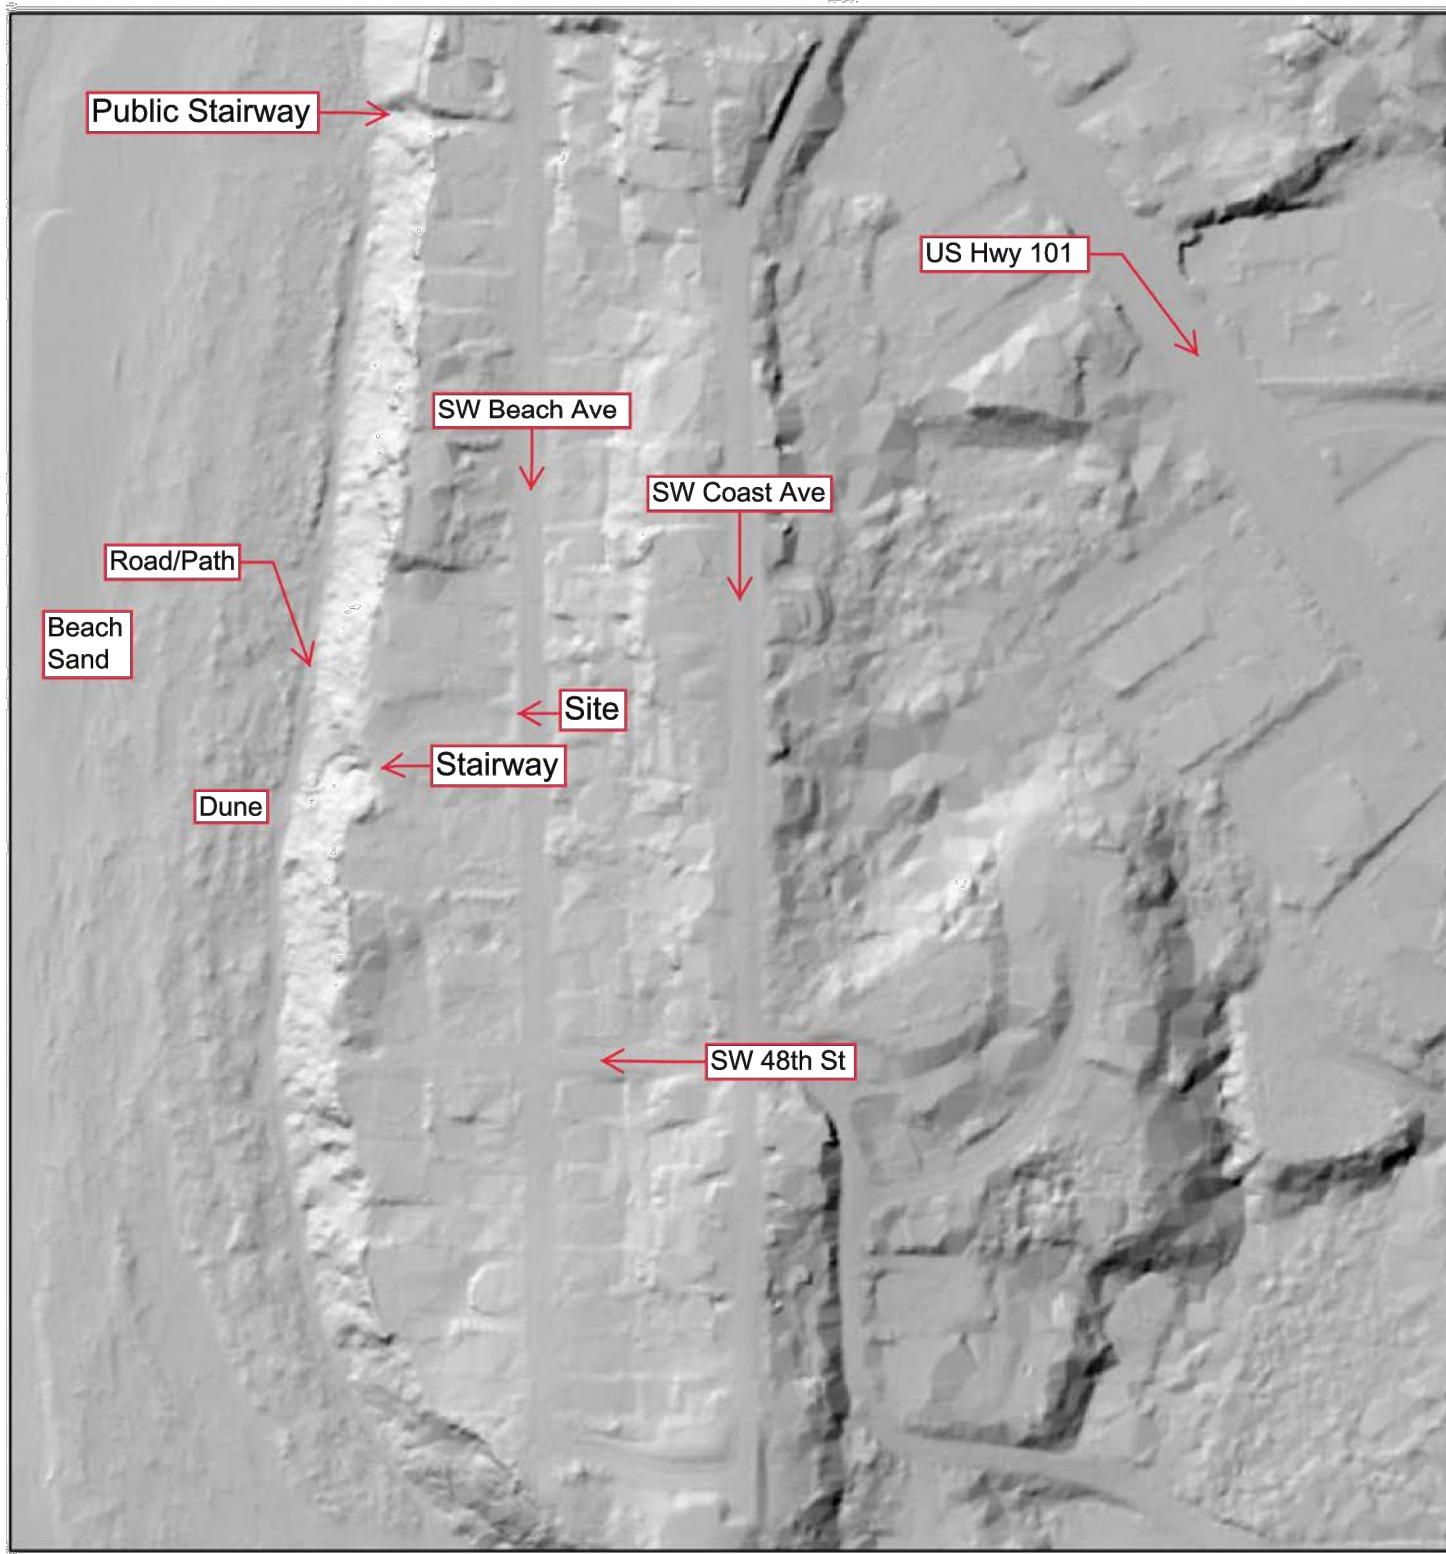
LIDAR Image

LIDAR imaging (Figure 12) suggests SW Beach Avenue was constructed on a bench excavated into the relatively gentle west-facing slopes of the north-south trending bluff with some spoils pushed onto the western shoulder forming the short, moderate slope leading down 15-feet from the edge of the pavement to the east property line of the subject site. Grading of the north-neighboring parcel likely generated the short, moderate slope about a foot high observed near the common boundary. The eastern half of the site is underlain by gentle, west-facing slope ranging from 1- to 5-degree. The area is vegetated with long grass, scattered blackberries and occasional ferns, with common blackberry vines the on the short moderate slope adjacent to SW Beach Avenue. A stand of lodgepole pine trees with salal, wax myrtle, English ivy and fern understory, cleared in places, extends westward from about 120-feet west of the SW Beach Avenue pavement, beginning a few feet west of the exploratory boring. Slopes begin to steepen slightly about 150-feet west of the pavement, increasing to more than 12 degrees at about 170-feet, increasing to about 27 degrees past 190-feet and generally exceeding 45 degrees past about 200-feet. Abundant, dense vegetation combined with steep slopes made the slopes beyond 200-feet relatively inaccessible. A narrow pathway was found down to a platform on the south neighbor’s wooden stairway to the beach and the base of the slopes were accessed from that stairway.

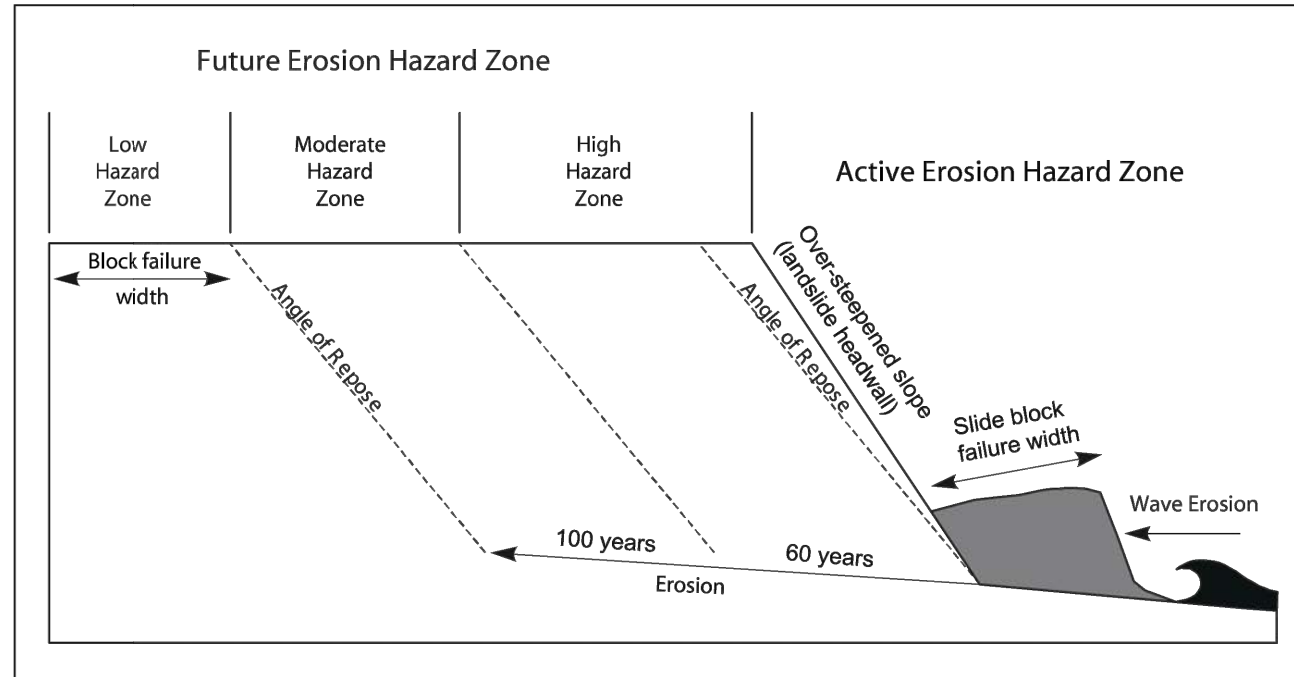
DOGAMI OFR O-04-09 Bluff Erosion Hazard Zone Diagram

high hazard zone suggests active erosion within 60 years; this zone extends west of the treeline on the site about 140 feet from the pavement. The moderate hazard zone extends eastward to about 110-feet west of the pavement, the approximate location of HA-1, and the low hazard zone ends about 80 feet west of the pavement; no hazard is mapped in the easternmost margin of the site. Previous hazard mapping (Figure 5 DOGAMI O-97-16) mapped erosion rates in the site vicinity at 0 to 0.1-foot per year, averaging 0.05 foot per year, or a little more than a half inch per year. Google Earth historical imagery dating from 1994, in our opinion shows no significant change in the location of the edge of the bluff, and vegetative cover has become increasingly dense on the dune area west of the road/path at the base of the slope while the height of the dune remained fairly constant. OFR-O-04-09 quotes research that indicates the Lincoln City vicinity is submerging at a rate of approximately 1.5 millimeters a year due to crustal warping and sea level increase due to global warming.
