March 13, 2024
Update April 17, 2024

**RE: REVISION TO LETTER OF UPDATE TO: GEOLOGIC HAZARD ASSESSMENT AND GEOTECHNICAL EVALUATION
4600 SOUTHWEST BEACH AVENUE
TAX LOT 7-11-27-CD 3600, ACCOUNT R420048
LINCOLN CITY, OREGON 97367
Branch Engineering Inc Project No. 19-225**

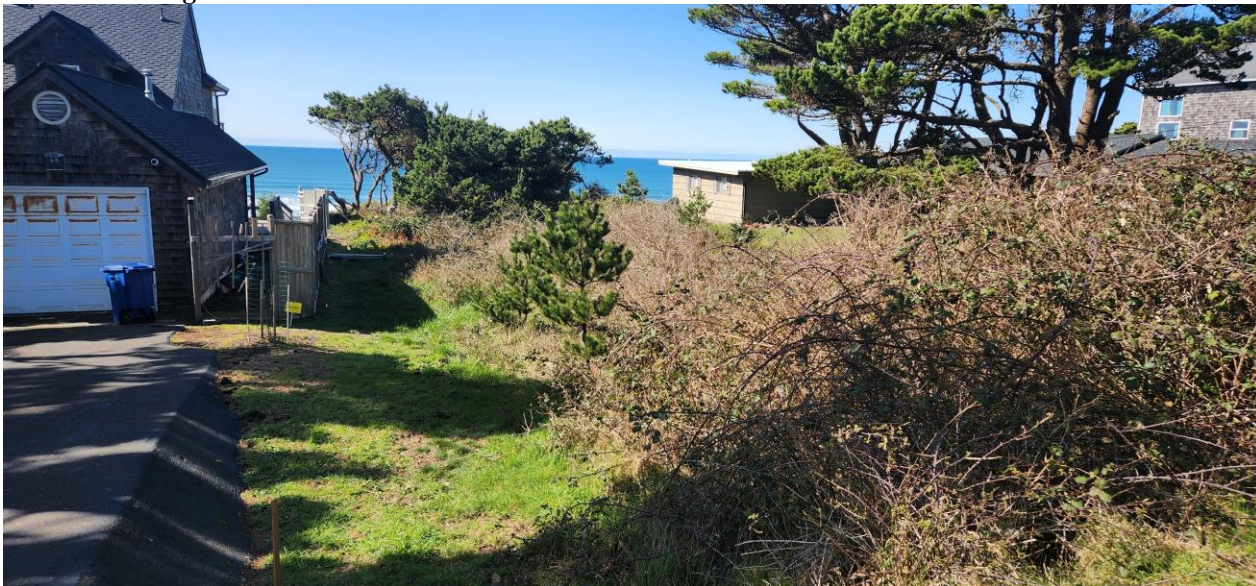
1. Looking West across site:

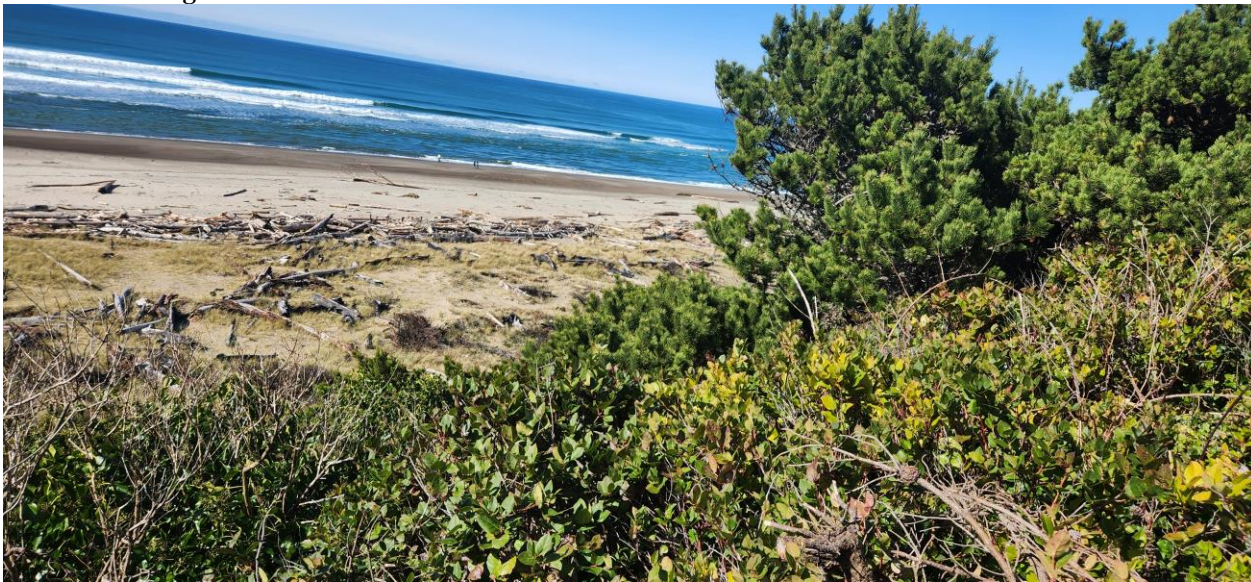
2. Looking over bank down to beach:

We had previously concluded that there is no apparent increase of bank erosion or instability since our 2019 study. Updated hazard mapping by the Oregon Department of Geology and Mineral Industries now shows the entire site is within the area or predicted “severe” shaking during a subduction zone seismic event with 20-30% damage probability. Other hazard mapping remains consistent with our 2019 study.

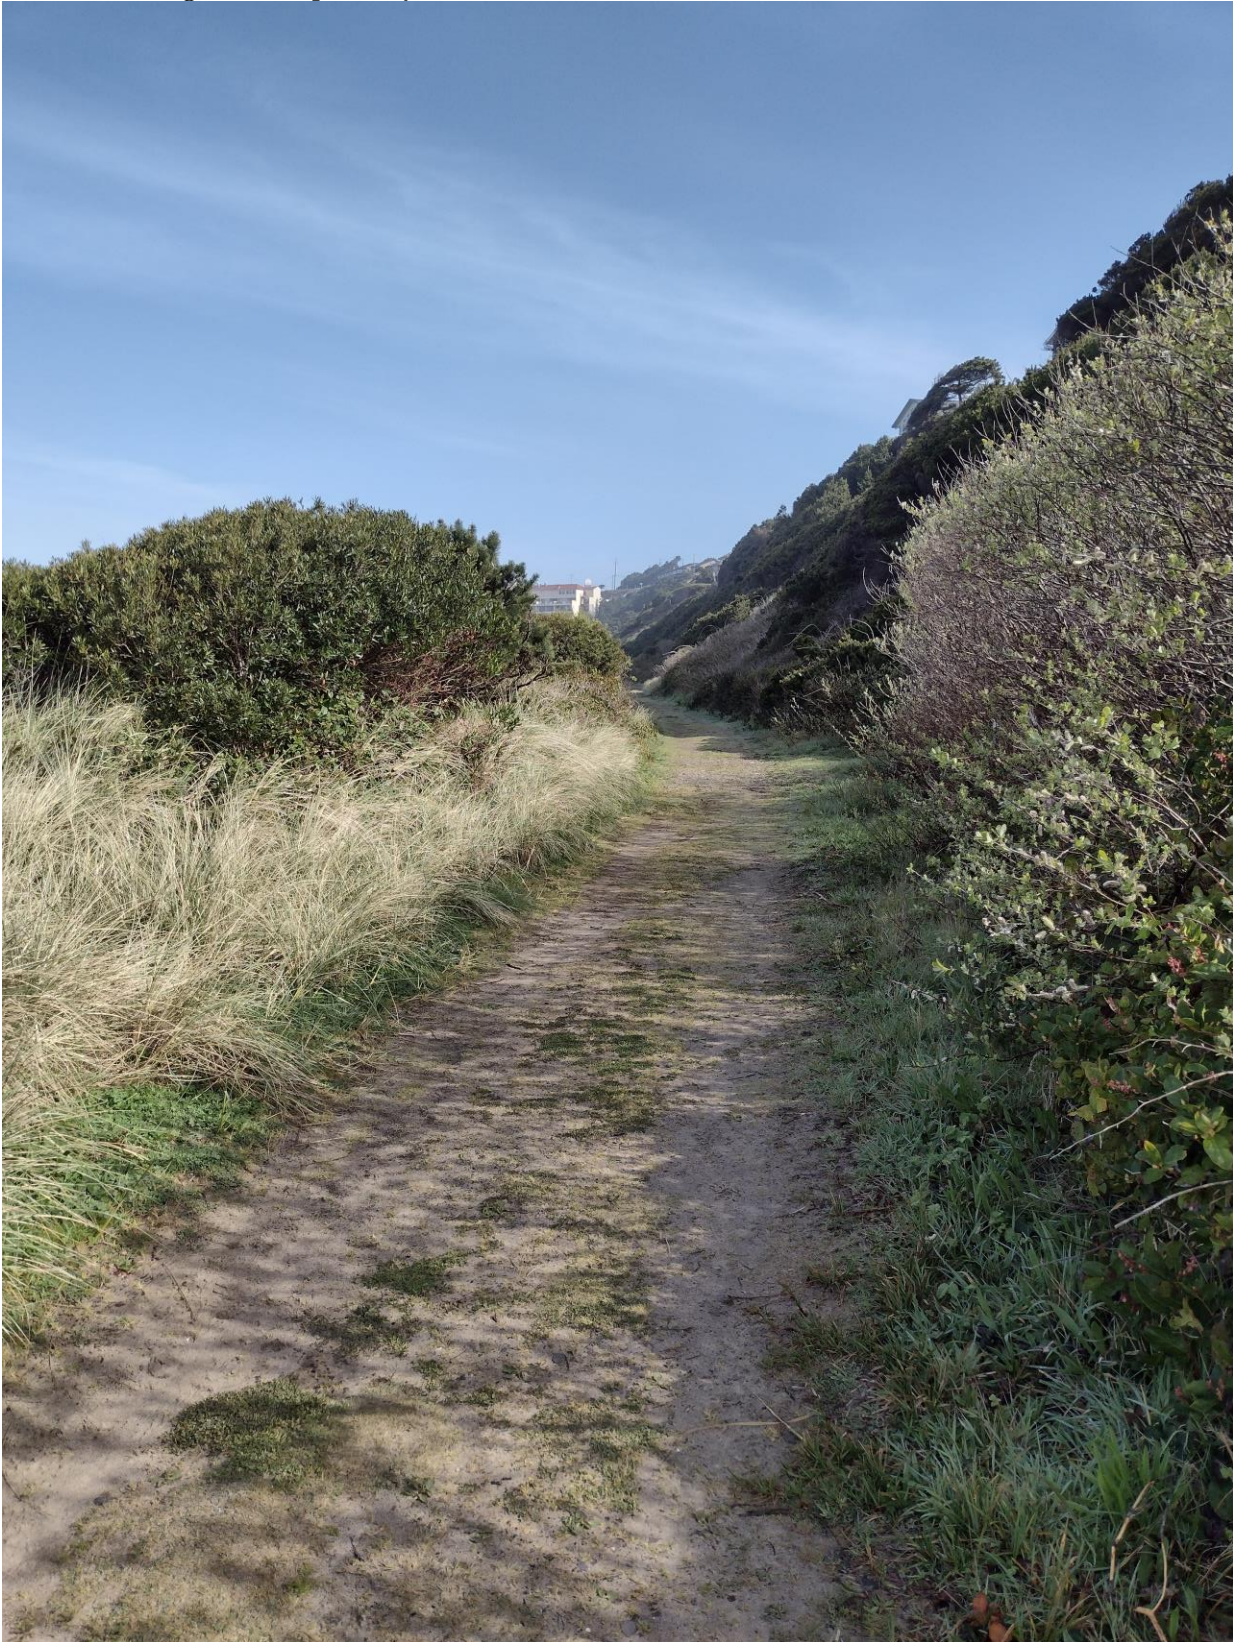
3. Looking north at pathway at toe of bluff

Calculation of wave runup - The actual calculations of wave runup found in the 2006 Coastal Engineering v. 53, no 7 reference is beyond the scope of geotechnical engineering practice; however, based on Google Earth® imagery the pathway seen in Photograph 3 appears to have remained intact since 1994 and the fore dune and vegetation has become more pronounced. The amount of flotsam on the beach varies throughout the last 20 years but appears to have been relatively consistent since 2016, with similar quantities as seen in the April 10, 2024 photograph below.

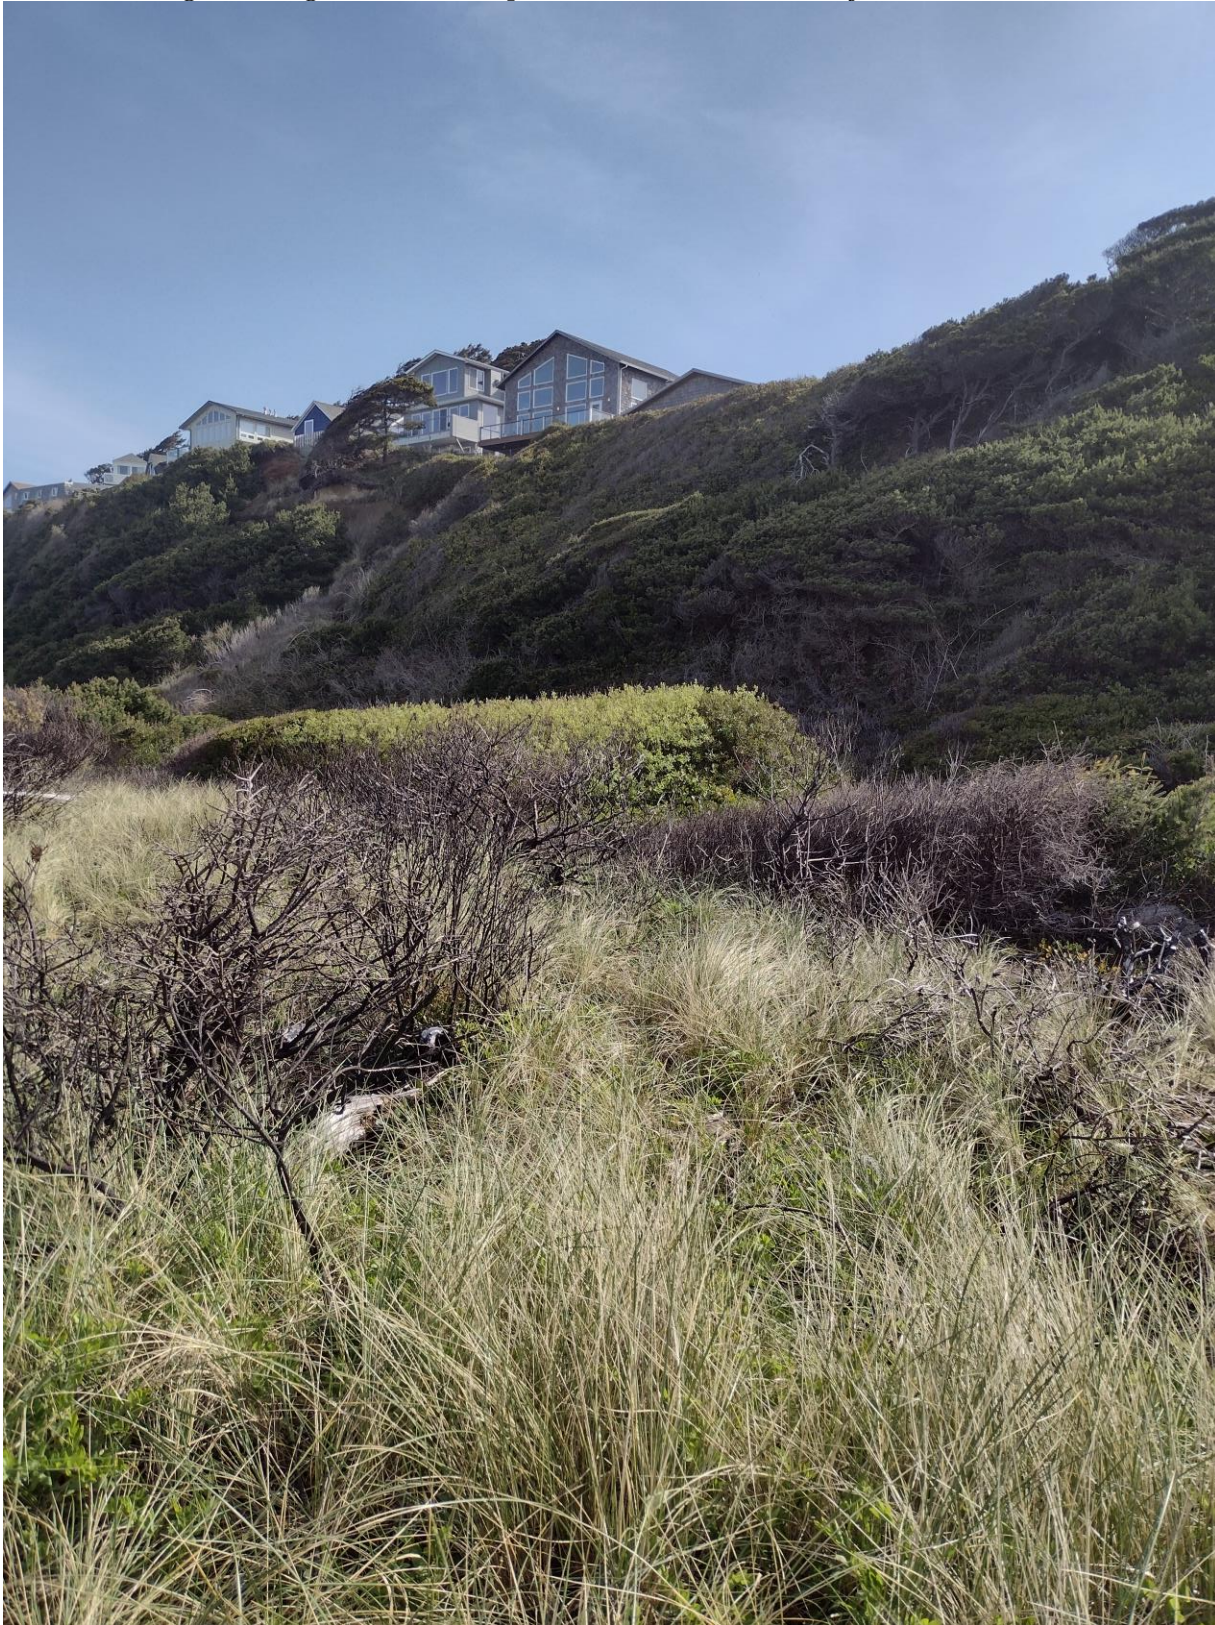
Description of the fronting beach - The approximately 60-foot high 1H:1V, bluff on the west side of the subject site is heavily vegetated as seen in the photographs below with a pathway at the toe of the slope and a vegetated fore dune prior to encountering about a 100-foot, wide area of dune grass and flotsam. The photographs were taken on April 10, 2024. Based on aerial imagery from Google Earth®, the normal high and low tide levels are over 200- and 500-feet from the toe of the bluff slope, respectively.

4. Looking NE at vegetated bluff slope and fore dune below subject site

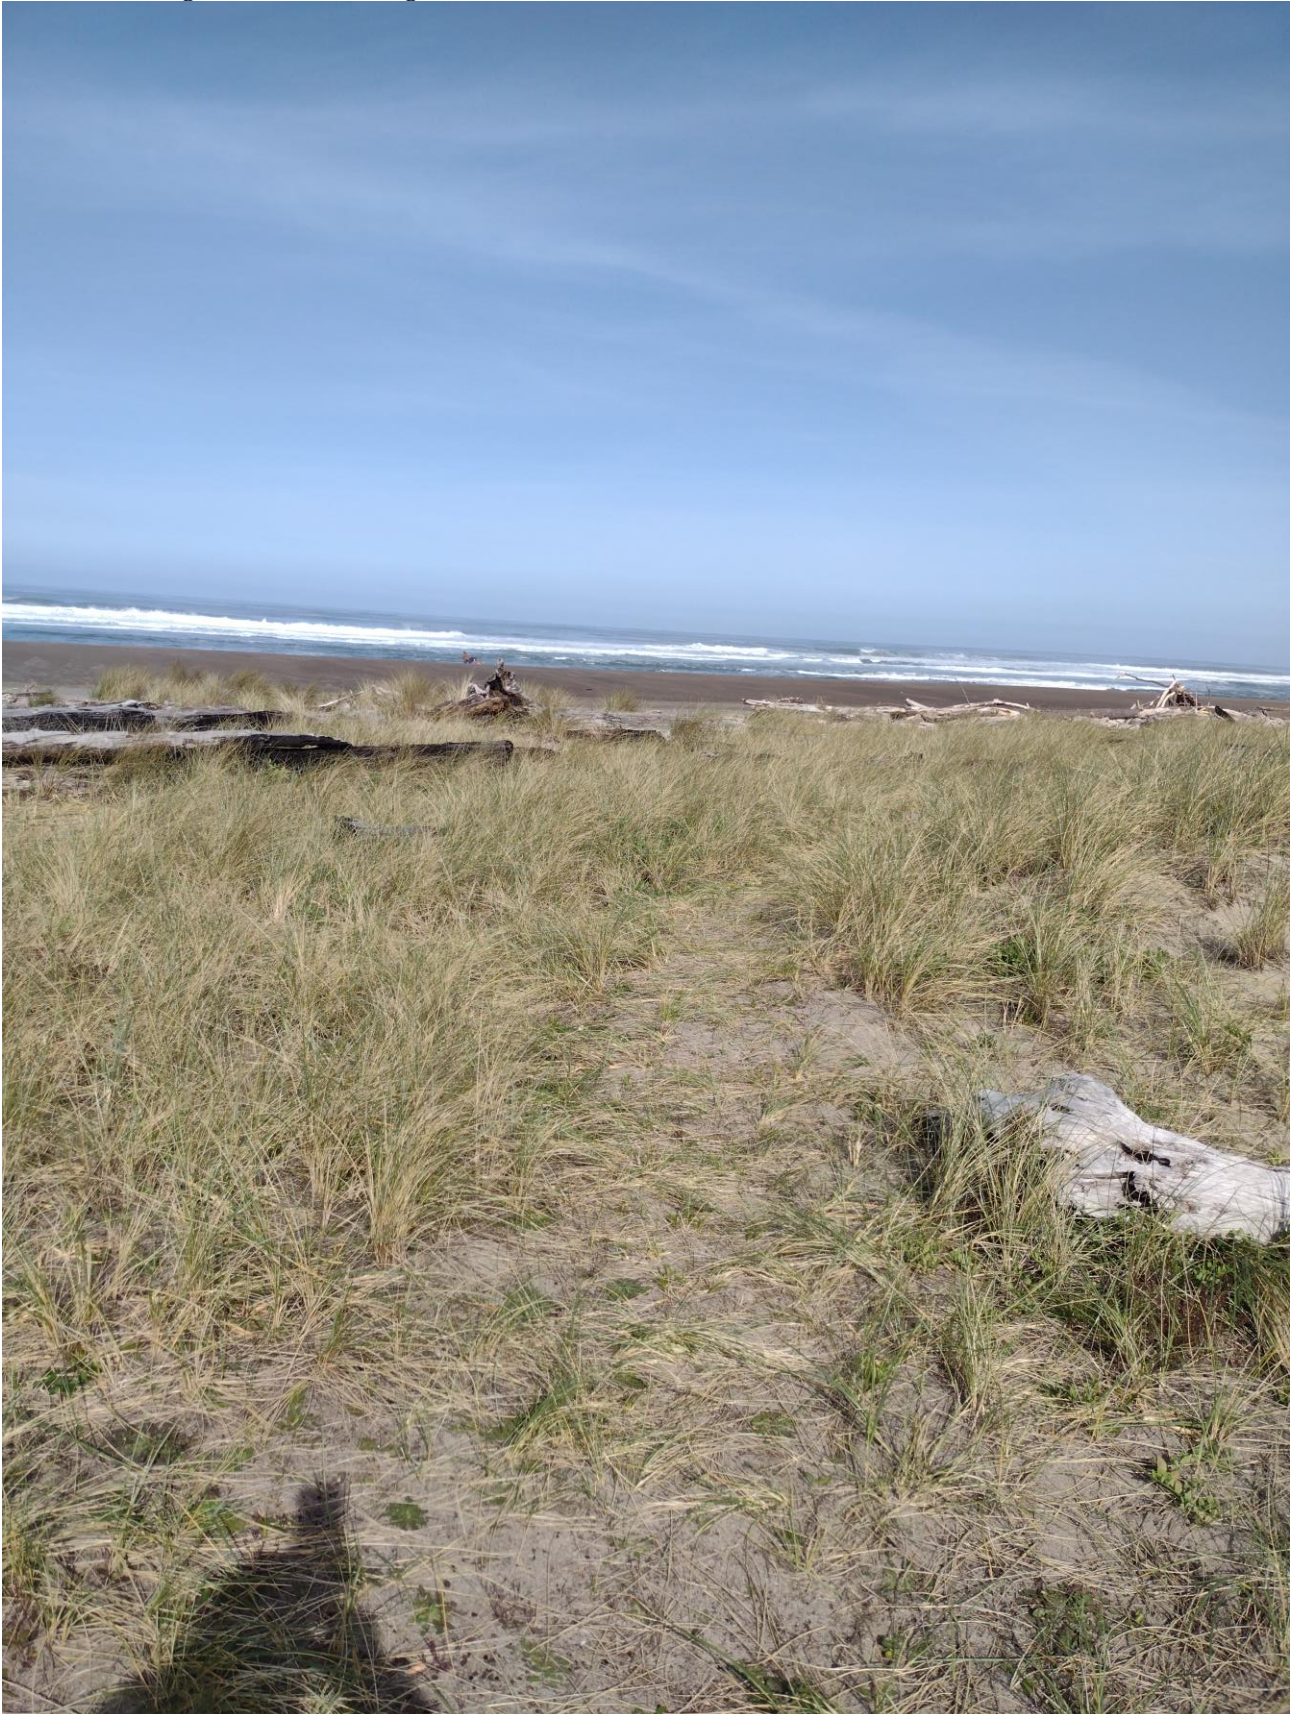
5. Looking SW across dune grass and flotsam between fore dune and ocean

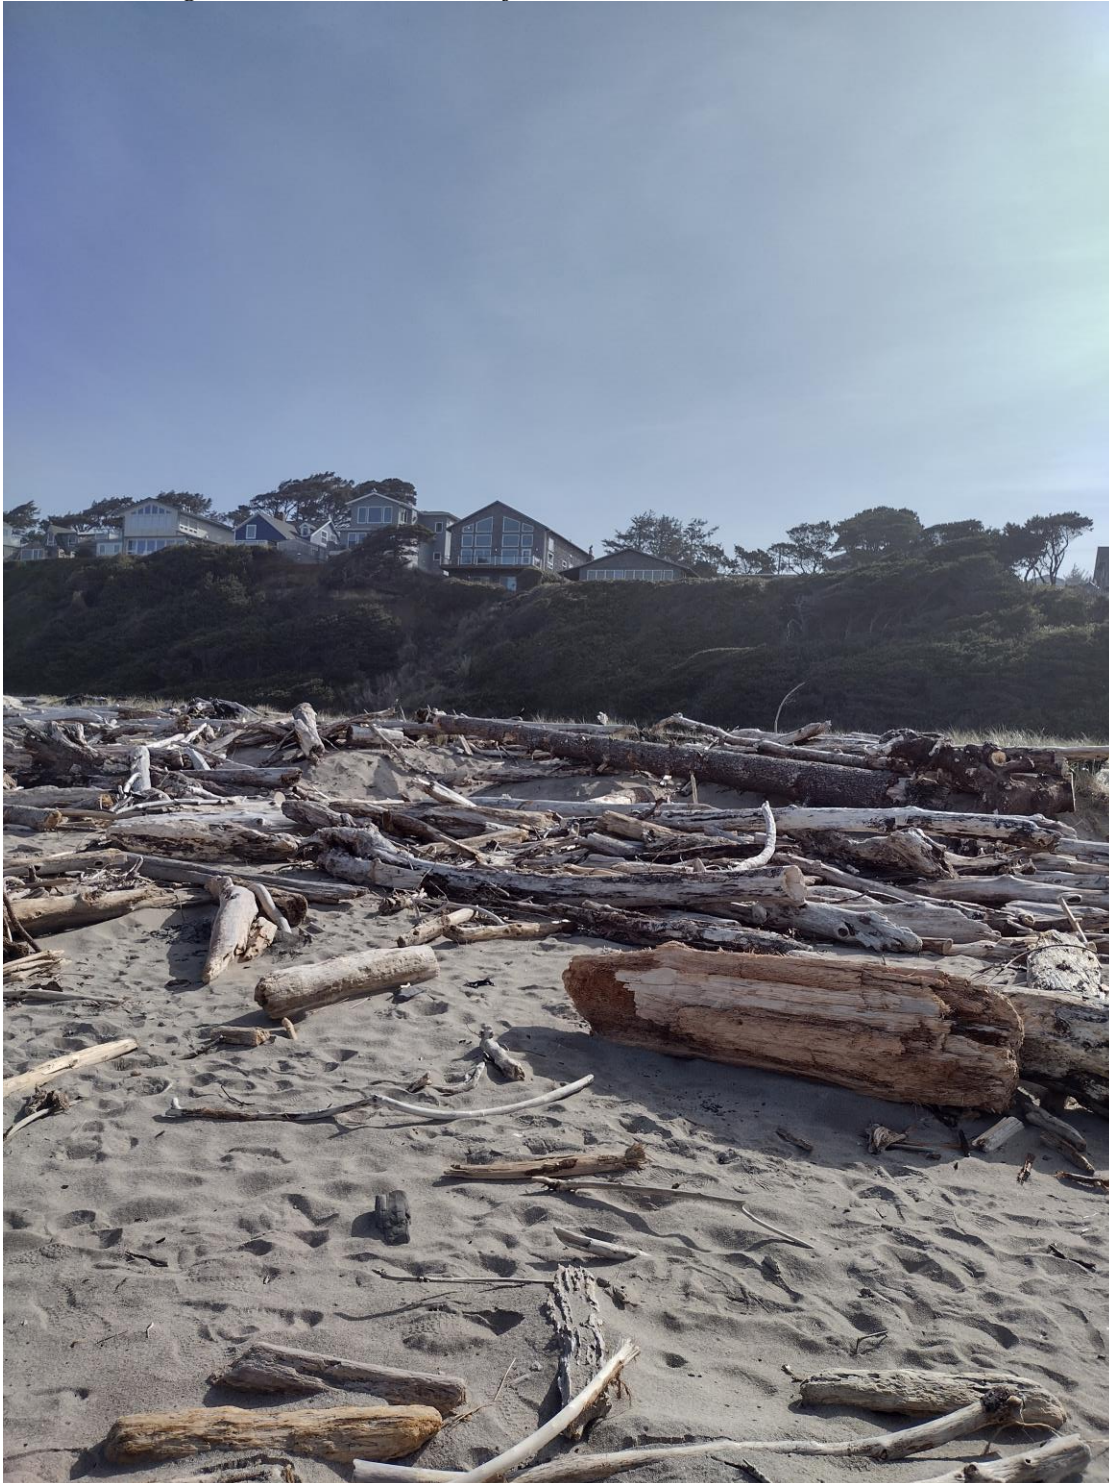
6. Looking east across beach at subject site

Although the general erosion rate along this area of the Oregon Coast has been estimated to be up to 1-foot per year, as previously stated in our July 19, 2019 report a rate of 0 to 0.3-inch per year was estimated for this specific area, and the site does not appear to have been impacted by erosion or bluff caving for the last 30 years. There is indication of human impacts or concentrated drainage on the bluff slope or beach area that would reduce the resistance to erosion. The beach is comprised of poorly grade, fine sand with a shallow slope to the ocean shore and no apparent rock outcrops or sea stack on or off shore.
