## SCOPE OF SERVICES

Our scope of services was limited to addressing the minimum information required for a City of Lincoln City and Lincoln County-required geo-hazard assessment. No geotechnical engineering recommendations are included in our scope of work (i.e. the report identifies geologic hazards that could impact the property, and broadly presents mitigation options and/or recommendations for additional investigation), nor was subsurface investigation, surveying, or producing topographic site plans or erosion control drawings. Based on our understanding, the project does not include expansion of the building footprint on the west (ocean bluff-facing) side of the property. We have also provided an explanation of the published erosion rates for this part of Lincoln County.

The 0.22-acre property located at 866 Southwest 8<sup>th</sup> Street, Lincoln City, Lincoln County, Oregon includes a 3-story single family residence. The tax lot, 07-11-15-DB-09100-00 is bounded to the north, east, and south by existing residential properties, and to the west by an approximate 120-foot-tall bluff facing the Pacific Ocean. The beach is accessed at Canyon Drive Park, approximately 500 feet

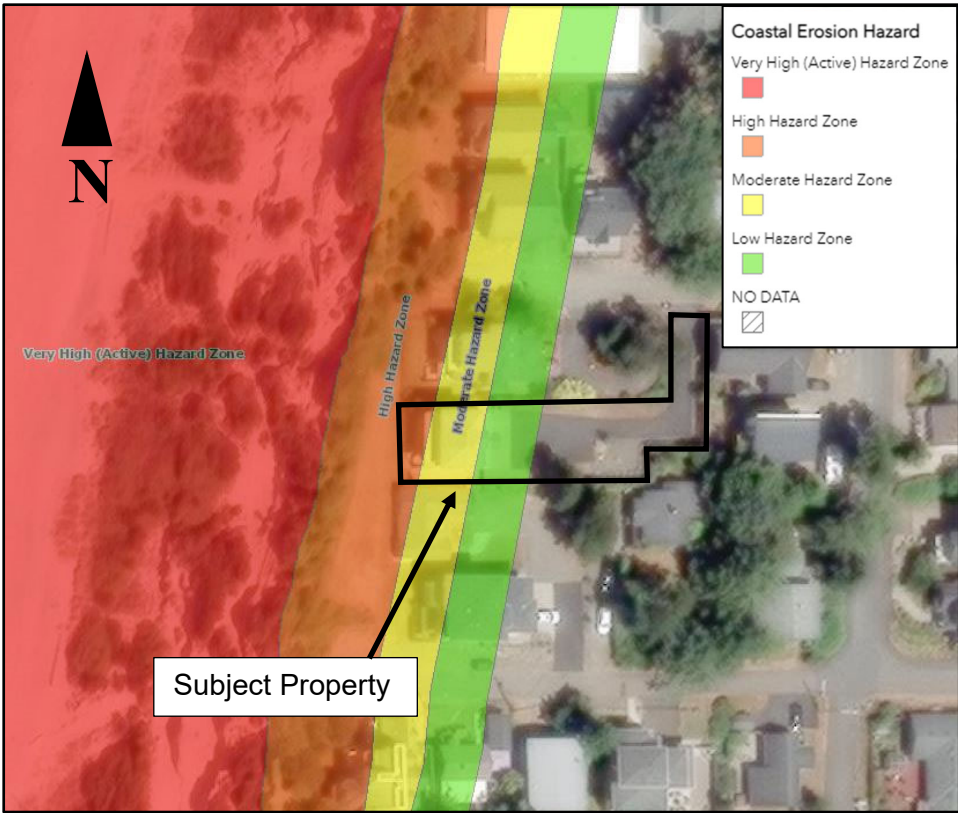
HazVu indicates that the property is within the Coastal Erosion Hazard zone. The erosion hazard ranges from moderate to high (active) on the western side of the lot, to low hazard on the eastern side nearest to Southwest Ebb Ave (Figure 3). The very high (active) zone is defined as being actively eroded by waves and mass movement caused by wave energy. Allan and Priest (2001) define this area as potentially being affected by active erosion within the next 60 to 100 years.

**Figure 3:** Site location within the Coastal Erosion Hazard Zone.

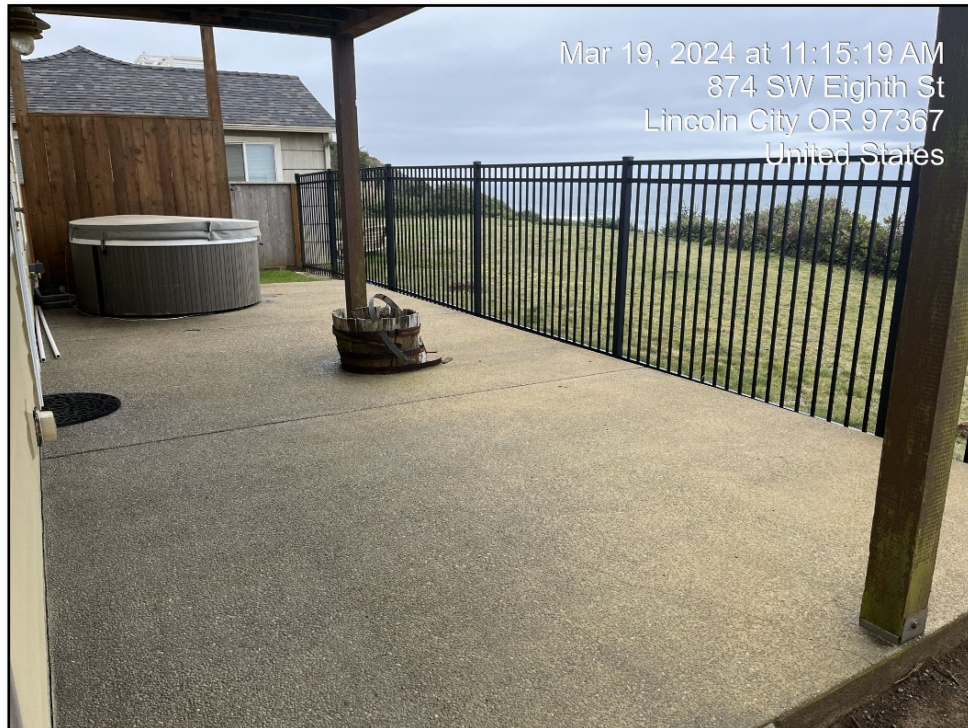
**Photo 1:** View of residence from rear porch, looking southwest from west side of house.

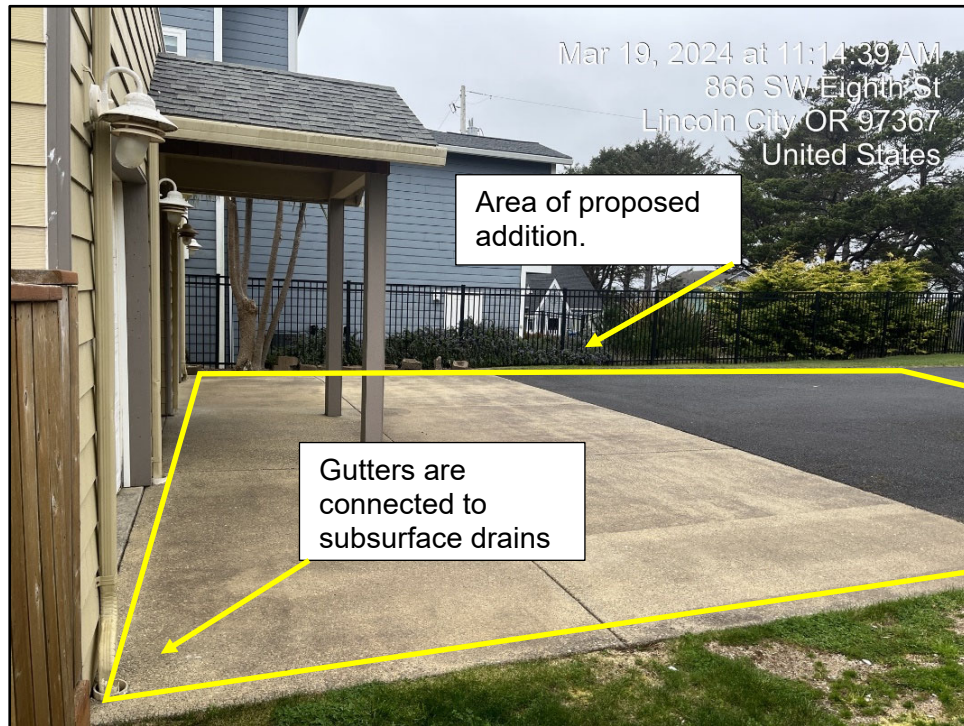
**Photo 2:** View of east side of residence looking northeast toward the area of the proposed house addition. Note that the entire area is currently covered in impermeable surfaces of either asphalt or concrete. Furthermore, note that all gutter downspouts were connected to subsurface drains.

there is no additional proposed impermeable surfaces. If possible, we recommend that the proposed addition should have gutters and downspouts connected to subsurface drains that will transport runoff from impervious surfaces to a storm sewer. Because of this, we recommend that the proposed addition should have no negative impact on bluff stability or erosion, and stormwater management on the property will not include additional discharge of concentrated stormwater onto the west side of the lot as a result of the improvements.

We understand that the project includes the addition of an impermeable surface area (roofline); however, the area of the proposed addition is currently paved with either concrete or asphalt. Therefore, the impermeable surface area will be the same after development as existing. If possible, we recommend that surface water should be collected from the roofline area and diverted from building foundations and walls, to approved disposal points on the eastern portion of the property, or discharged to a municipal storm sewer (if present). Regardless, the water should be diverted in such a way so as to not cause erosion or visual impacts. For new perimeter footings, subsurface drainage of the building perimeter using footing drains is recommended

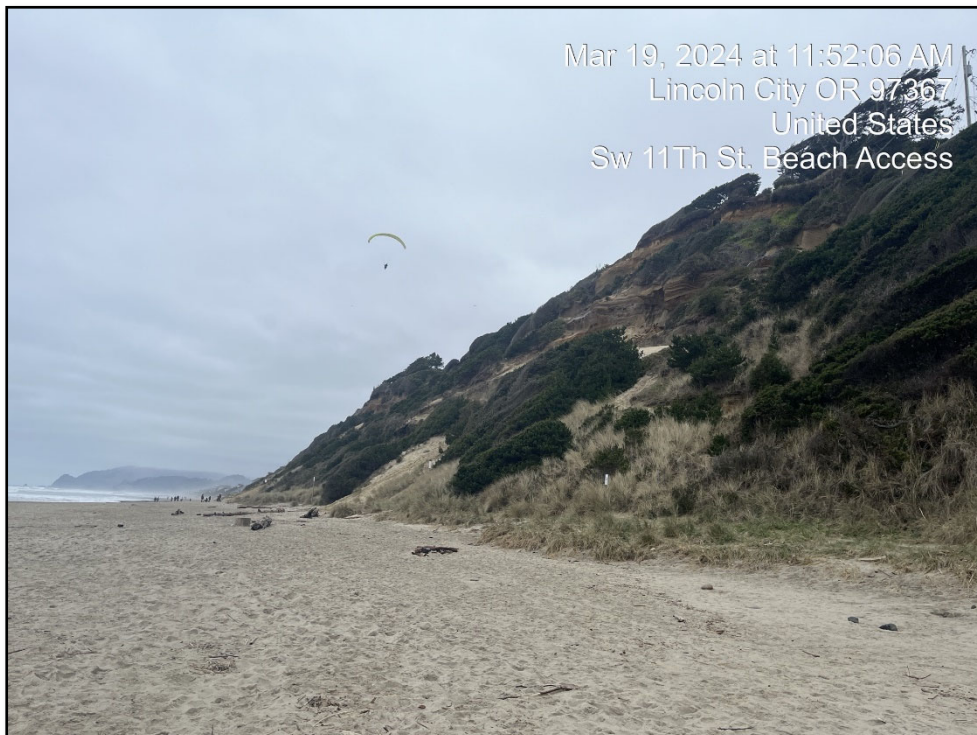
**Photo 2:** View of bluff on western side of the site, viewed to the north east.

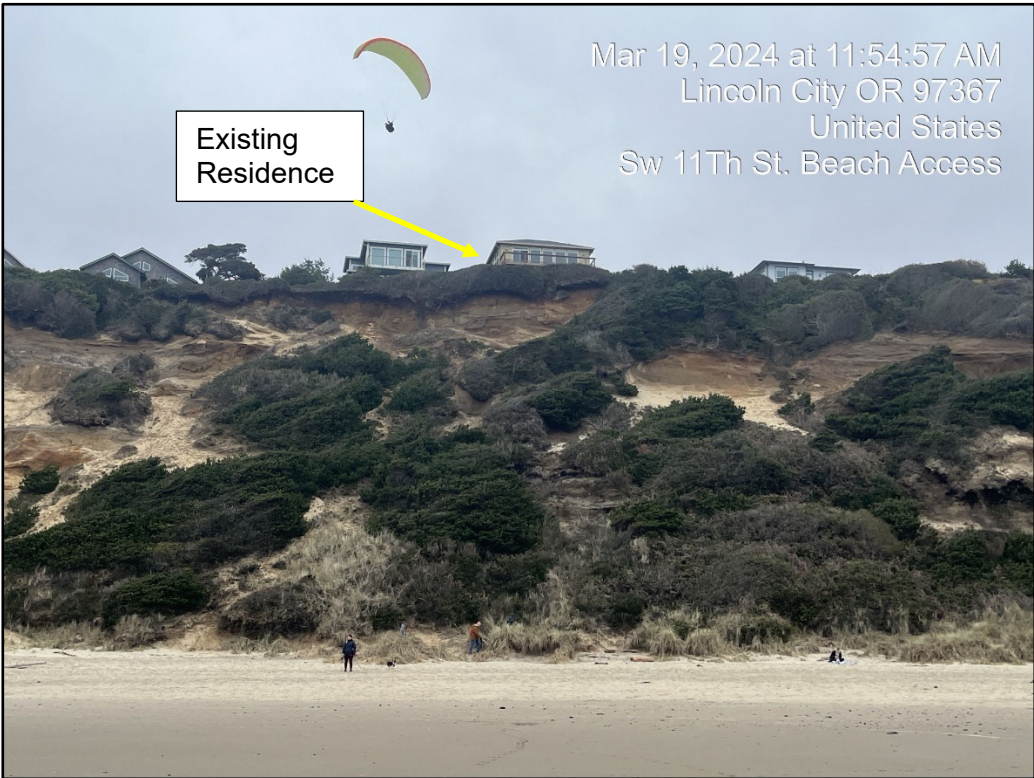
**Photo 3:** View of property looking up from the beach (tan house, right side), looking towards the east.

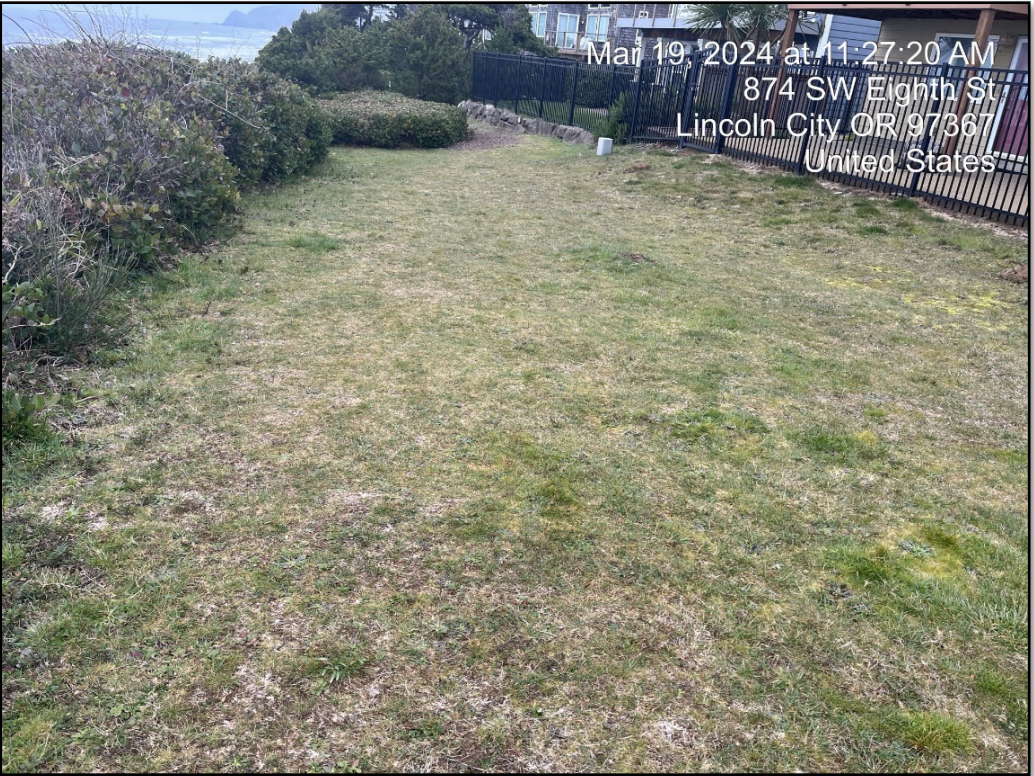
**Photo 5:** Backyard of property, looking towards the north.

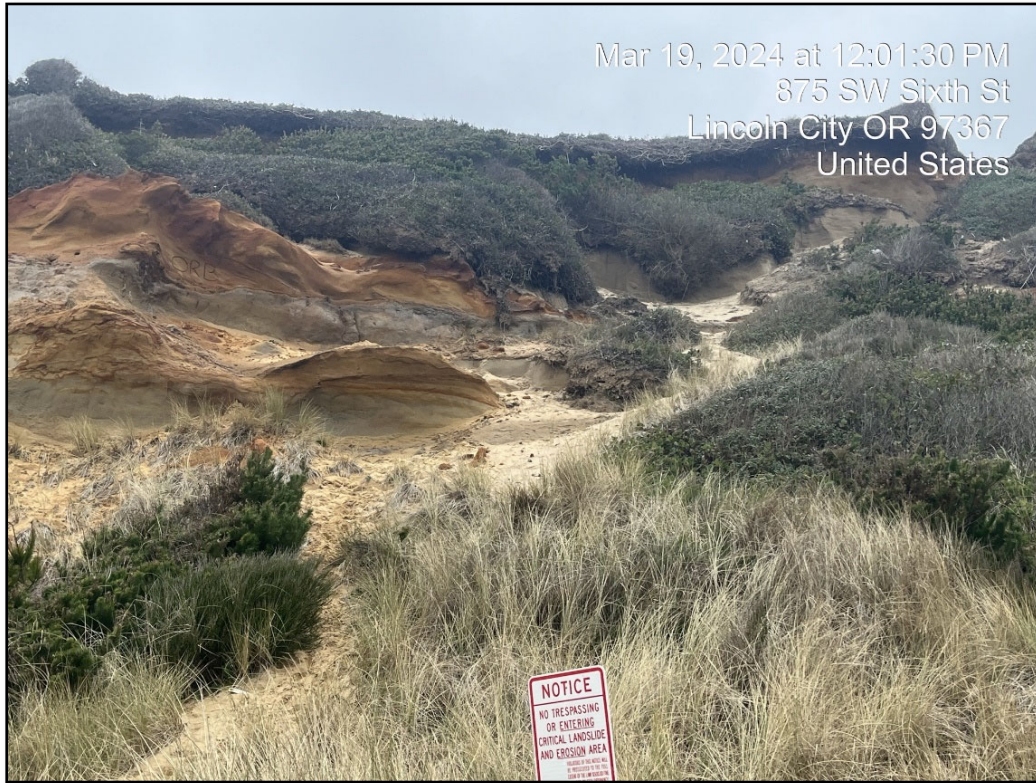
**Photo 6:** View of the sandstone bluff on western edge of property, with notable landslide warning sign at the base of the bluff.

2. There is no SPS at the base of the bluff, and there is notable signage (Photo 6) warning of potential landslide risks.
3. The bluff is vegetated with grass and small shrubs, typical of most adjacent bluffs to the north and south. The bluff slopes are sparsely vegetated with large shrubs near the top of the slope and beach grasses and shrubs at the base of the slope.

While there is no shoreline protection structure to prevent bluff erosion. Signage has been placed to keep people from climbing onto the bluffs. At the time of our site visit, it appears that the signs do little to prevent people from climbing the bluffs as evidenced by carvings onto the soft rock relatively high on the bluff.

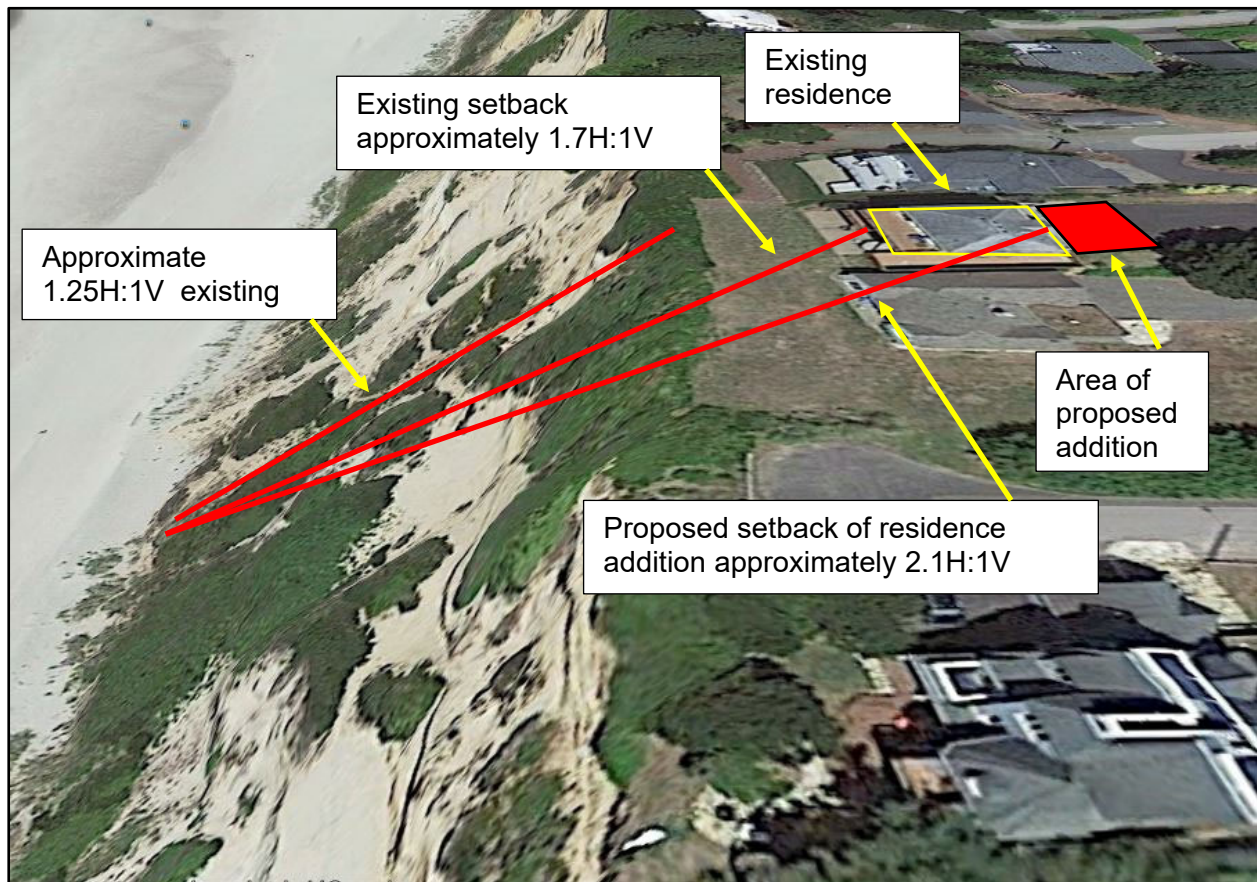
1. The majority of the parcel generally consists of flat topography (including beyond the western edge of the property for approximately 25 feet before the edge of the bluff as shown in Figure 1). The bluff generally descends at an approximate 1.25Horizontal:1Vertical (1.25H:1V) slope as shown in the below Figure 10. Elevations provided by DOGAMI LiDAR (<https://pubs.oregon.gov/dogami/ldq/LDQ-45124A1.zip>) show the relatively flat property at an elevation of approximately 136 feet and the base of the bluff at an elevation of approximately 20 feet (NAVD 88).

**Figure 10:** Showing the site with oblique view to indicate observed slopes, existing setback, and proposed setback of proposed residence addition.
