**Geologic Hazards and Geotechnical Investigation
Tax Lot 1100, Map 7-11-10AB
2715 NW Inlet Avenue
Lincoln City, Oregon**

Project #Y244738

July 17, 2024

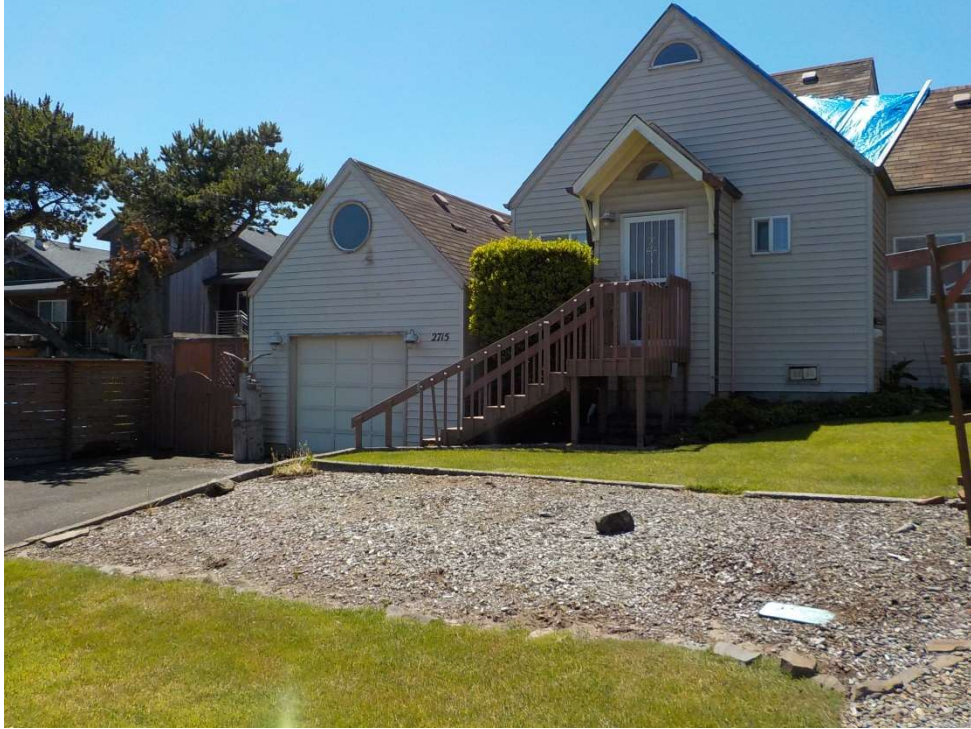
Photo 1 – Southwesterly view of 2715 NW Inlet Avenue from near Inlet Avenue.

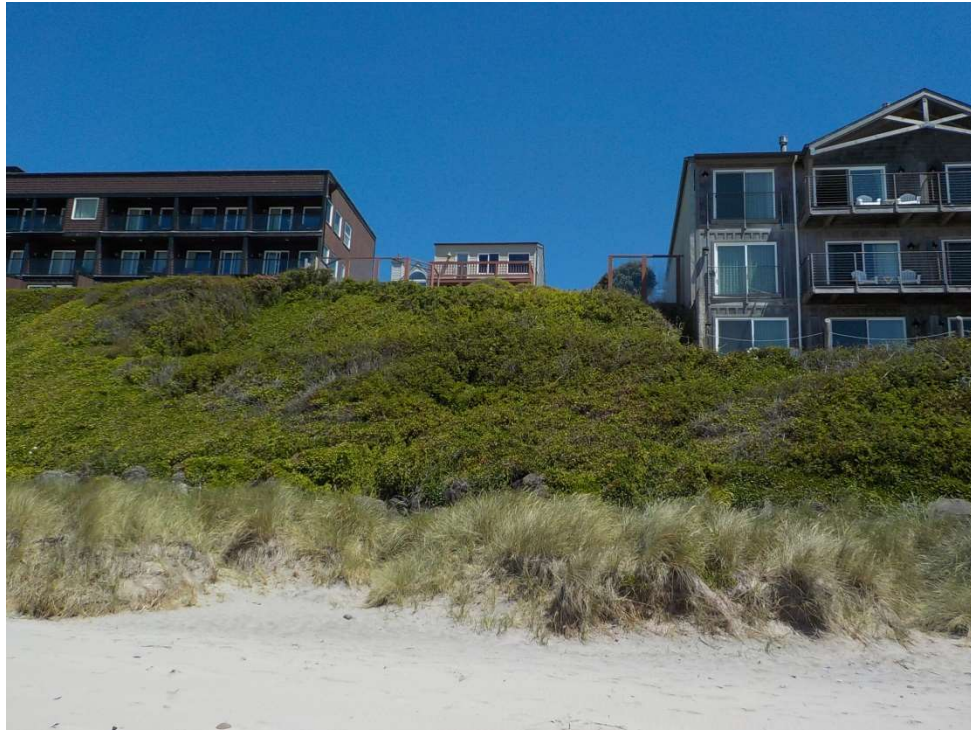
Photo 2 – Easterly view of the site from the beach.

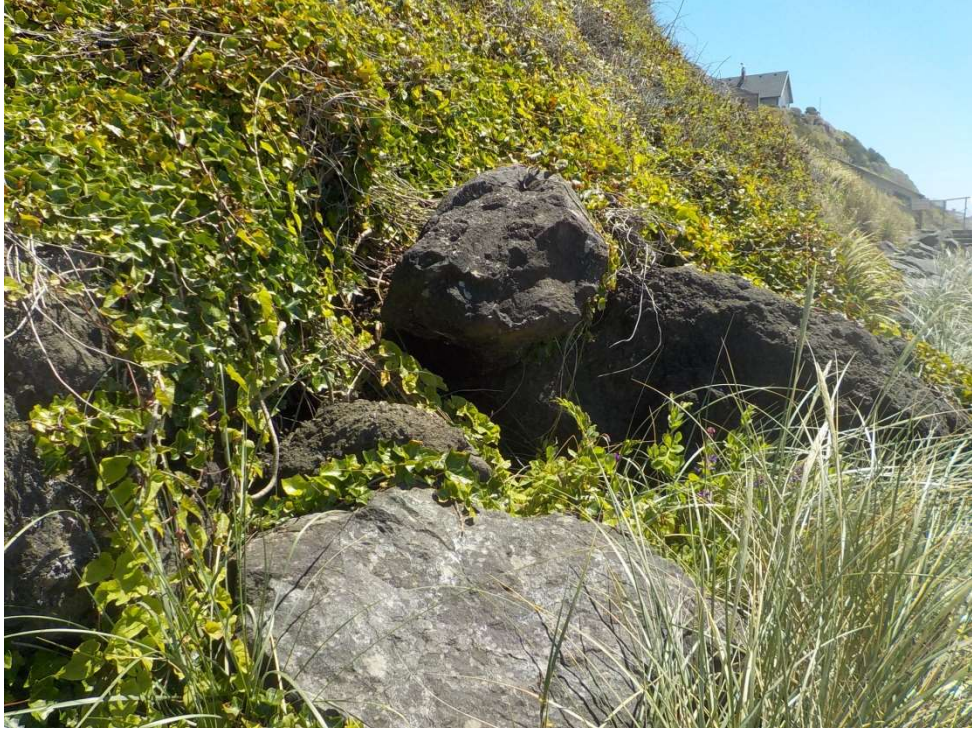
Because the existing riprap protects the base of the bluff slope, only minor erosion, if any, is expected with a high wave run-up event at this site. The existing dense vegetation above and below the revetment indicates that it has not been recently overtopped. However, it is the chronic nature of the wave attack hazard that undercuts the toe of the bluff, creating bluff instability, and over an extended period of time, has the potential to undermine the revetment.

Photo 3 – Close-up view of the existing rip rap stone along the base of the bluff.

When older revetments are severely damaged, replacing them with a new revetment using a modern design and configuration is recommended.

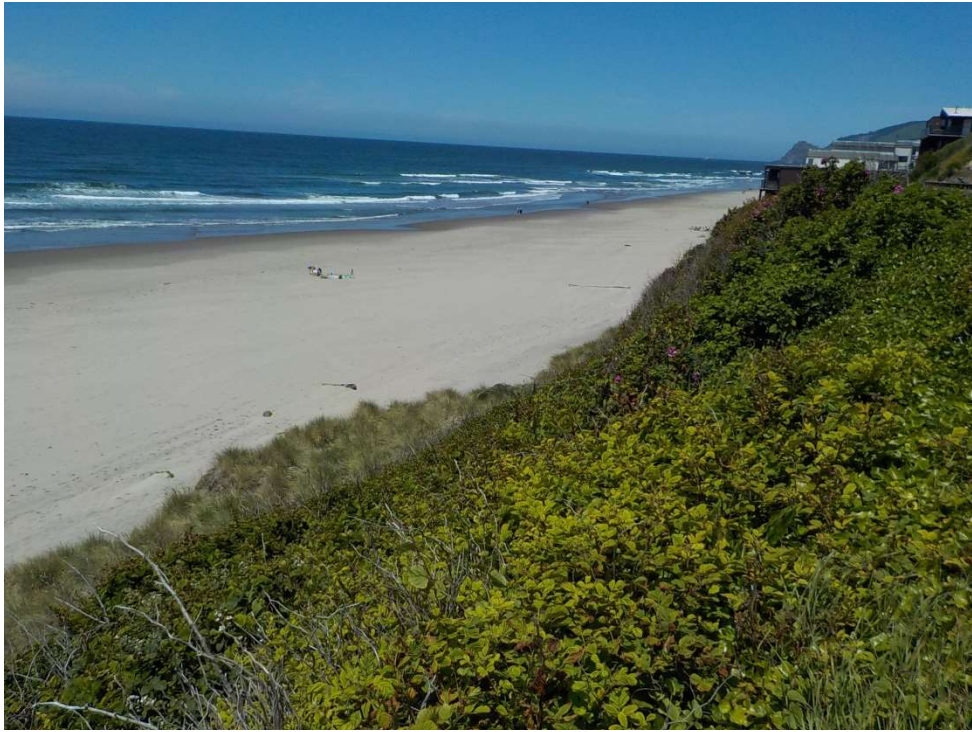
The western portion of the site is mapped in an area of moderate to high landslide susceptibility based on the DOGAMI methodology (Burns, Mickelson, and Madin, 2016). However, the relatively short height of the bluff and the existing revetment protecting the base of the bluff slope from erosion reduces the potential for landsliding.

Photo 4 – Northerly view of the bluff slope from near the bluff edge.

2. The site and nearby vicinity along the bluff should be monitored for signs of ground movement, sloughing, increased bluff recession, and sudden/rapid erosion events, particularly during times of heavy precipitation, inclement or severe weather, and major storms. The condition of the riprap revetment at the base of the bluff should be monitored, maintained and repaired as needed.
3. Carefully control and maintain all stormwater drainage systems at the site. Plan sets should incorporate drainage and erosion control, as discussed in Sections 8.4, 8.5, 8.8, 8.9, 8.10, and 8.11 below.
4. Lincoln City may require a topographic survey performed by a licensed land surveyor to identify the bluff edge and determine the bluff setback's location to be used in planning, permitting, and construction.

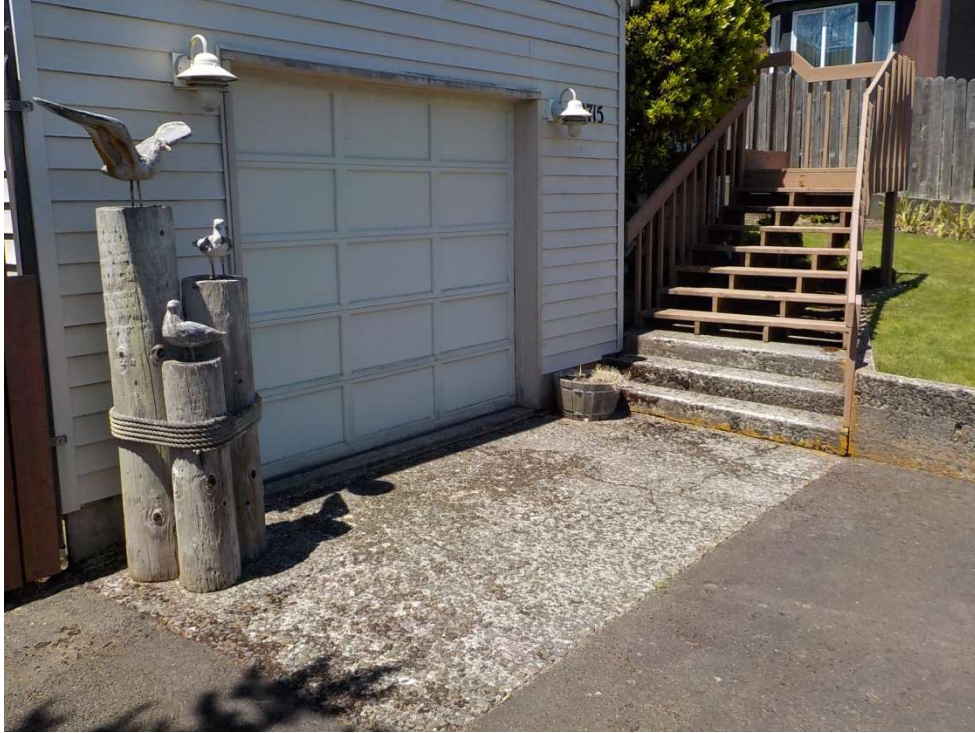
Photo 5 – View of the east side of the garage and driveway.

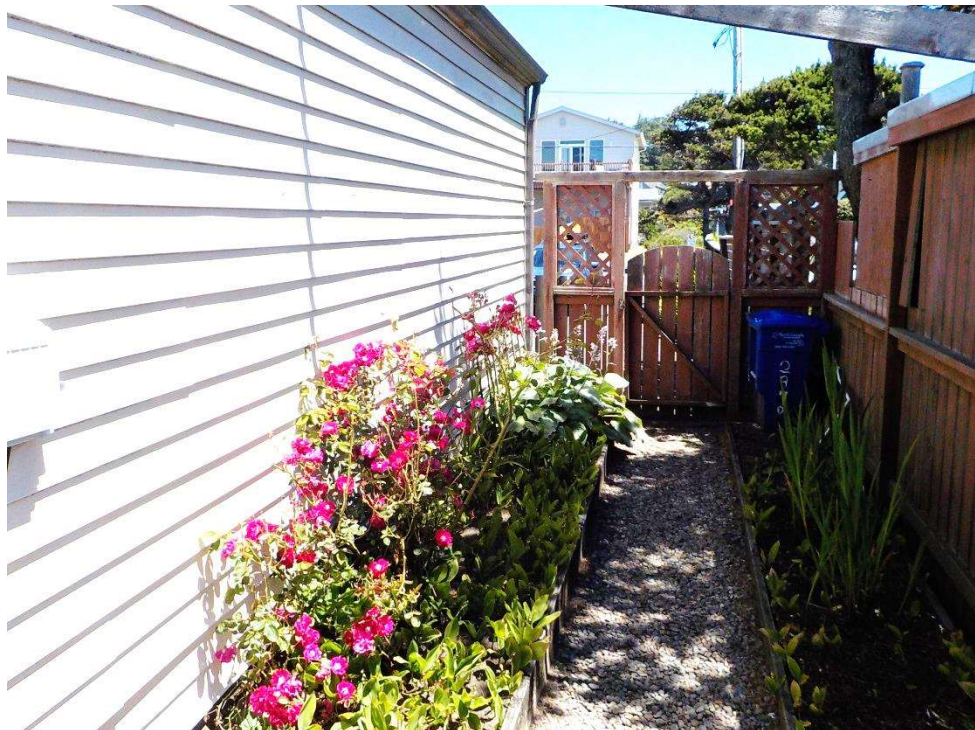
Photo 6 – View along the south side of the garage.

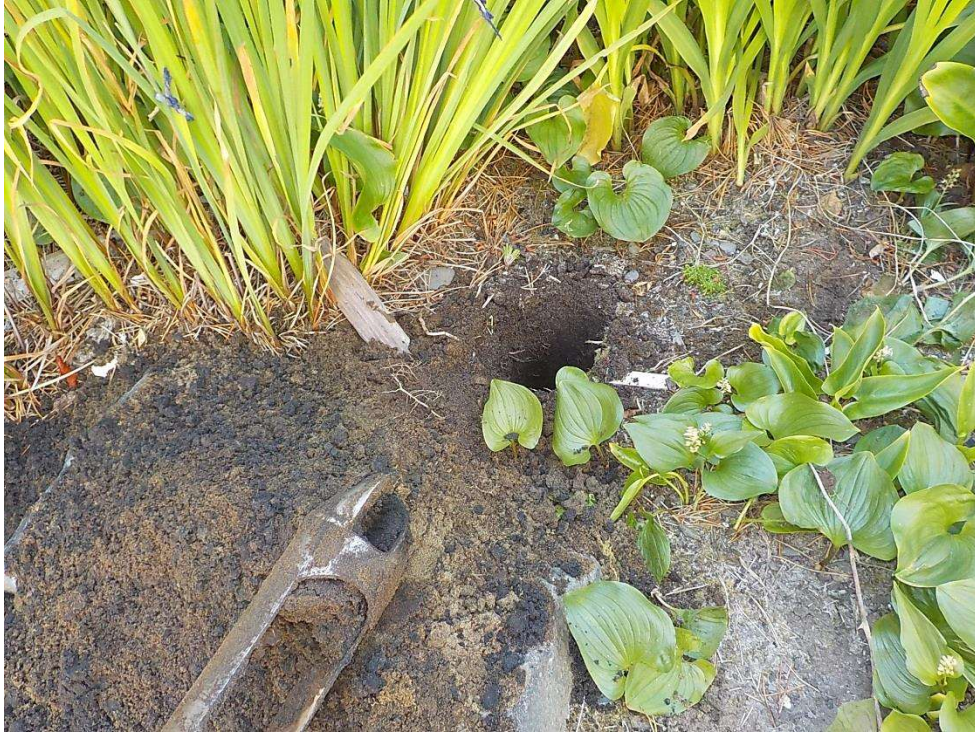
B-1	<u>Depth (ft.)</u>	<u>USCS</u>	<u>Description</u>
	0 – 3.0	ML (Fill)	SILT FILL; dark black, moist, loose. Organic rich with variable sand content throughout
	3.0 – 4.0	SM	Silty SAND; brown, wet, loose, with minor organics.
	4.0 – 5.0	SM	Silty SAND; brown, moist, loose to medium dense. With isolated seams of black silt. Free groundwater was not encountered.
B-2	<u>Depth (ft.)</u>	<u>USCS</u>	<u>Description</u>
	0 – 1.6	ML (Fill)	SILT FILL; dark black, moist, loose. Organic rich with variable sand content throughout. River rock landscaping at the surface.
	1.6 – 3.0	SM	Silty SAND; brown, moist, medium dense to dense. Non-cemented.

In general, we encountered loose sandy silt fill and organic-rich soils to depths up to approximately 3 feet, overlying loose to medium dense silty sand in the area southwest and southeast of the garage. We also probed the site with a tile probe to depths up to approximately 4 feet in areas of the proposed addition where the presence of utilities was suspected; we encountered highly variable resistance over a short distance.

Photo 7 – Close-up view of the fill and loose sandy soils encountered in boring B-1.

All new footing and slab areas shall be stripped of all organic, disturbed, and loose/soft soils, existing fills, and debris. We anticipate that non-organic, suitable sandy soils will be encountered at depths of 2 to 4 feet; however, depths may vary.

Sandy soils within the footprint of the proposed construction should be moisture-conditioned and compacted to a dense state utilizing a vibratory compactor. Over-excavation and replacement with structural fill may be necessary to achieve the desired final grades.

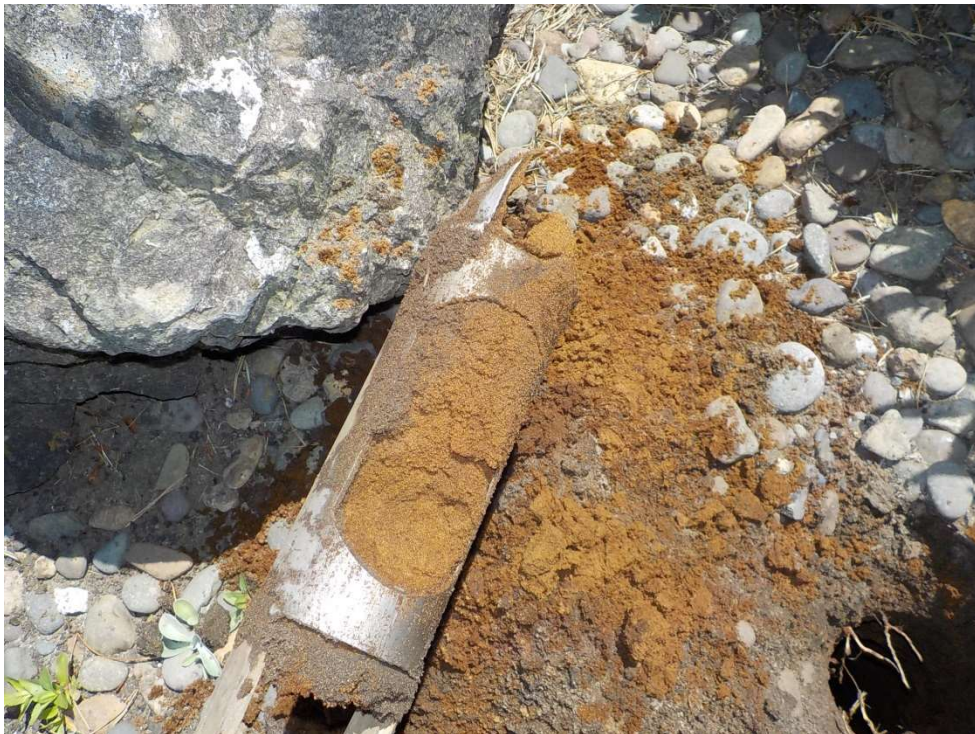
Photo 8 – Close-up view of medium-dense sandy soils encountered in boring B-2.
