Geologic Hazard Report Review Application

**Geologic Hazards and
Geotechnical Investigation
Tax Lot 1300, Map 7-11-15DB
887 SW 5th Street
Lincoln City, Oregon**

Project #Y214550

September 24, 2021

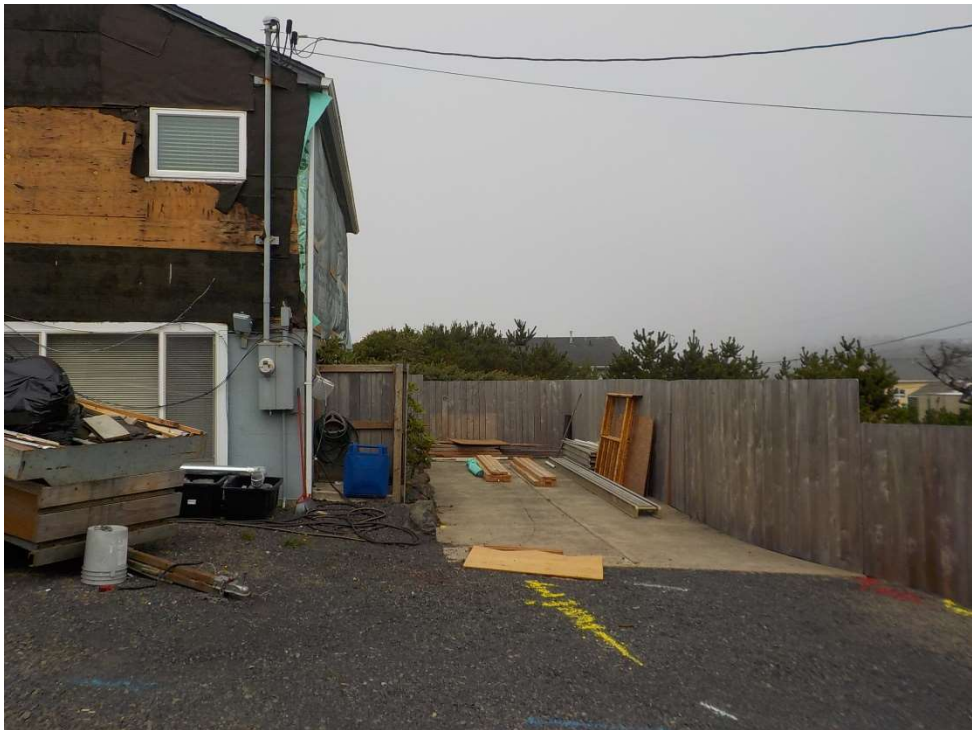
We did not observe any substantial cracks in the observable foundation or the poured concrete parking area on the eastern side of the house (Appendix A).

Photo 2 – Northerly view of the area proposed for construction of the attached carport addition.

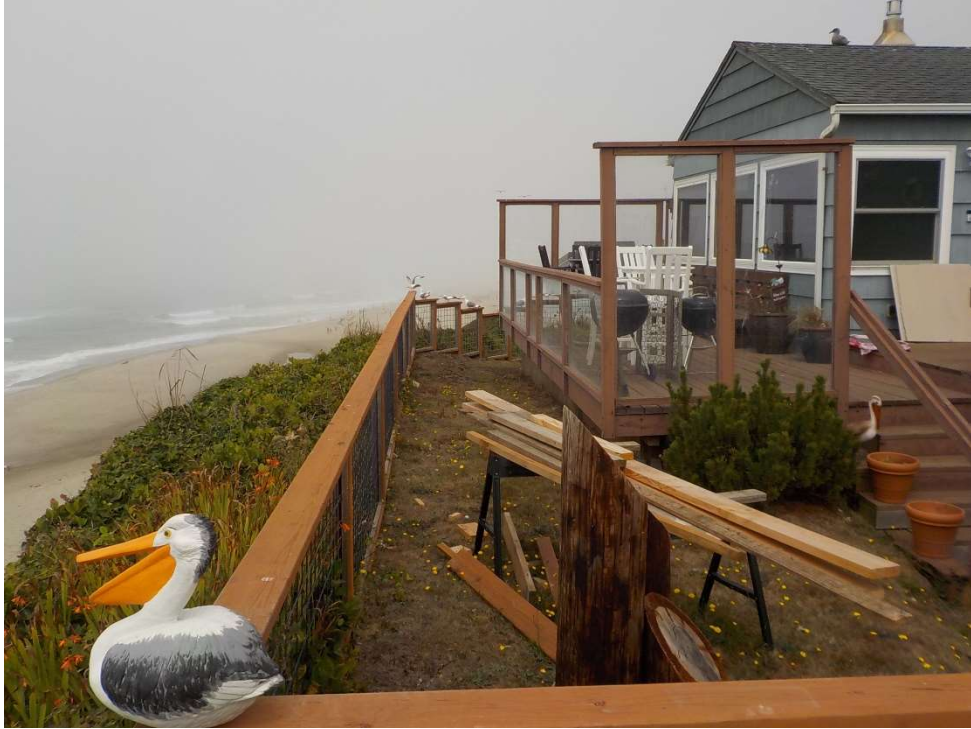
According to Lincoln County records, the site currently has an existing one-story house with a finished basement, built in 1948 (Appendix A). The westernmost foundation of the house is located approximately 19 feet east of the upper bluff edge. The westernmost footings for the deck attached to the western portion of the house are approximately 9 feet east of the upper bluff edge.

Photo 3 – Northerly view of the western side of the existing house, deck and bluff edge

To help mitigate future recession of the bluff caused by erosion and landsliding, we recommend that new shallow foundations be set back a minimum of 21 feet east of the upper bluff edge, as shown on Figures 3 and 4. This setback would allow room on the subject property to mitigate slope issues should a (less probable) larger landslide occur in the future. We have determined this oceanfront setback based on an average annual erosion rate of 0.27 ft/yr for 60 years and have added Lincoln City's required additional 5 feet. Existing foundations for the deck and western portion of the house currently lie within the setback area; however, the proposed carport construction area lies east of this setback area.

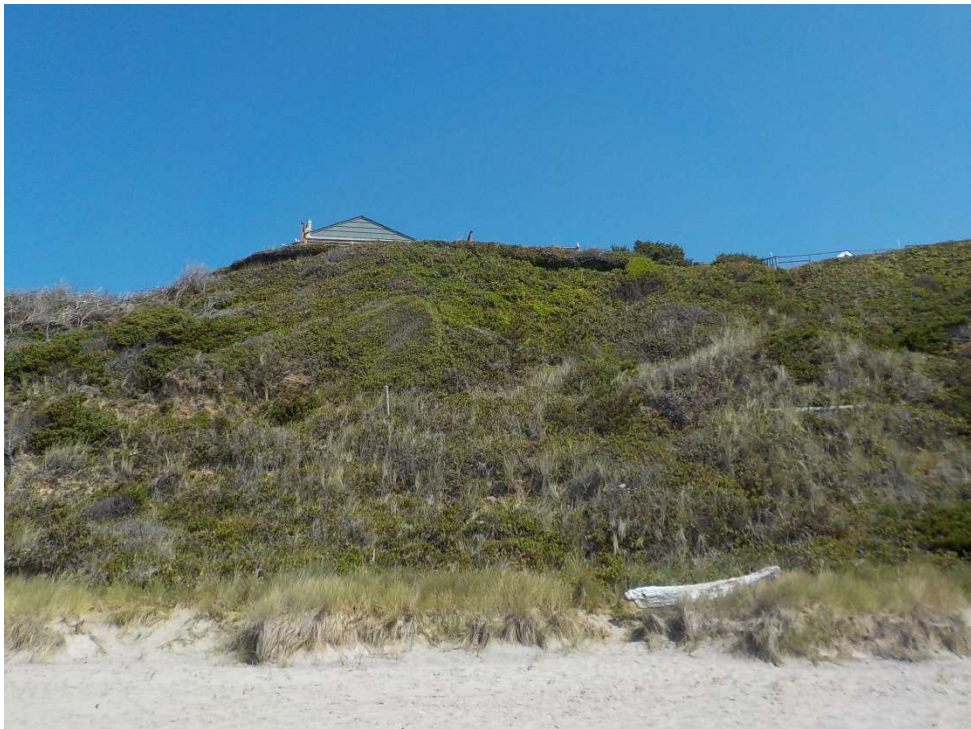
1. The bluff slope on the western part of the site is undergoing continuous erosion, sloughing, and landsliding, which can fail back 3 to 10 feet or greater at a time. Undercutting by ocean waves causes retreat of the toe of the slope, resulting in

instability and failures along the lower, middle, and upper slope. These hazards are common to oceanfront property in this area.

Photo 4 – View of the densely vegetated bluff slope from the beach.

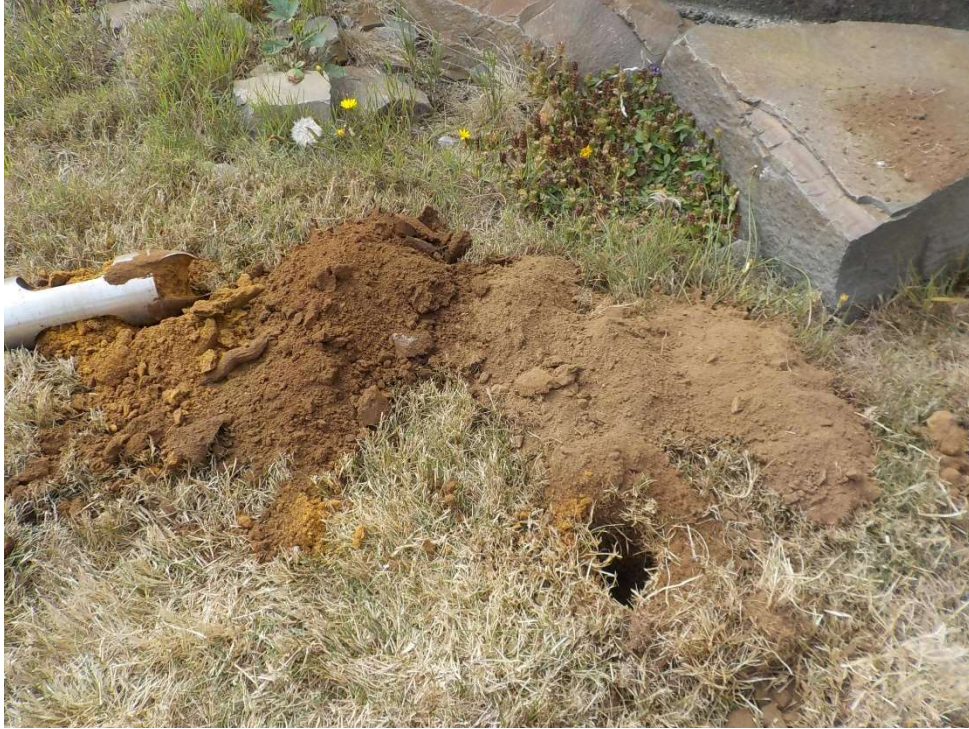
<u>Depth (ft.)</u>	<u>USCS</u>	<u>Description</u>
0 – 2.5	ML(FILL)	Gravely Sandy SILT FILL; light brown, dry, loose.
2.5 – 3.5	ML	Sandy SILT; brown, moist, loose to slightly dense.
3.5 – 4.0	SP	Slightly Silty SAND; light brown/orange-brown, moist, dense. Moderately- to well-cemented dune sand.
Refusal in dense cemented sand at approximately 4 feet bgs. Free groundwater was not encountered.

Photo 5 – View of the soils encountered in Boring B-1.

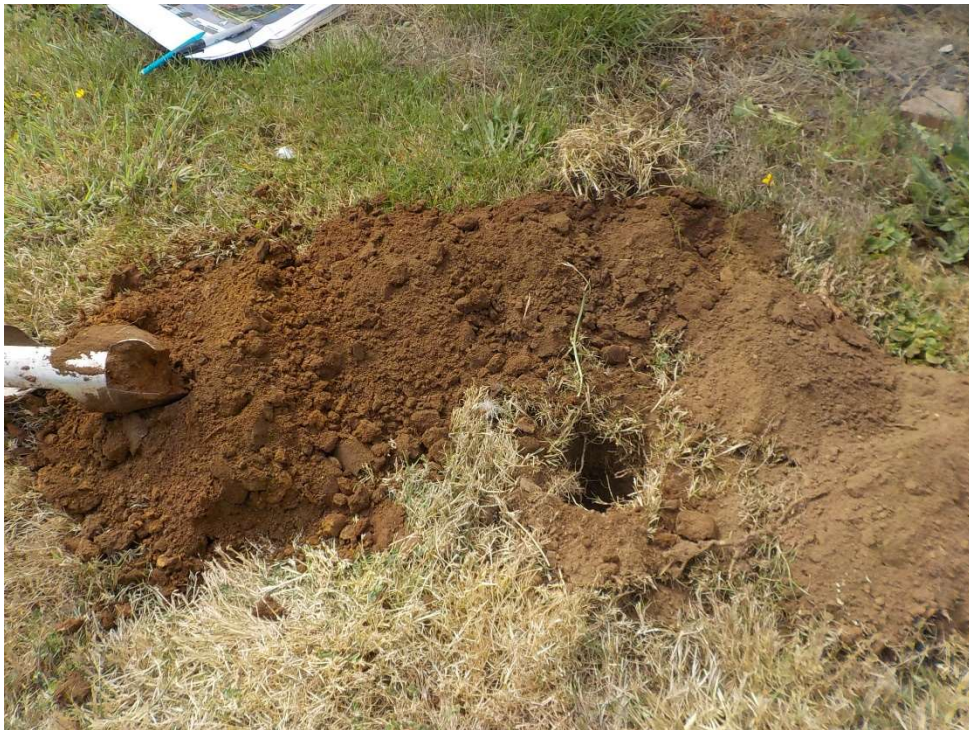
<u>Depth (ft.)</u>	<u>USCS</u>	<u>Description</u>
0 – 2.5	ML(FILL)	Gravely Sandy SILT FILL; light brown, dry, loose.
2.5 – 3.5	ML	Sandy SILT; brown, moist, loose to medium dense. Increasing density with depth
Boring terminated at the extent of the auger at approximately 5 feet bgs. Free groundwater was not encountered.

Photo 6 – View of the soils encountered in Boring B-2.

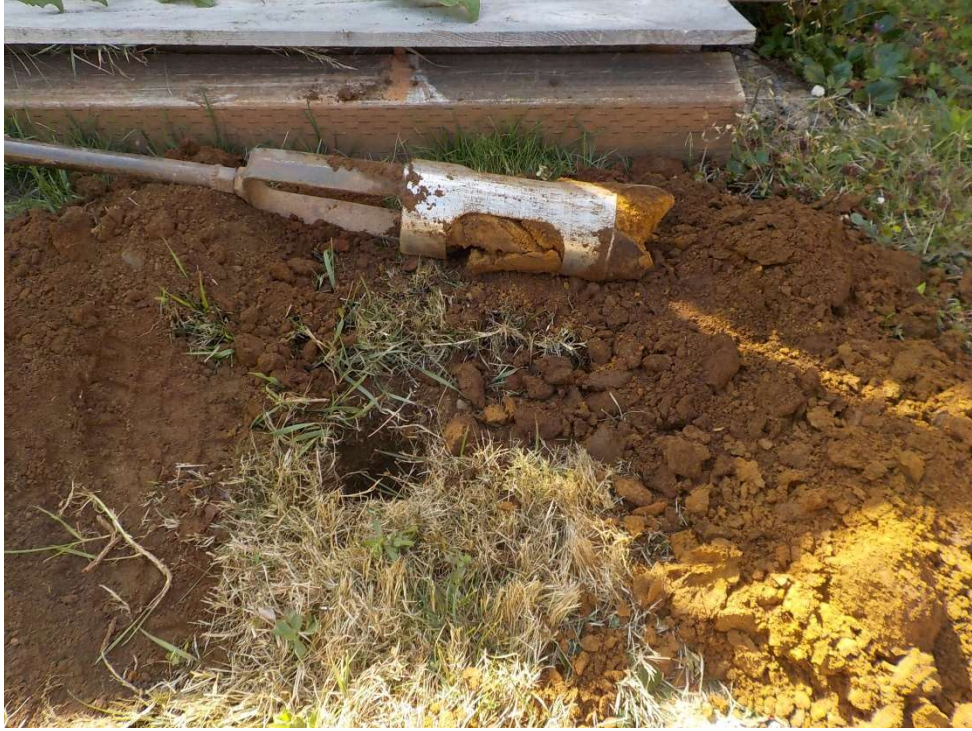
<u>Depth (ft.)</u>	<u>USCS</u>	<u>Description</u>
0 – 2.5	ML(FILL)	Gravely Sandy SILT FILL; light brown, dry to moist, loose.
2.5 – 4.5	ML	Sandy SILT; brown, moist to wet, slightly dense to medium dense.
4.5 – 5.0	SP	Slightly Silty SAND; light brown/orange-brown, moist, dense. Moderately- to well-cemented dune sand.

Photo 7 – View of the soils encountered in Boring B-3.
