# Geologic Hazard Report Review Application

# Geotechnical Report for Deck

3730 SW Anchor Court  
Lincoln City, Oregon

# TOPOGRAPHIC SURVEY

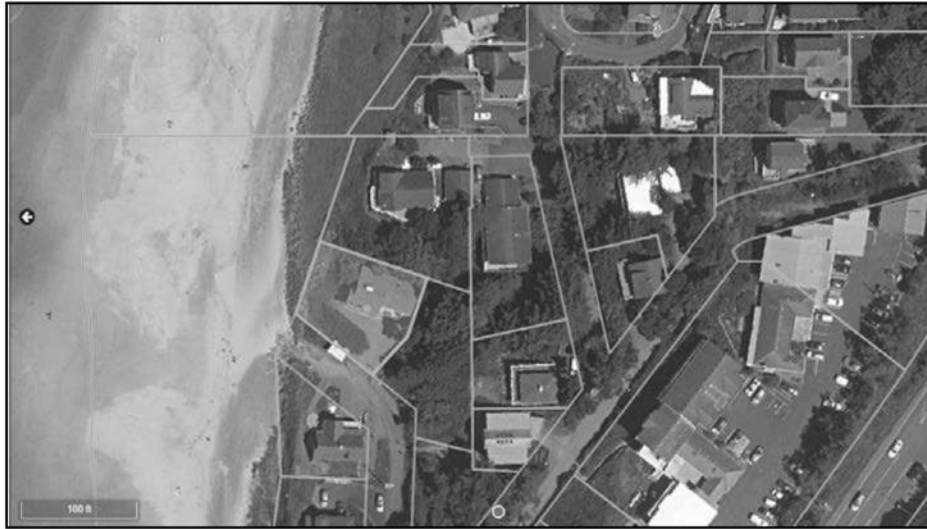
*Lincoln County web maps: 2021 aerial image of the site.*

Historic aerial imagery dating back to 1982 was referenced as part of this investigation. This imagery indicates that the north-northwest trending SW Anchor Ct that leads to the beach was developed prior to 1982. The 1982 image depicts the vacant and vegetated subject site. In 1994, majority of the ocean front parcels, including the subject site, were developed containing single-family dwelling homes. Local residential developments continued slowly and intermittently through the most recent image.

Overall, review of the aerial images from 1982-present depicts no substantial changes to the subject site.
