Earth
Engineers,
Inc.

**Subject: Geologic Hazard Visual Assessment Report
6703 NW Logan Road,
Lincoln City, Lincoln County, Oregon
EEI Report No. 24-026**

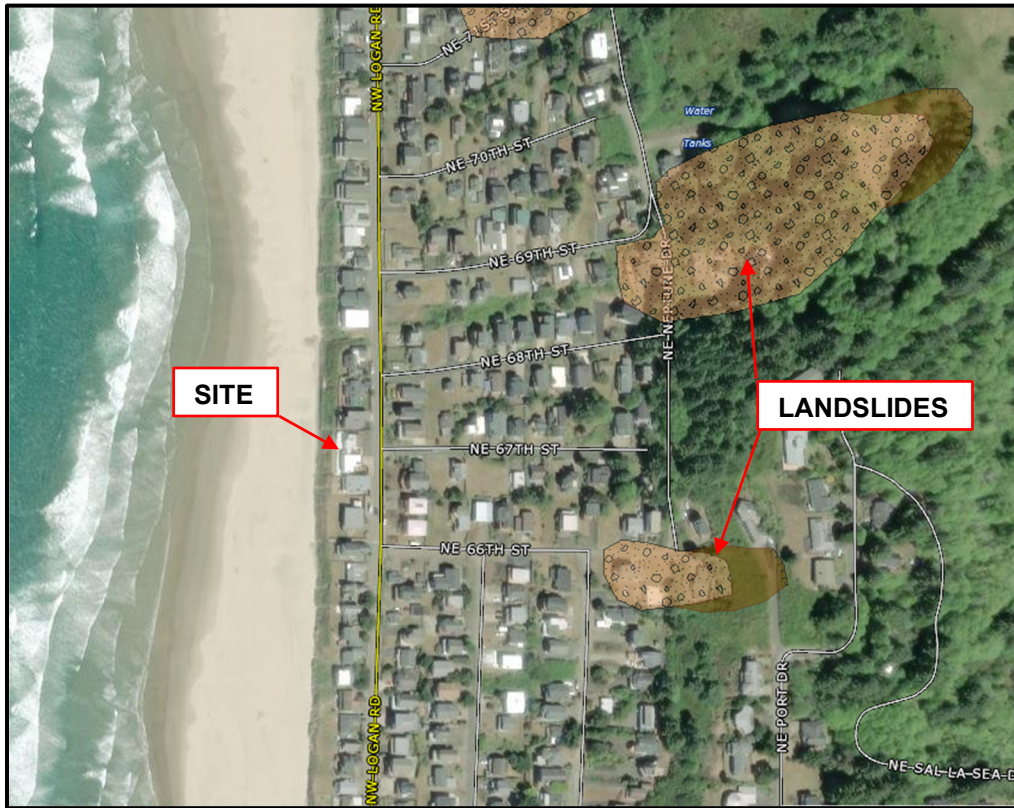
According to HazVu, the property is not mapped within an area that includes any mapped landslides. However, two landslides have been mapped to the east of the site. The slides are mapped approximately 500 to 600 feet to the east of the site and originated in the hills east of NE Neptune Drive (Figure 2).

Figure 2: Location of nearest mapped landslides.

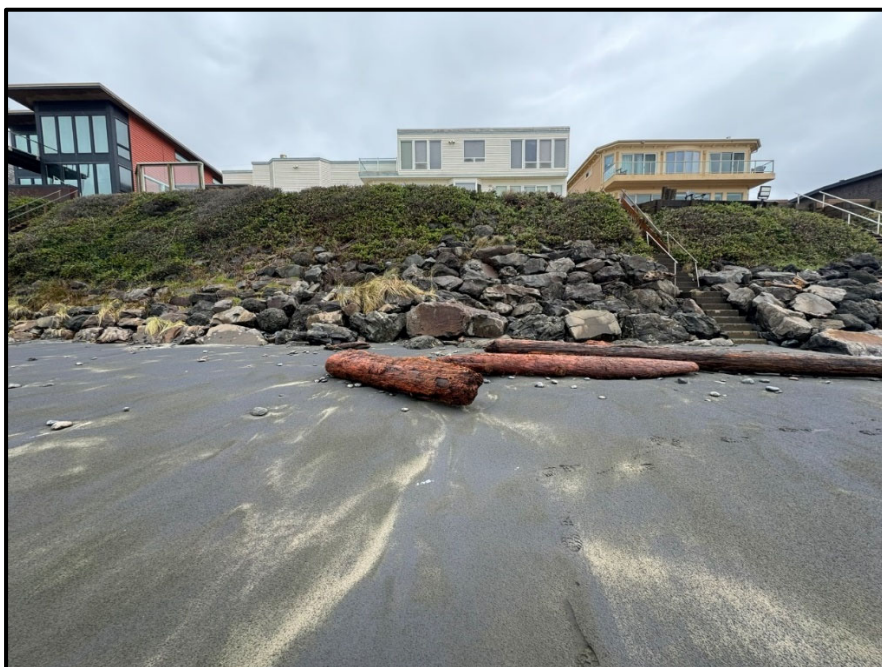
The existing residence built in 1999 is situated on a 0.52-acre property located at 6703 NW Logan Road, Pacific City, Pacific County, Oregon. The tax lot, 06-11-34-AA-01500-00 is bounded to the north and south by existing residential properties, to the west by the Pacific Ocean, and to the east by NW Logan Road. Approximately 0.26-acre of the site is west of the vegetation line. The site has an existing shoreline protection structure (SPS; rip-rap revetment) at beach elevation and access to the beach is by an existing wooden staircase near the southern property line (Photo 1).

2. The steepest portion of the lot slopes seaward (west), and consists of a SPS (rip-rap revetment) down to beach elevation. The SPS is approximately 20 feet high, 20 to 30 feet wide, and slopes at approximately 45 degrees towards the beach. The SPS runs the entire beachfront length of the property (approximately 100 feet). The SPS (where not covered in vegetation) appeared to be in good condition and functioning properly, and continues southward abutting the adjacent property to the south (Photo 1). The SPS for the lot to the north was observed to be composed of a concrete block wall. We did not observe any active seeps, streams, or springs at the time of our site reconnaissance. Three drift logs were observed on the beach near the base of the SPS.

Photo 1: Adjacent beach, looking east toward the existing residence and revetment.
