July 19, 2019

RE: GEOLOGIC HAZARD ASSESSMENT AND GEOTECHNICAL EVALUATION
4633 SOUTHWEST BEACH AVENUE
TAX LOT 7-11-27-CD 3600, ACCOUNT R420048
LINCOLN CITY, OREGON 97367
Branch Engineering Inc Project No. 19-225

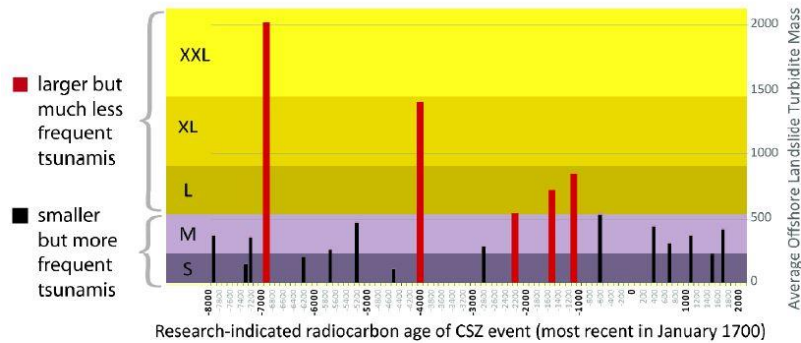
Occurrence and Relative Size of Cascadia Subduction Zone Megathrust Earthquakes

Research by geologist Chris Goldfinger at Oregon State University suggests the chance of a massive subduction zone earthquake in the next 50 years in the Newport/Lincoln City vicinity has a one in three to one in four probability, and an earthquake timeline graph is included showing size and frequency of coastal earthquakes

Figure 3: This chart depicts the timing, frequency, and magnitude of the last 19 great Cascadia Subduction Zone events over the past 10,000 years. The most recent event occurred on January 26, 1700. The 1700 event is considered to be a "medium sized" event. The data used to create this chart came from research that examined the many submarine landslides, known as "turbidites," that are triggered only by these great earthquakes (Witter and others, 2011). The loose correlation is "the bigger the turbidite, the bigger the earthquake."
