**Geologic Hazards and Geotechnical Investigation
Tax Lot 1100, Map 7-11-10AB
2715 NW Inlet Avenue
Lincoln City, Oregon**

Project #Y244738

July 17, 2024

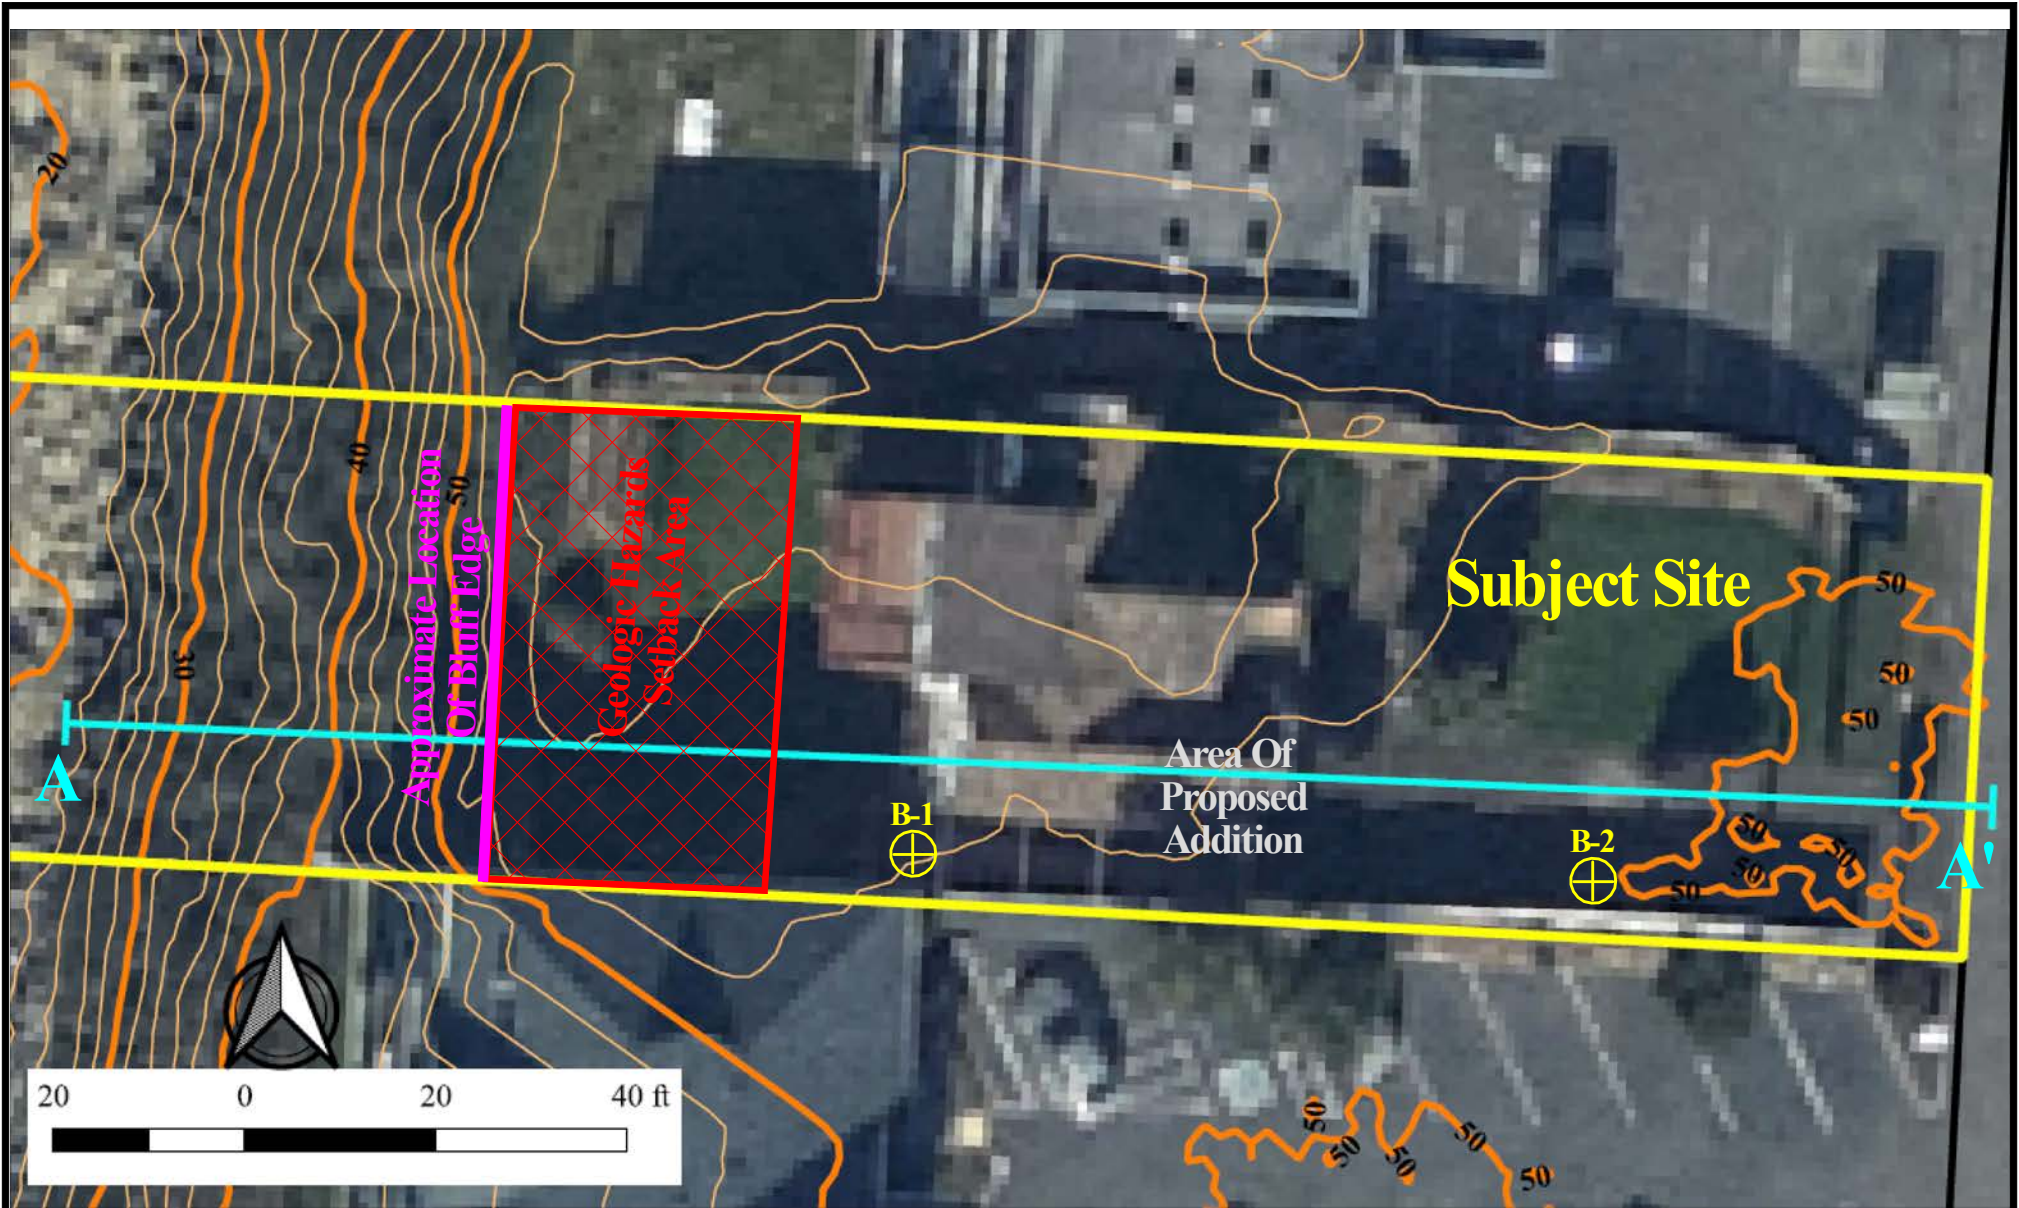
Date: 07/17/2024	Project #Y244738	Prepared by: MGB
		Approved by: AML
Site Topographic Map Tax Lot 1100, Map 7-11-10AB 2715 NW Inlet Avenue, Lincoln City, Oregon		
H.G. Schlicker & Associates, Inc.		Figure 3

The area of the subject site east of the top of the bluff slope is gently sloping between approximately 1 and 6 degrees, and the elevation ranges between approximately 50 and 54 feet (NAVD 88) (Figures 3 and 4).

The beach slopes west at approximately 2 degrees in the winter and a few degrees in the summer. Based on our review of beach morphology monitoring data available for this section of Oregon's coast from 1997 to 2002, beach elevations varied by 0 to approximately 4 feet from minimum to maximum (Allan and Hart, 2005). The beach elevation can change substantially associated with El Niño and La Niña events. Topographic contours derived from 2016 lidar data provided by NOAA show the elevation above mean sea level of the beach-bluff junction west of the subject property as approximately 20 feet (NAVD 88) (Figure 3), which generally agrees with data from Allan and Hart (2005).

used a tile probe to estimate depths to dense material in areas closer to utilities and other existing improvements. The approximate location of the boring is shown on Figures 3 and 4. A geologist from our office visually classified the soils encountered according to the Unified Soil Classification System (USCS) as follows:
