Instructions for Geologic Hazard Report Review Application

Geologic Hazard Report Review Application

Rapid Soil Solutions Inc (RSS) has prepared this geotechnical report, as requested, for the proposed deck addition located at the Lincoln County tax lot currently assigned the site address of 1327 NW Harbor Avenue. The subject parcel accommodates 6-unit ocean front townhomes/rowhomes; development area is located on the northernmost end of the parcel (unit6). The purpose of this report is to assess the geotechnical suitability of the subject site and provide geotechnical recommendations based on visual observations, collected soils samples and review of available literatures.

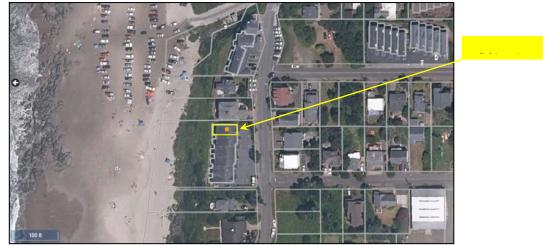
Lincoln County web maps: 2021 aerial image of the site.

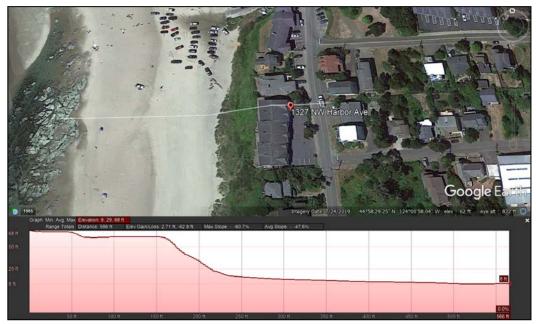
Google Earth: satellite aerial image of the site and elevation.

The property envelope is perched upon a marine terrace graded roughly 5-6 feet lower than NW Harbor Avenue. The Google Earth DEM suggests that the internal slopes on the property are roughly 2%. The bluff west of the site is on slopes of about 45-55 percent. The existing dwelling is positioned at approx. 20-ft from the abrupt slope break at the top of the bluff.

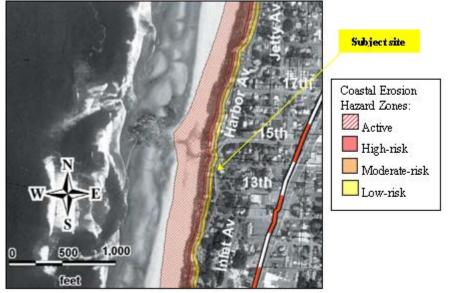
Erosion hazard zones of the local coastal environment. Excerpt from Priest and Allan (2004: O-04-09).

The subject site is located directly adjacent to a mapped Active Erosion Hazard Zone (Priest & Allan, 2004: OFR O-04-09). The zone extends from the shoreline to the top of the edge the bluff, and/or to the headwall of active and potentially active shoreline landslides. Consistent with the current understanding of beach process, building within and along the upper edges of bluff-backed shorelines reflects a considerable risk from direct wave attack at the bluff toe and slope instability. The site spans across high-risk, moderate-risk, and low-risk hazard zones. The high-risk zone represents a best-case scenario for erosion, assuming a gradual mean erosion rate over 60 years while maintaining a slope at the angle of repose for talus. The low-risk zone represents a possible extent of bluff retreat assuming a maximum erosion rate for 100 years paired with a maximum slope failure (slough/landslide).

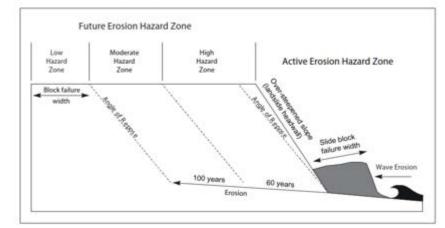
Erosion hazard zones schematic illustration, excerpt from Priest and Allan (2004: O-04-09).

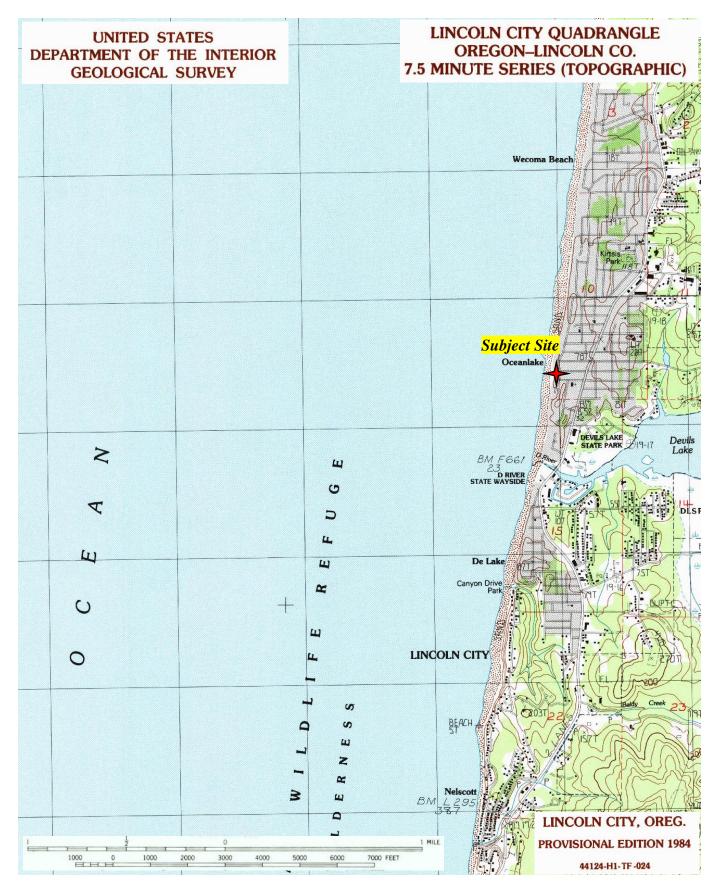
Figure 1: Subject site location on the northeast quarter of the Lincoln City Quadrangle

The subject site can be found in the southwestern region of the southeast quarter of Section 10, Township 7-South, Range 11-West (W.M.) in Lincoln County and distinguished by the tax lot number of 07-11-10-DC-80001-00. The alternate account number of the site is R502363. The legal description of the site is 'Ocean Place Townhouse Condo, Lot Unit 6, DOC202110482.' The latitude and longitude of the site are 44.9747926 and -124.015964 (44°58'29.32"N, 124°0'57.47"W). See Appendix, Figure 1 for site location. Subsequent figures include additional site location information.

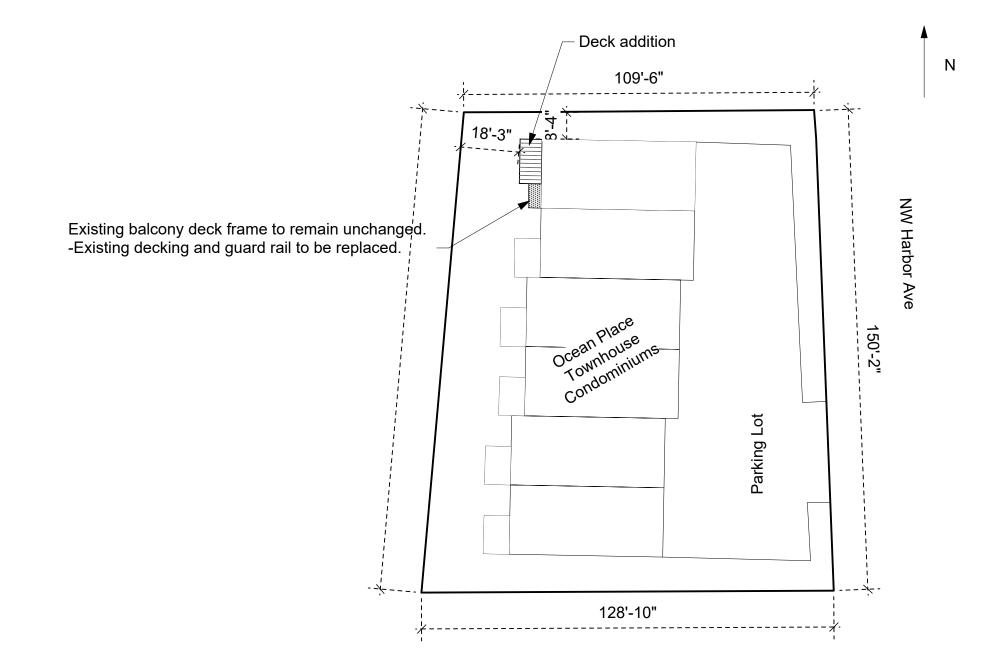
General Contractor	Project Title	Project Manager	Drawing Title
TnT B	uilders	TnT Builders Inc		Brent Mosser	Site Plan
77		620 Queen Ave. SW Albany, OR 97322	Wright Deck Modification 1327 NW Harbor Ave	October 24, 2022	Scale 1" = 30'
deck and patio	o cover experts	CCB #105770	Lincoln City, OR 97367	Phone (541) 926-3117
